Alpine Condominiums

Level 1 Reserve Analysis

Report Period – 03/01/07 – 12/31/07

Date of Property Inspection – January 10, 2007 and March 8, 2007

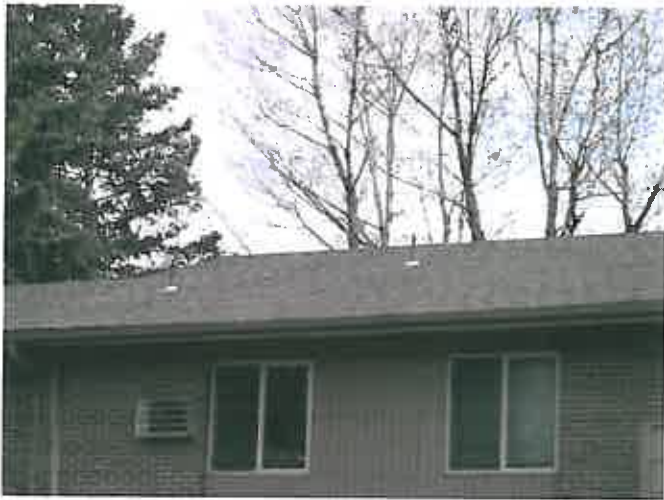
Comp #: 105 Comp Shingle Roof - Replace

There was some loss of granules and other general signs of deterioration, such as minor curling. These are the beginning stages of the roof material nearing the end of the life expectancy. This roof appears to be a "25-year" rated shingle. Despite this rating, replacement typically needs to occur within 15 - 20 years due to weather elements such as hail, wind, and temperature fluctuations. It is not recommended that an overlay is applied when a roof needs to be replaced. With overlays, it may cause further damage from hailstones due to being a softer surface and wind due to uneven surfaces. Therefore, Reserve funding includes complete tearoff and replacement. Based on condition, we believe replacement will need to occur within the next 5 years.

\$150/square; Estimate to replace

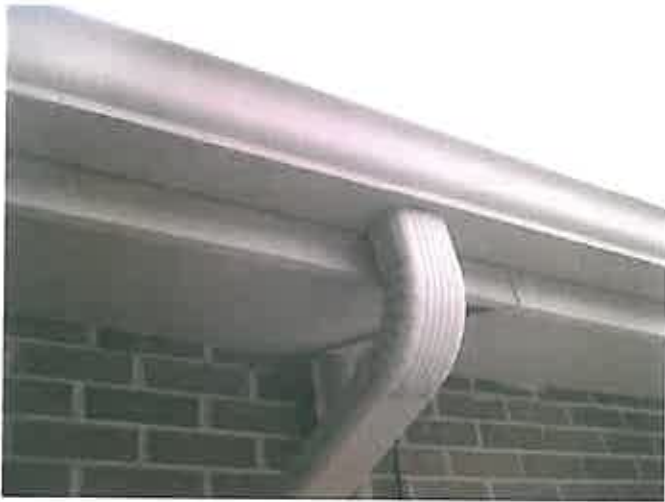
Comp #: 120 Gutters/Downspouts - Replace

Conditions varied throughout the community with the majority of lines older and nearing the end of their life expectancy. The average replacement cycle for gutters and downspouts ranges between 20 - 25 years, depending on maintenance. Keep gutters and downspouts free from debris which can cause corrosion of metal materials or blockage which can cause the downspouts to freeze and expand during winter months. Due to the varying conditions and per the request of the client, we have included Reserve funding for periodic replacement to 20% of area (400 LF) every 5 years. In addition, when replacement is required, we suggest increasing the lines to 5" for better drainage. Coordinate with roof replacement cycles.

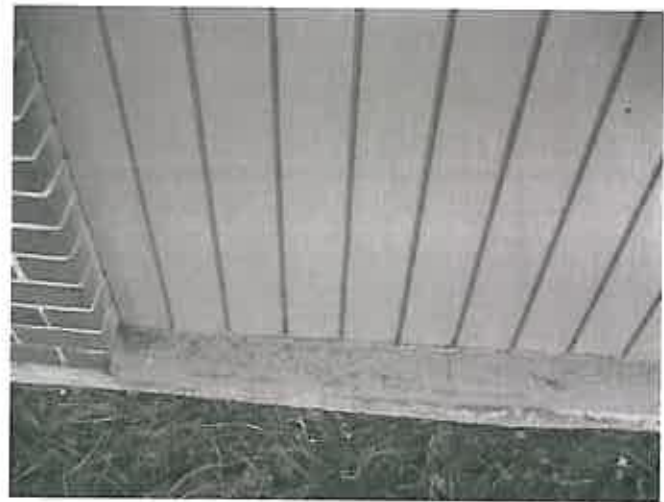
Comp #: 202 Wood Surfaces - Repaint

All wood surfaces between the brick (above the doors) and the trim was repainted in 2005 and is in good condition. In this climate, these surfaces should be repainted approximately every 3 to 5 years to maintain appearance and protect wood. Remaining life based on current condition and age of painted surface.

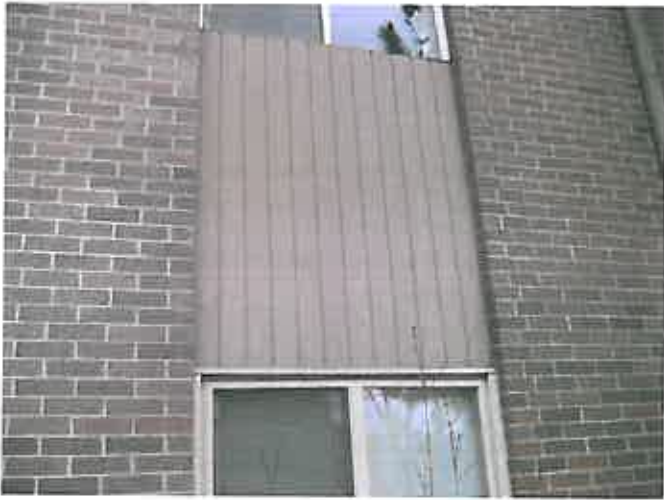
Comp #: 303 Wood Siding - Repair

Any wood work that needed to be repaired was done in 2005 as part of prep work before painting. We recommend Reserving a small allowance for periodic repair to wood trim and panels before each painting cycle every 5 years. The estimated cost of repairs was based on the last amount of repairs in 2007.

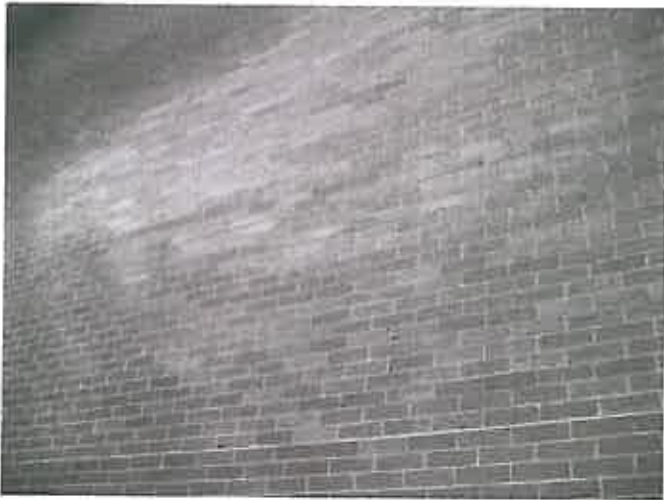
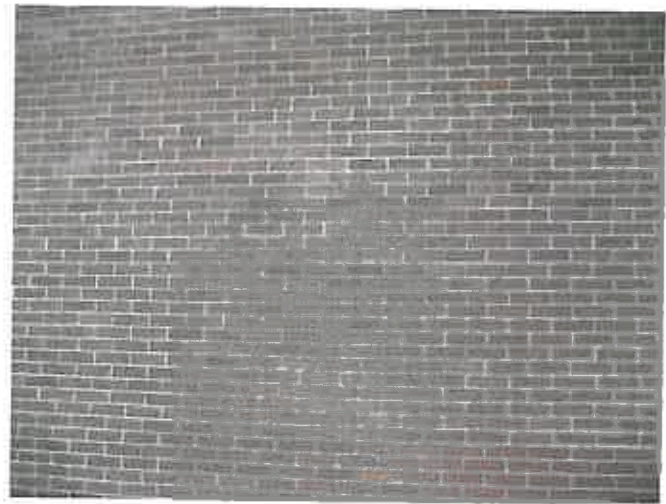
Comp #: 306 Brick - Replace

Bricks appeared to be attached to the sides of the building well with no loose or missing material noted. Typically, bricks have an extended life expectancy and complete replacement is unlikely. There are times where minor repairs may become necessary, but this is unpredictable when and how much would occur. Repairs should be handled as a maintenance issue on an as needed basis. Reserve funding is not required for this component at this time. If it later turns out that frequent repairs are necessary, then funding could be added in future Reserve Study updates.

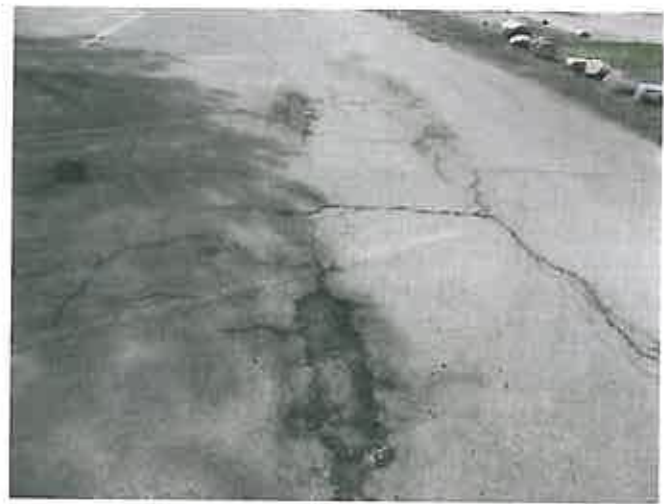
Comp #: 401 Asphalt - Overlay

The asphalt is generally in poor condition with severe cracking, and other signs of age and deterioration. The average life expectancy for asphalt surfaces ranges between 20 - 27 years for surfaces that are maintained on a regular schedule. Maintenance includes crack fill and repairing small potholes annually as an operating expense. In addition, asphalt should be seal coated every 2 -3 years, depending on the level of traffic and snow removing techniques. Based on observed condition, we suggest resurfacing with a 2" overlay this next year.

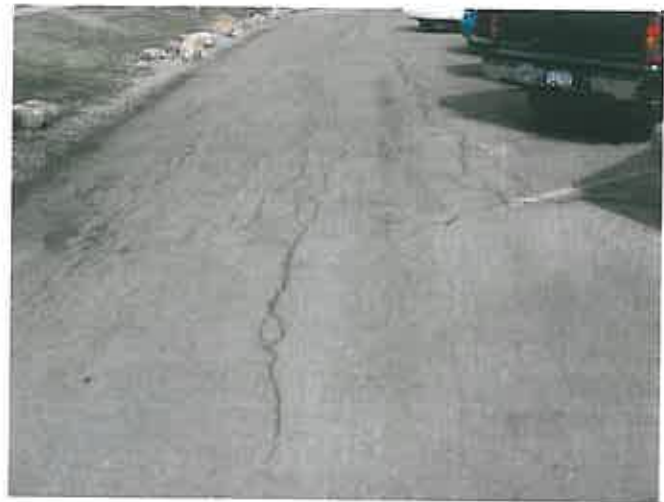
Comp #: 402 Asphalt - Seal Coat/crack fill

Current conditions are extremely dry, with severe cracking noted throughout. Based on current conditions, we believe an overlay is needed. Industry professionals recommend seal coating within 12 months of application of a new surface. In this environment, expect to seal asphalt every 2 - 3 years, depending on traffic levels and effects from weather. Sealcoating is applied to protect the asphalt from ultra-violet rays and water. This helps in slowing the process of oxidation and raveling. While acting as a protective barrier, it also maintains the appearance of the community to maintain or improve property values.

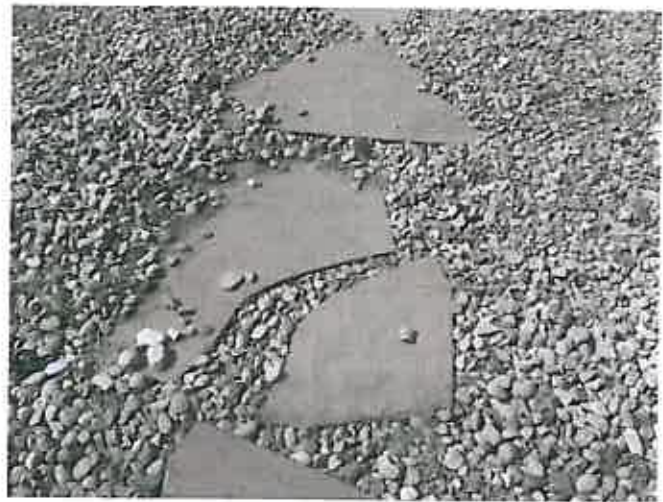
Comp #: 405 Flagstone Path - Repair/Replace

No unusual conditions observed at time of inspections. We suggest handling repairs on an as needed basis using operating funds. Therefore, at this time, Reserve funding is not required for this component.

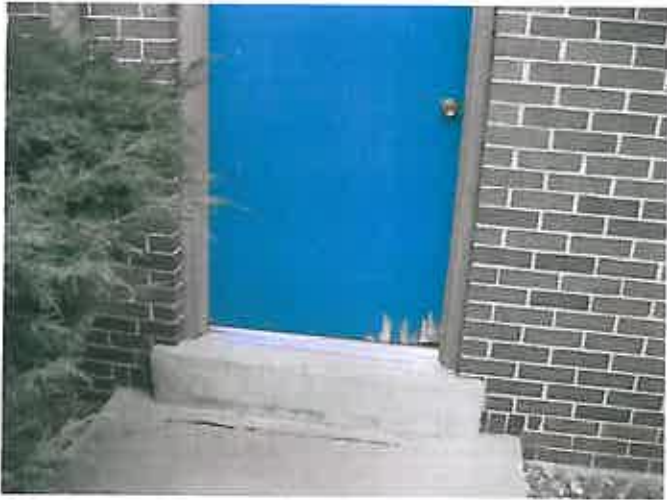
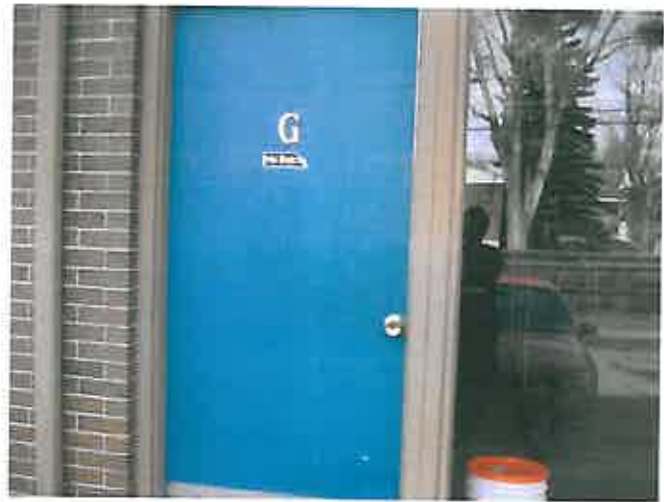
Comp #: 501 Common Doors - Replace

Along the bottom of some of the doors, the wood is beginning to delaminate and peel away. In order to maintain a consistent appearance, we recommend replacing all doors at the same time. Future life expectancies will depend on the quality of the door installed and the level of maintenance over the years.

Best Cost: \$6,300
\$350/door; Estimate to replace with new doors

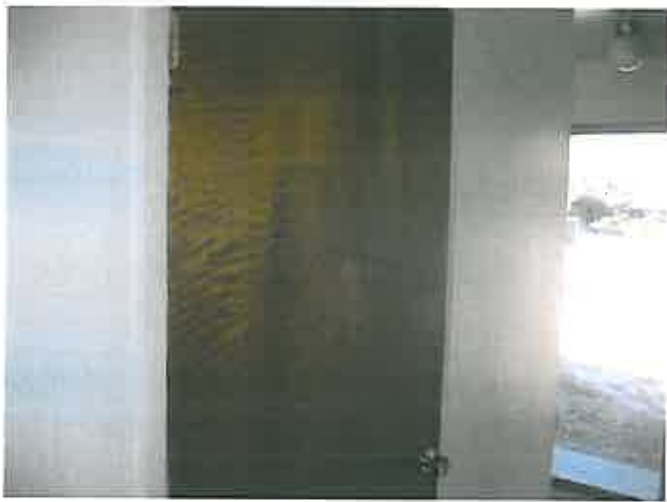
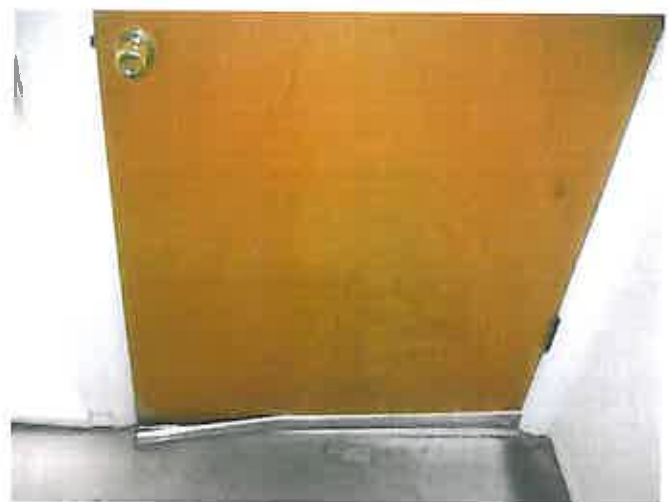
Comp #: 502 Interior Doors - Replace

Doors are dated in appearance, but functional. Replacement will depend on the aesthetic importance of bringing the style up to current trends. At this time, we suggest treating replacement on an as needed basis as a separate issue from Reserves.

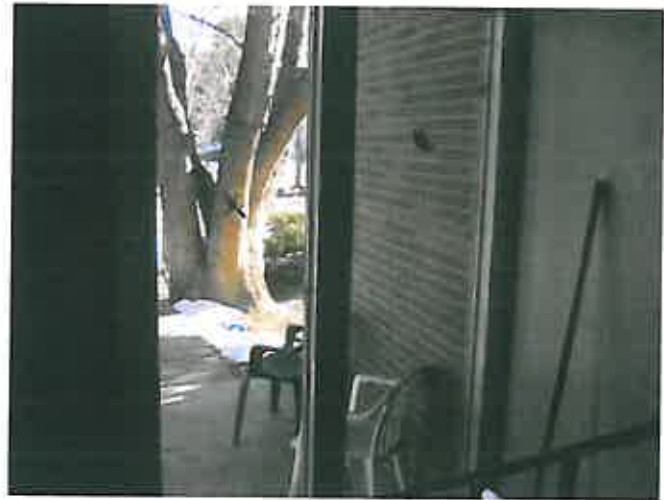
Comp #: 506 Windows - Replace

There was evidence of single pane windows on majority of corridors. These are less efficient when it comes to energy savings. The windows are functional and there were no broken windows or other problems observed. As reported by the Client, windows will be replaced on an as needed basis, therefore, reserve funding is not required at this time. The sooner the windows are replaced, the more energy savings the association can expect to receive. The exact cost of window replacement will depend on the quality of window installed.

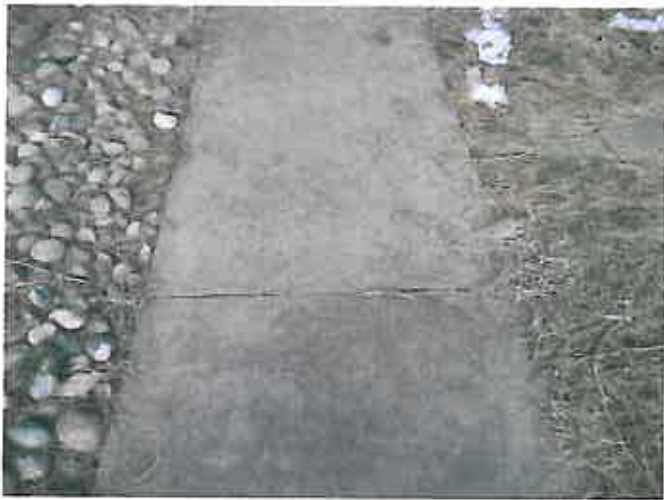
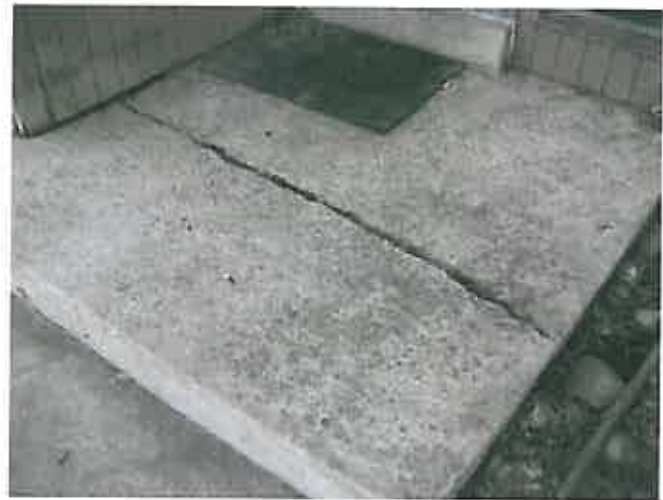
Comp #: 601 Concrete Sidewalks/Patios/Pool Deck - Repair

The concrete pad in the courtyard is in poor condition and does not appear to be used frequently. There were many trip hazards noted throughout the community at time of inspections. Sidewalks are older and have spalling throughout and have settled and cracked in numerous areas. Unit "D" sidewalk is in better shape than the others. While it is unlikely that all concrete surfaces will fail and need to be replaced at the same time, frequent repairs and replacement to a percentage of the area (10% or 565 GSF), should be anticipated. Per the request of the client, we have included an allowance to replace 1/10th of the area every year starting in 4 years (2011).

Location: Community Walks
Quantity: Approx. 5,650 GSF
Life Expectancy: 1 **Remaining Life:** 4
Best Cost: \$4,800
 Est. to replace 10% of area every year starting '11

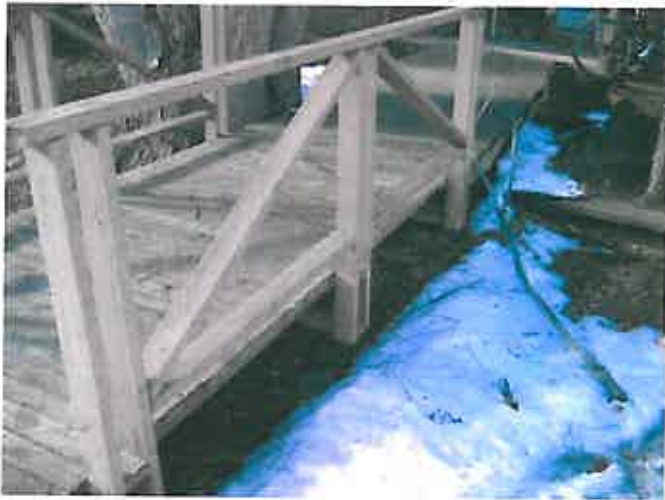
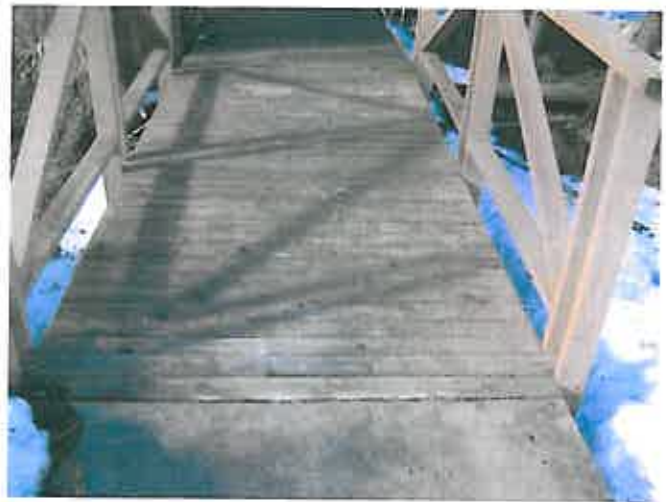
Comp #: 606 Wood Bridges - Replace

Bridges are older and nearing the end of the life expectancy. Since the association is currently replacing the pool deck with a synthetic material, expect similar material to be used on the bridges. Based on the current conditions, expect to replace within the next year. Synthetic decking material typically carries a 5 year warranty in a commercial setting. With proper maintenance and use, we would expect this product to have a replacement cycle of 15 - 20 years under normal conditions (shorter than pool deck due to expected higher foot traffic volume).

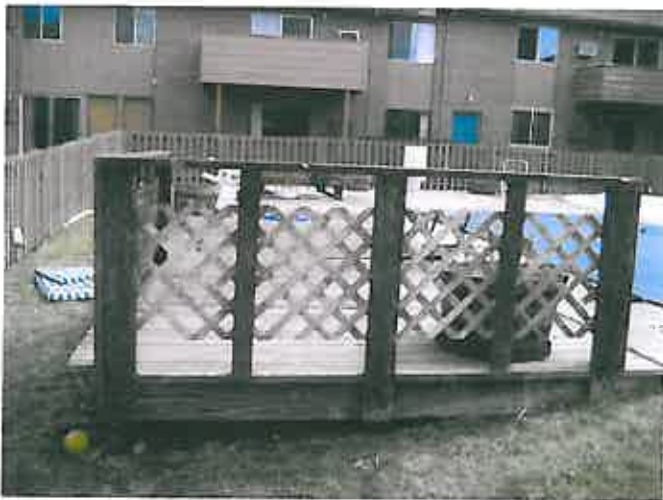
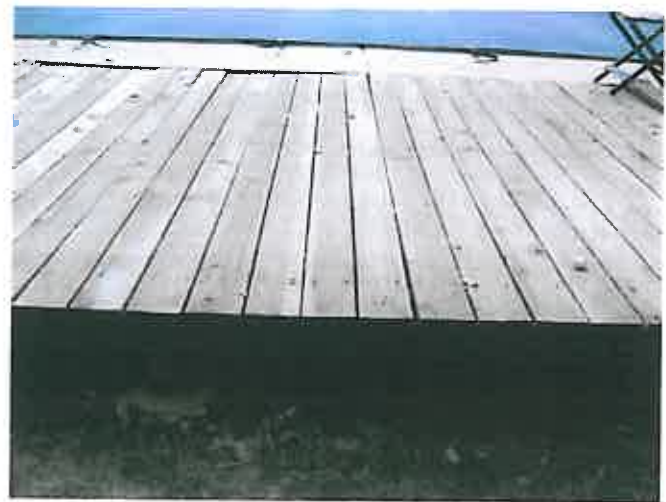
Comp #: 607 Pool Deck - Replace

At time of second inspection, the pool decks was weathered and deteriorated in appearance, According to the client, the deck was in process of being replaced with a composite material in May 2007. This material typically has a 5 year warranty in a commercial setting. With proper maintenance and use, we would expect this product to have a replacement cycle of 20 - 25 years under normal conditions.

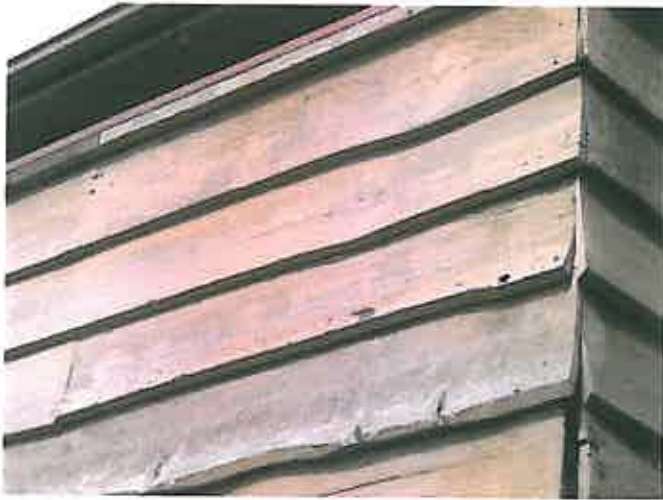
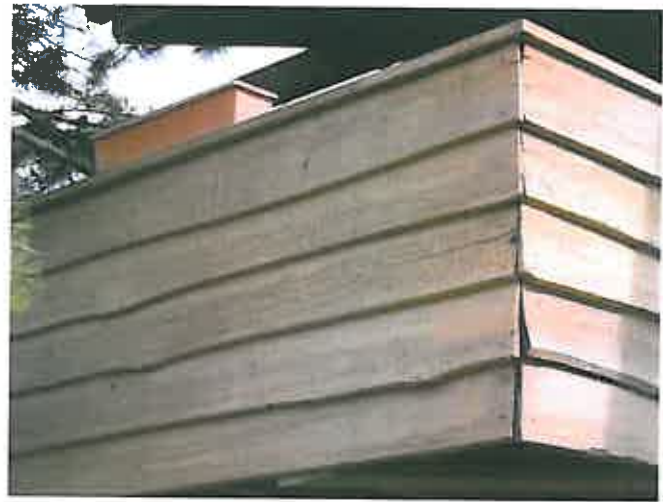
Comp #: 608 Wood Balconies - Replace (B)

Buildings (A) & (B) balconies could use repairs and new paint. In general, the conditions of the balconies are poor and should be addressed soon. Reserve funding to address the siding is included in component #302, so additional funding is not required. This line item is for the deck material only. Due to the financial situation of the association, we have deferred this project a few years to allow the Reserve fund to strengthen. When replacement is required, we recommend using an alternative product that has a longer life expectancy and won't require maintenance as frequently.

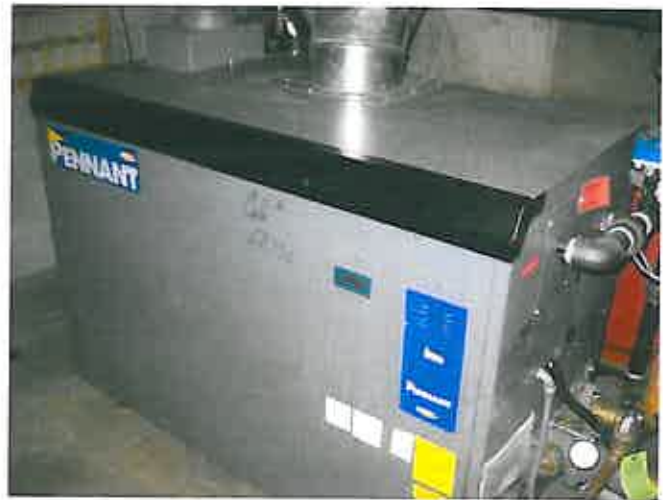
Comp #: 701 Large Boiler - Replace (A)

Boiler is new within the past few years and appears to be in very good working condition. According to manufacturer, these units typically do not require complete replacement. However, parts eventually become obsolete after numerous years and with advances in technology, replacement may become necessary at some point in the next 25 - 30 years.

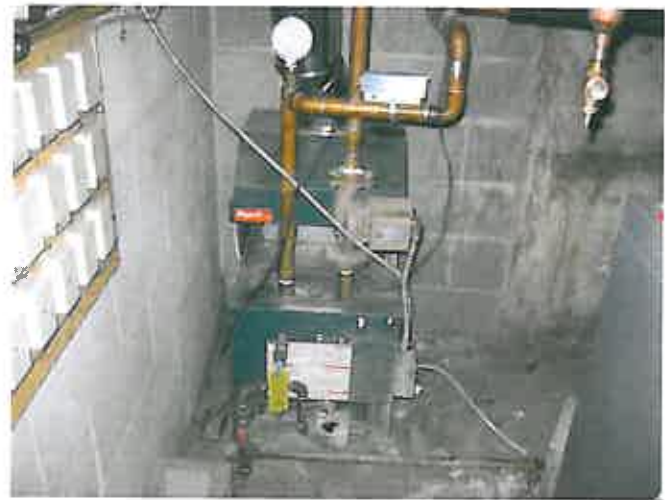
Comp #: 702 Small Boilers - Replace

These are most likely used for the baseboard heaters in the building corridors. These appear to be older and nearing the end of the life expectancy. There was evidence of rust and corrosion noted on the base of the heaters. Replacement cycle will depend on the level of use, maintenance, and quality of water running through the system.

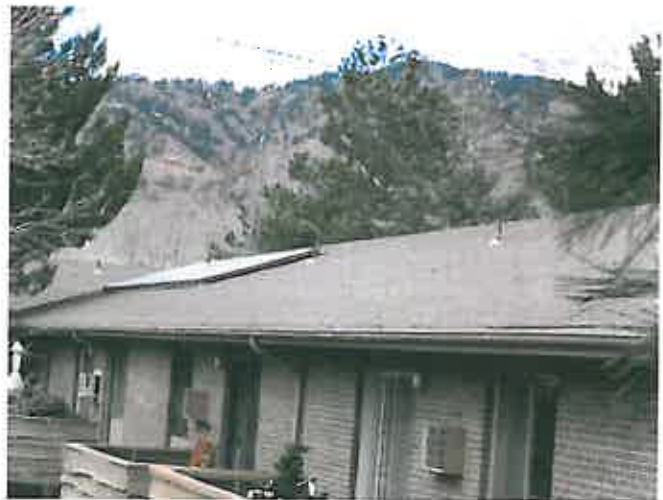
Comp #: 704 Solar Panels - Replace

It is unknown whether this system is still operable today. Reported these have not been used in many years and there are no plans to reinstate the unit. Therefore, at this time, Reserve funding is not required for this component.

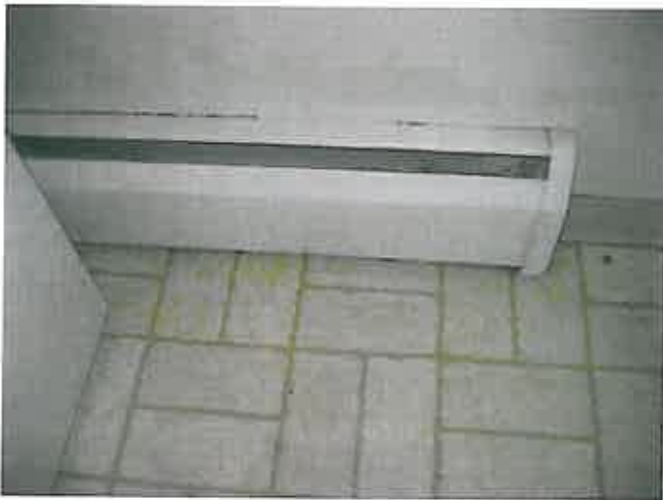
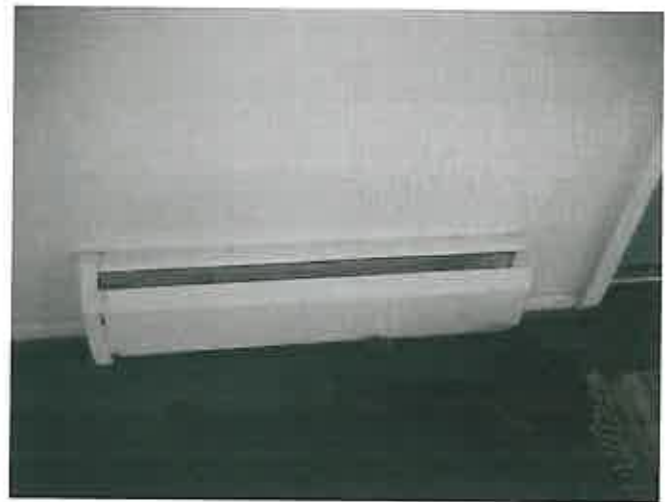
Comp #: 705 Baseboard Heaters - Replace

No unusual conditions reported or observed during inspection. These units have an extended life expectancy and should be replaced on an as needed basis with operating funds. At this time, separate Reserve funding is not necessary for this component.

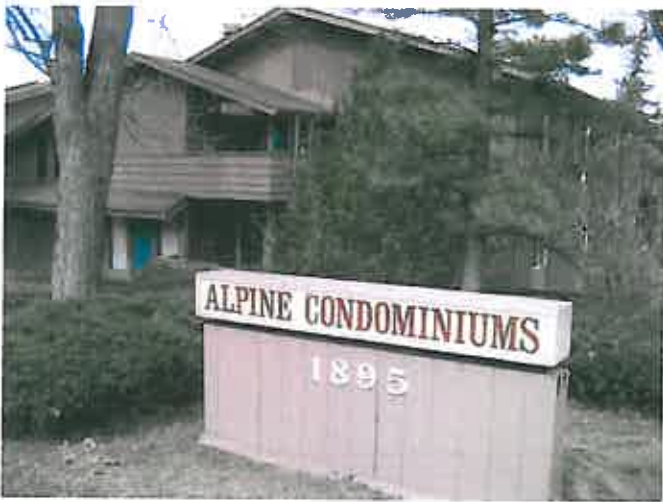
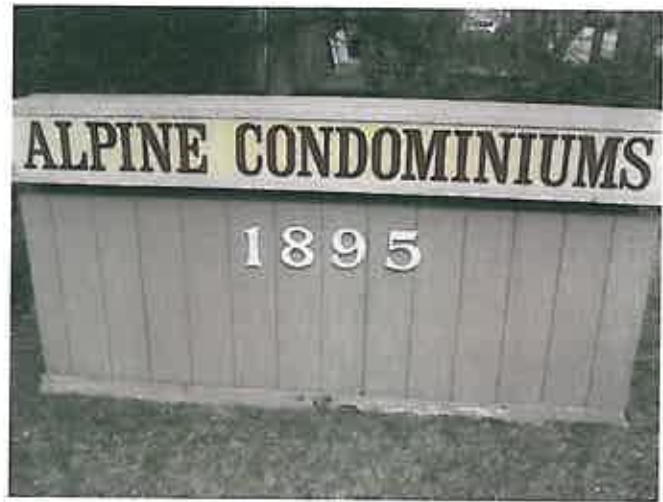
Comp #: 801 Monument - Rebuild

Sign is unstable with general signs of weathered wood and some rot was observed. Despite these conditions, the client has requested the remaining life of this component to be extended out to 7 years. The cost of replacement and future life expectancies will depend on the style and materials used when replacement occurs. The life expectancy can be adjusted in future Reserve Study updates depending on material selected for the new sign.

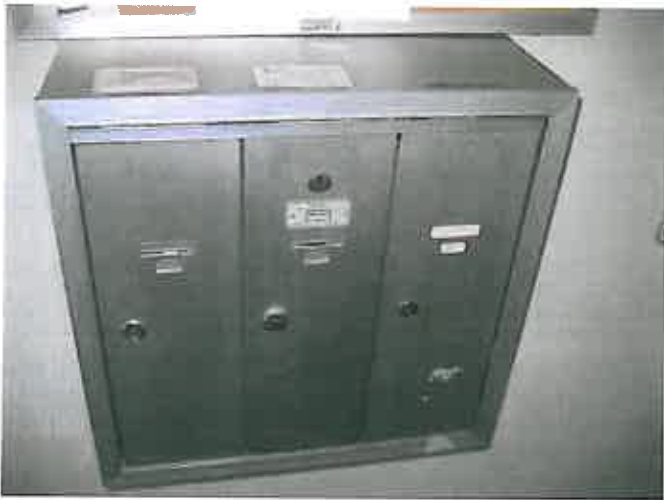
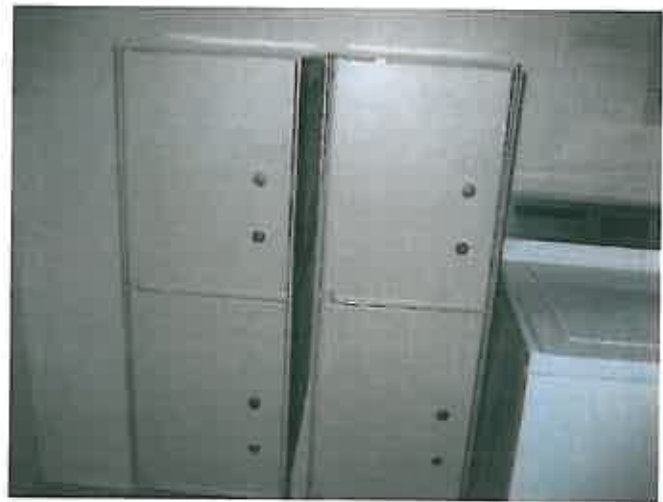
Comp #: 803 Mailboxes - Replace

No unusual conditions observed at time of inspection. These are installed inside and protected from the elements. According to the manufacturer, these boxes will have a life expectancy of 18 - 20 years due to location and quality. Remaining life is based on age and observed condition.

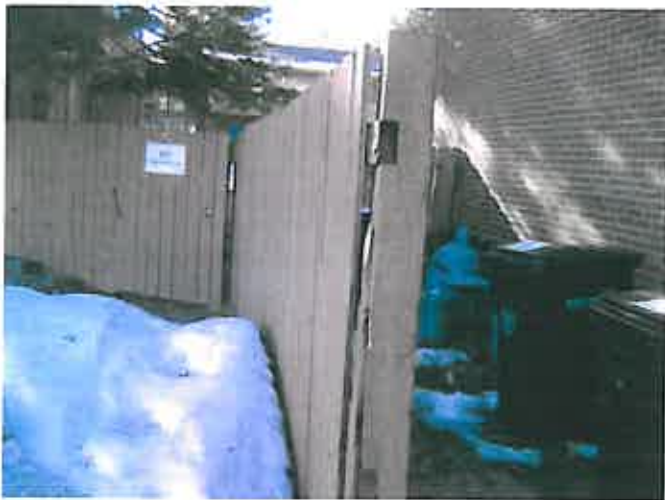
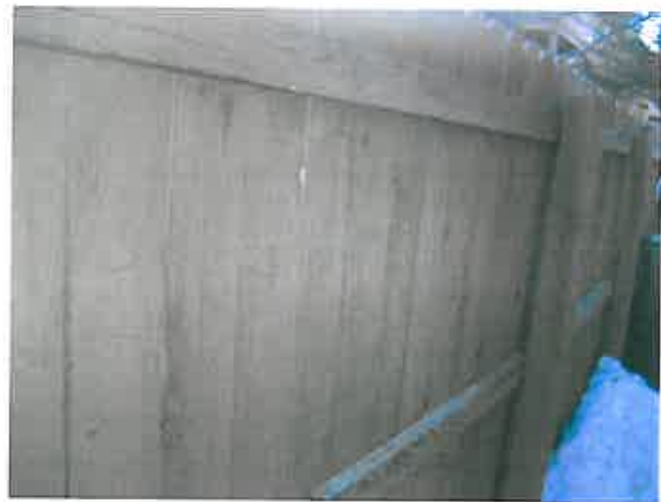
Comp #: 1001 Wood Fencing - Replace

Fencing connecting E/J has been replaced recently, but paint is peeling in areas. The fencing connecting A/F is in fair condition and could also use paint. Trash enclosures are in poor condition with boards coming loose and paint peeling. One of the courtyard wood fence enclosure is new and one is old and in need of replacement. Per clients request, we have established a 10 year replacement cycle with 4 years remaining.

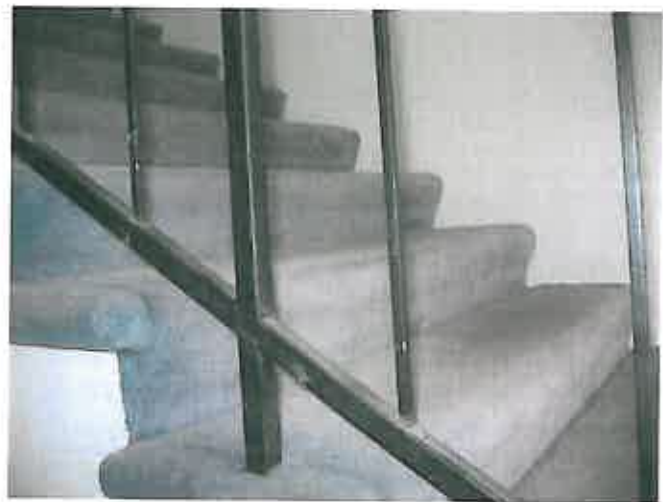
Comp #: 1002 Interior Iron Hand Rails - Replace

Iron Handrails are not to code because of distance between pickets. We suggest replacing immediately due to safety concerns. Despite this suggestion, the association wants to replace these on an as needed basis with general operating funds. It should be noted that this is strongly against our recommendation. If the association decides to do this as needed, we suggest replacement begins immediately. .

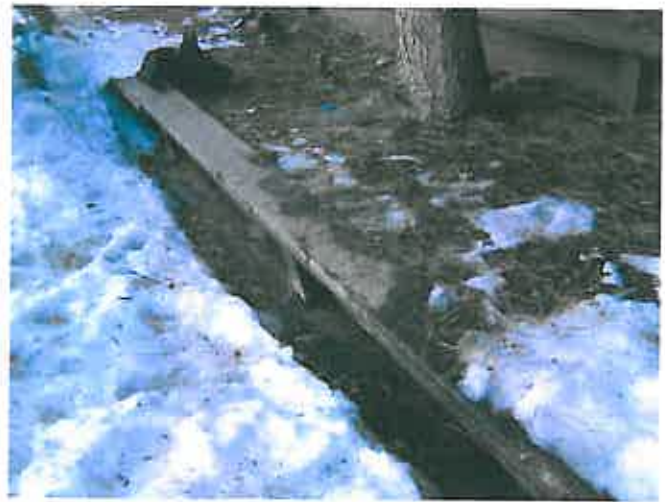
Comp #: 1007 Wood Retaining Wall - Replace

Wood retaining wall is leaning badly and in poor condition. We recommend that the wall be replaced with a block retaining wall. Per the clients request, we have extended the remaining life out 5 years to be replaced in 2012. Future funding requirements can be deleted if the association replaces with block. If association replaces with wood, then expect to replace every 15 - 18 years.

\$18/GSF; Estimate to replace with block wall

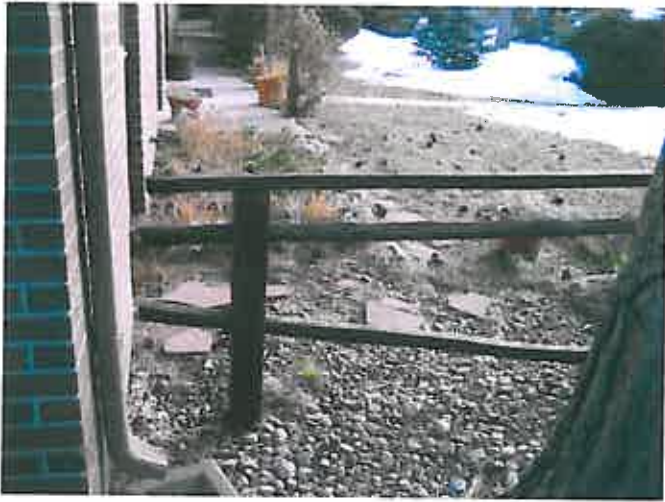
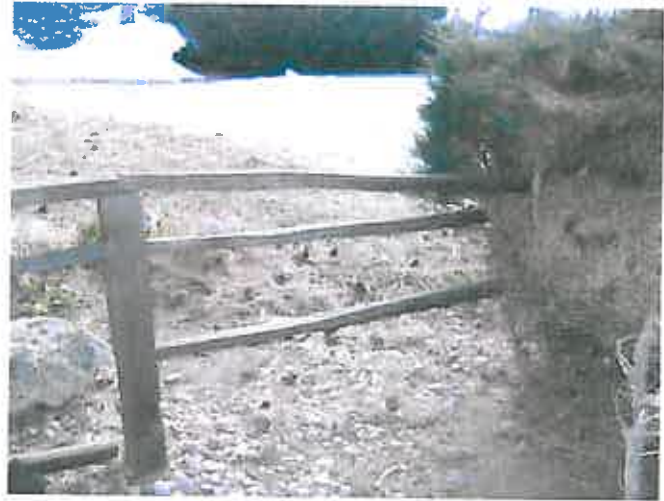
Comp #: 1009 Split Rail Fencing - Replace

Split rail fencing is in poor condition and falling apart. Due to the small area, this fence should be replaced on an as needed basis with general operating funds.

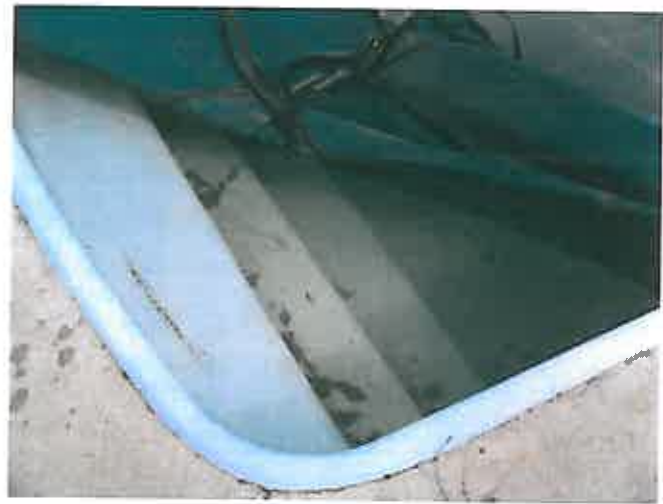
Comp #: 1101 Fiberglass Pool - Gel Coat

Pool appears to be older but still structurally in good condition. Acrylic pools have a limited warranty of 25 years, but according to local representative, the life should be indefinite (pools installed in 1950's are still in existence without any problems). The major maintenance requirements is to gel coat the surface every 3 - 5 years, depending on the chemical levels and the amount of use. Based on observed condition, we recommend performing a gel coat application before next pool season in 2008.

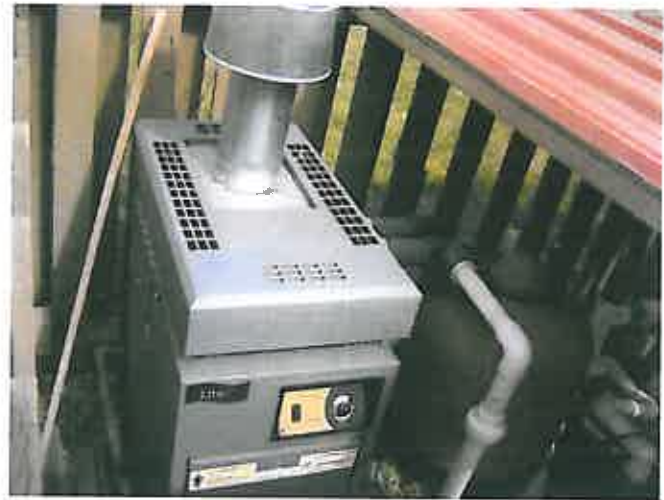
Comp #: 1104 Pool Heater - Replace

Heater appears to have been replaced within the past 2- 3 years and is in good condition. No significant carbon build-up or rust noted at inside base of unit. This type of pool heater typically has a useful life of approximately 10 to 12 years. Remaining life based on current age and condition.

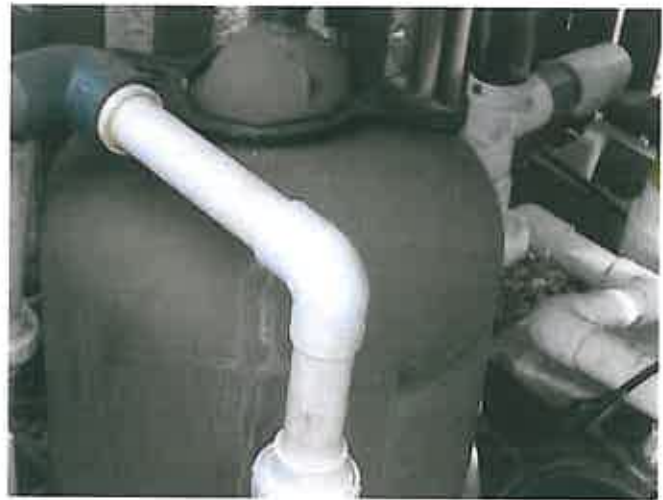
Comp #: 1107 Pool Filter - Replace

Pool was winterized at time of inspection, so we were unable to inspect for leaking. Reported that the filter is original (or very old) and nearing the end of its life expectancy. There were no signs of past leaks or any other unusual conditions during inspection. Plastic filter tanks typically have a life expectancy of 12 - 15 years under normal conditions and with proper maintenance. The remaining life is based on age and current condition.

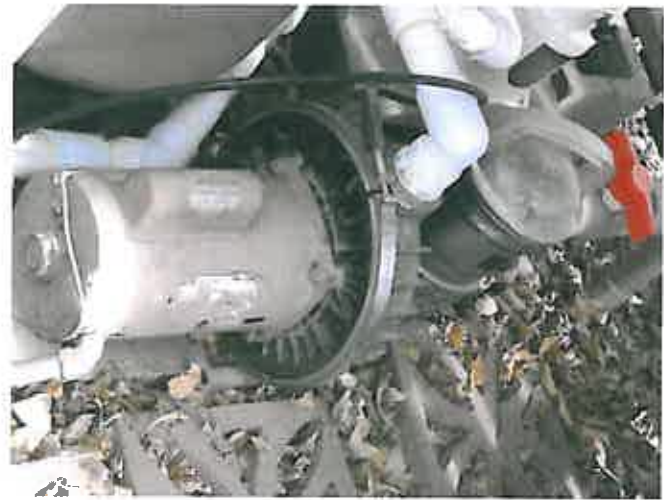
Comp #: 1110 Pool Pump - Replace

No unusual conditions observed during inspections. Pool was winterized at time of both inspections, so unable to observe in operating condition. According to service company, there were no problems toward the end of last year. Due to the minimal cost (less than \$600) to replace individual pumps we recommend repairing/replacing pumps as necessary as an operating issue. No reserve funding necessary for this component.

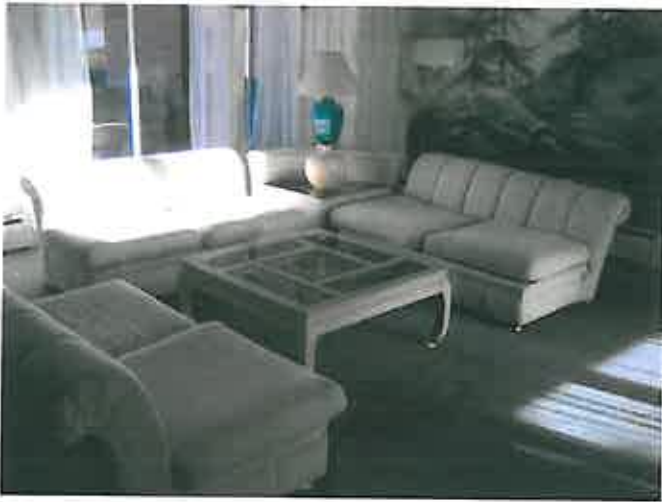
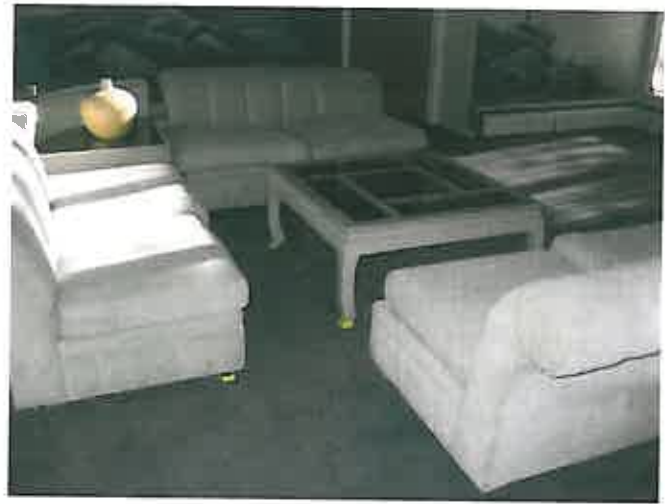
Comp #: 1415 Interior Lobby - Remodel

Older furniture in fair condition. Based on observed condition, we recommend updating and replacing furniture within the next couple years. Replacement cycles depend on level of use and care.

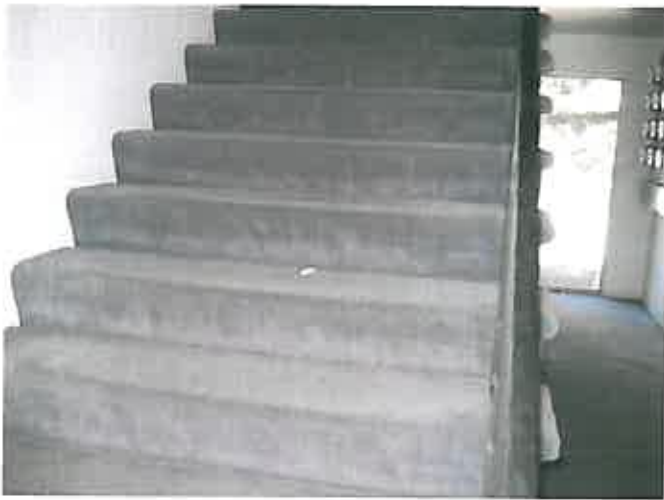
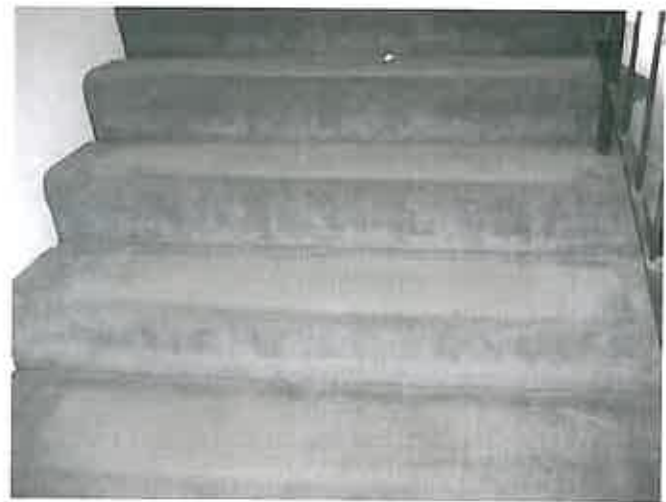
Comp #: 1501 Carpet - Replace

In general, the carpeting is worn and in poor condition. Based on observed condition, we recommend replacing in near future. However, per the clients request, we have extended the replacement cycle out to occur in 5 years, or 2012. Future life expectancy depends on the level of foot traffic and quality of carpet.

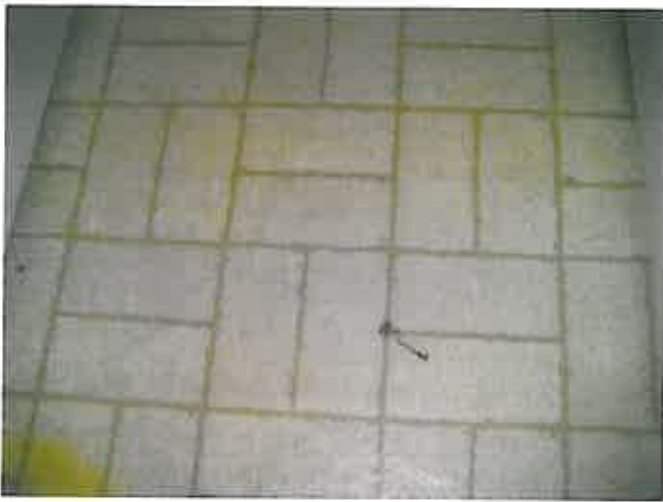
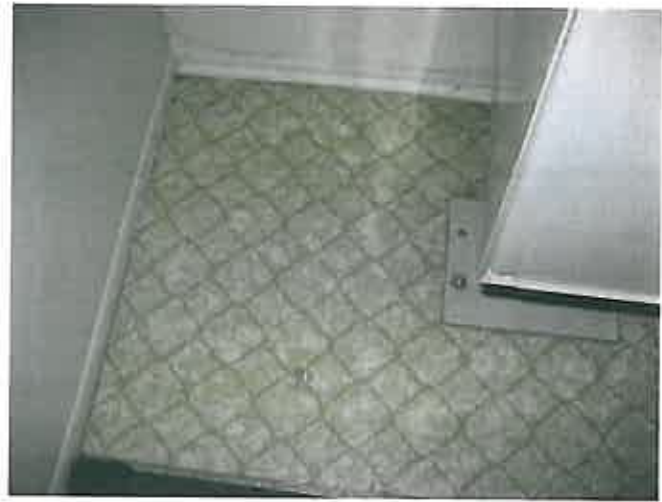
Comp #: 1502 Linoleum - Replace

Flooring is old and dated in appearance. There were several areas where the edges were curling, which could cause water damage if a leak occurred. We recommend replacing in near future based on condition. Typically, this is replaced at the same time as carpeting. However, it was requested to extend the remaining life on this component to 2 years.

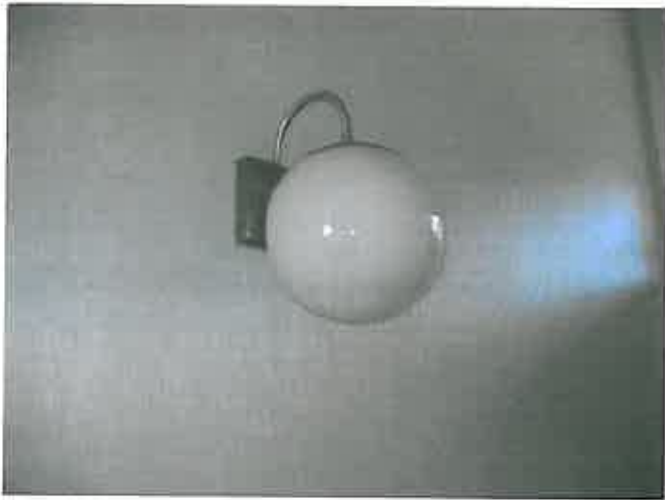
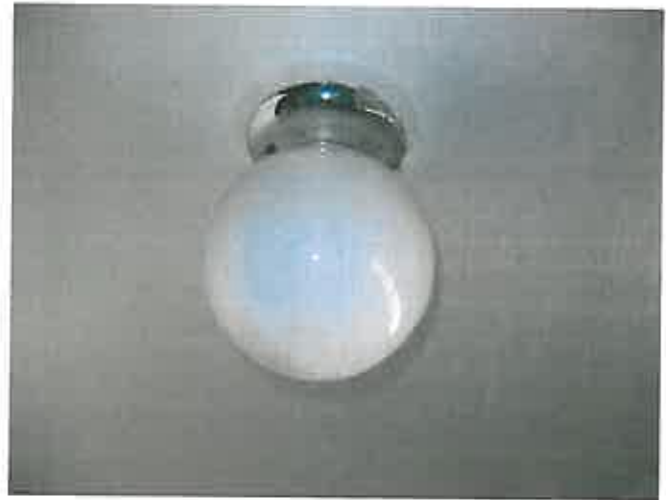
Comp #: 1601 Interior Hallway - Replace

All interior lights were functional and in good condition at time of inspection. Typically, associations prefer to upgrade and modernize lighting every 15 - 20 years, depending on changes in trends. Suggest replacing all fixtures at same time to get best cost estimate and match décor throughout all buildings.

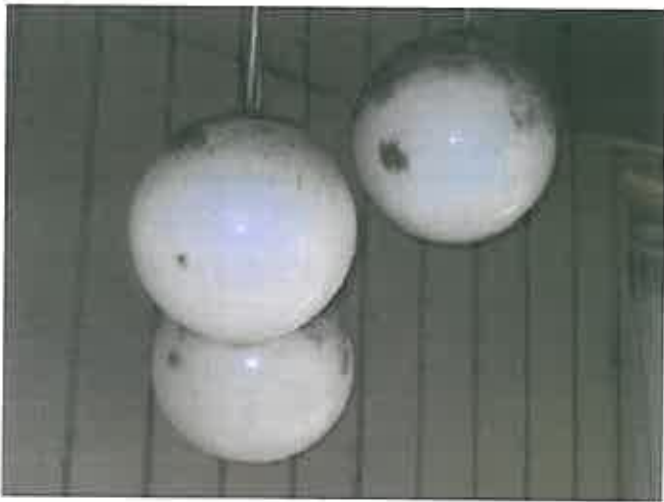
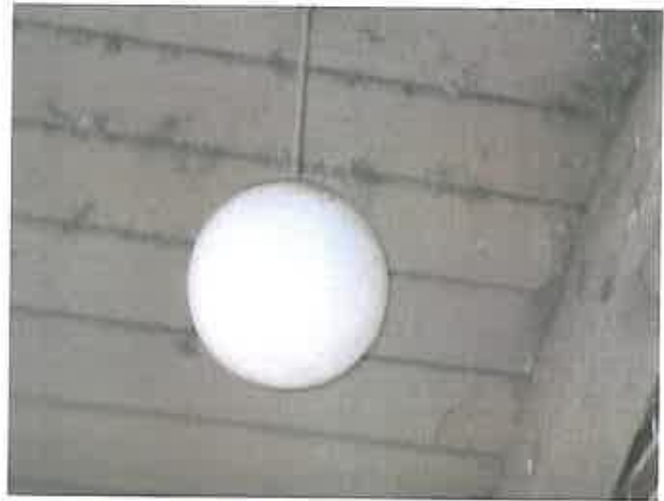
Comp #: 1602 Exterior Lights - Replace

Lights are older, but no reported problems. We were unable to inspect the condition due to inspection taking place during daylight hours. Due to the minimal cost to replace these lights individually, reserve funding is not appropriate. Repair and replace as necessary as an operating expense.

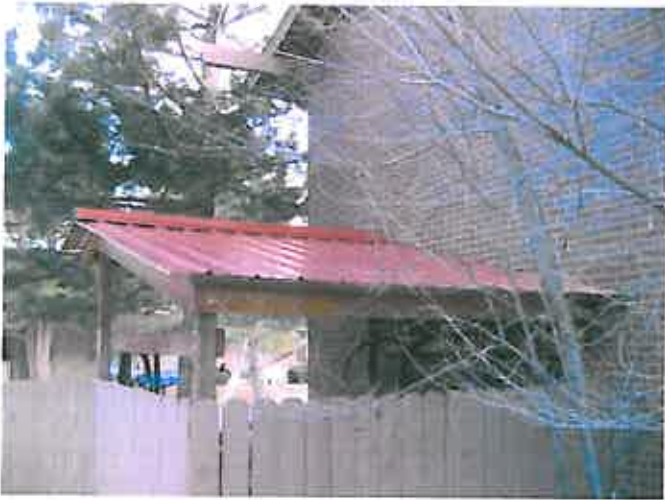
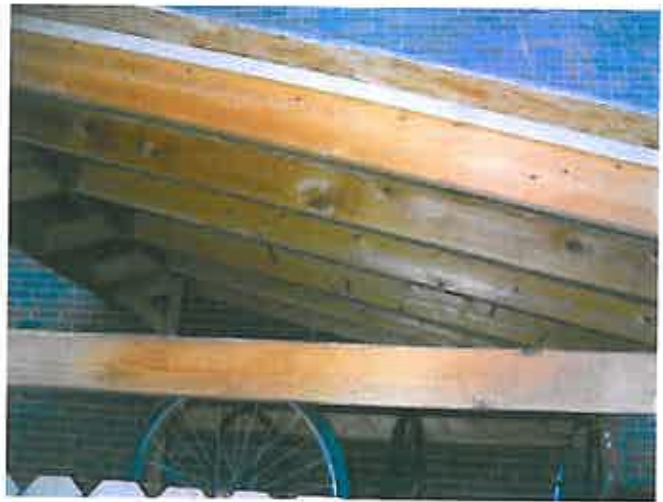
Comp #: 2001 Bicycle Shelter - Replace

The structure is currently in good condition with no signs of instability noted at time of inspection. It appears the structure was built within the past 5 years. Depending on the effects of the weather and the level of maintenance, we expect the shelter will need to be replaced every 12 - 15 years. The remaining life is based on the assumed age and current condition.
