Level 1, Premium Reserve Analysis

Alpine Condominiums 1895 Alpine Boulder CO. 80308

FINAL VERSION

Date of Property Observation – October 28, 2022

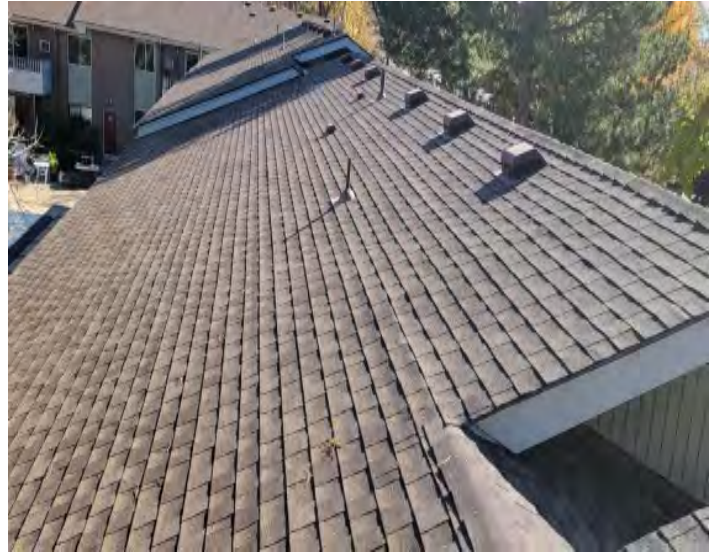
Comp #: 105 Comp Shingle Roof - Replace

- Evidence of fiberglass shards showing on edges of some shingles. This is an indication that the roofs are nearing the end of the life expectancy.
- Roofs don't appear to be original and exhibits conditions of being about 12 - 15 years old. As a result, we are estimating the roofs have about 5 - 7 years remaining before replacement is needed.
- It appears this roof material is rated as a 30 - 40-year product. Despite this rating, a life expectancy of 18 - 20 years is expected in this environment due to heavy snow, ice, UV, and temperature fluctuations.
- Remaining life is based on age of roof and observed conditions.

Best Cost: **\$138,125**
 \$425/square; Estimate to remove and replace

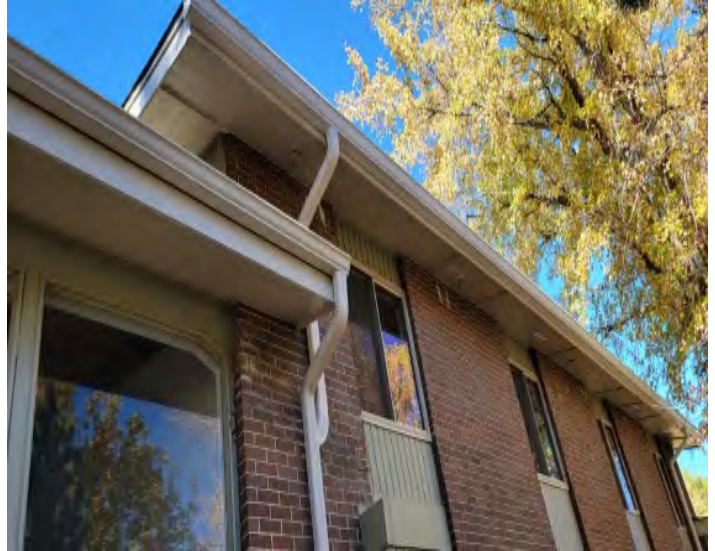
Comp #: 120 Gutters/Downspouts - Replace

- According to the contractor that recently repaired and replaced some lines, approximately 600 - 650 linear feet has been replaced. We noted and observed about 300 LF to be new (above B) and another 275 LF in the northwest corner of the building, by H. The rest of the lines varied in age and condition.

- The average replacement cycle for gutters and downspouts ranges between 20 - 25 years, depending on maintenance.
- Keep gutters and downspouts free from debris (which at the time of site observation were full of pine needles) which can cause corrosion of metal materials or blockage which can cause the downspouts to freeze and expand during winter months.

- Due to the varying conditions and the history of replacing sections at a time, we have included Reserve funding for periodic replacement to 20% of area (400 LF) every 5 years.

- In addition, when replacement is required, we suggest increasing the lines to 5" or 6" for better drainage.

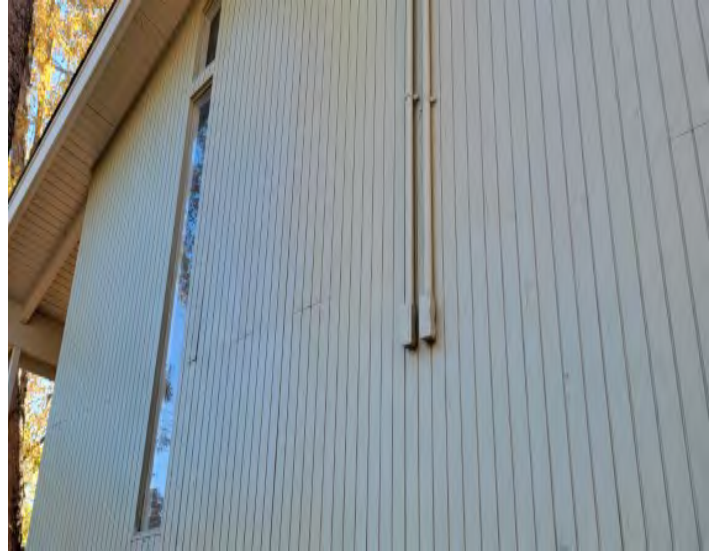
Comp #: 202 Building Exterior Surfaces - Repaint

- All surfaces (siding, fascia, soffits, doors, etc.) were painted in 2020 and is in good condition.
- While the only new surfaces is the fascia and soffits, the main body of the buildings is still wood siding.
- We suggest a repainting cycle of every 4 - 5 years to maintain an appropriate appearance and protect the wood from exposure to elements.
- When the association replaces the siding with an upgraded material, the painting cycle could be extended.

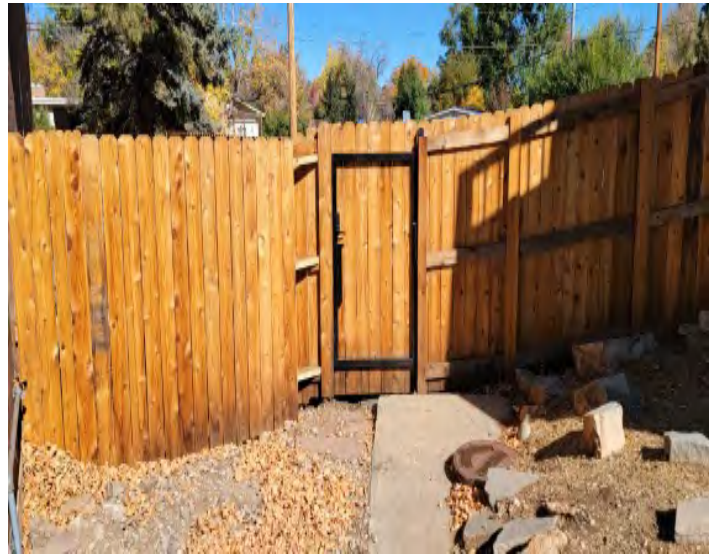
Comp #: 209 Wood Fencing - Restain/Repaint

- Most of the fences have been stained with a solid color stain. The new fence between E & J was recently installed, but had not been stained at the time of our site visit. Assume the new fence will be stained.
- In this climate, we recommend staining wood fences every 3 - 4 years to maintain appearance and protect wood surfaces from exposure to elements that will cause deterioration.
- The remaining life is based on the average condition of all fences.

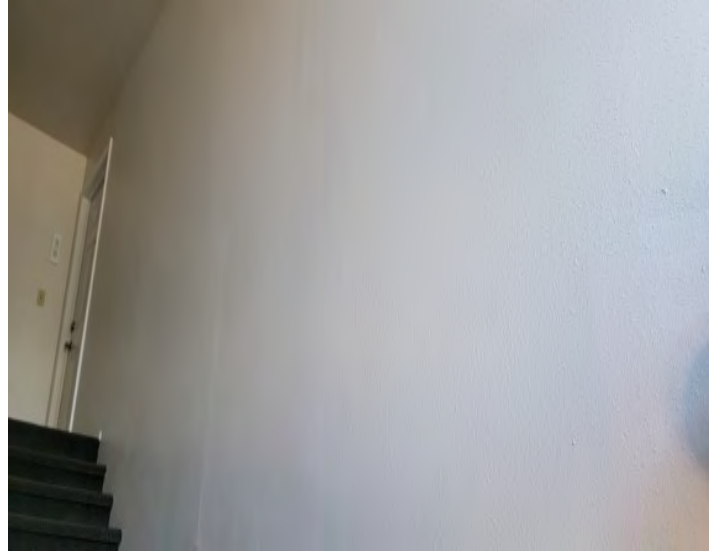
Comp #: 216 Interior Surfaces - Repaint

- We recommend reserving to repaint the interior spaces every 8 - 12 years to maintain appearance.
- Outside of this painting cycle, damage to the surfaces and touch-up work should be performed annually with operating funds.

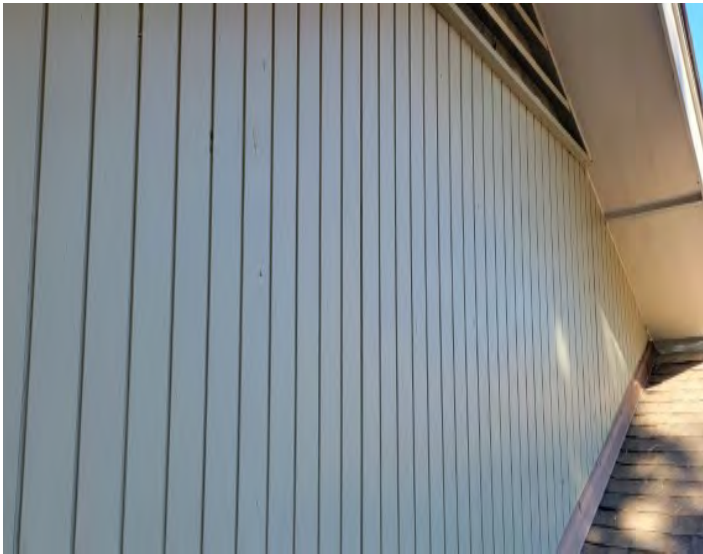
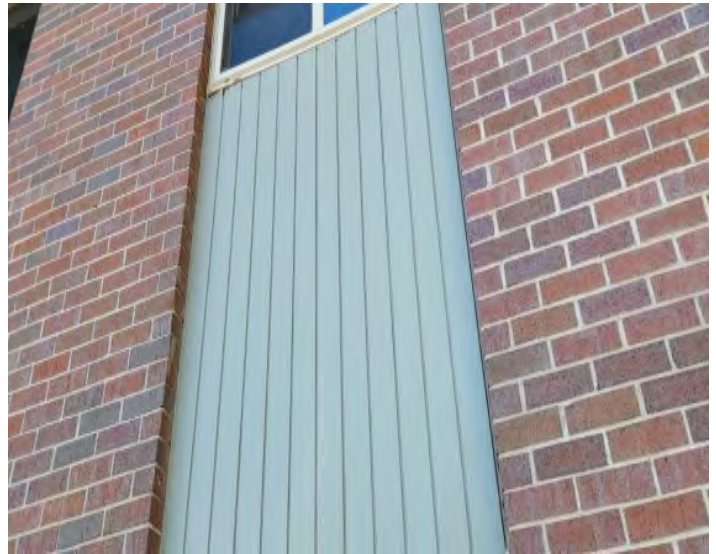
Comp #: 303 Wood Siding - Repair

- All soffits, fascia, and a small section of siding was recently replaced in 2020. Wood siding is generally in good condition, considering age of community.
- This material typically lasts 30 - 50 years, depending on how well it is maintained throughout the years.
- In order to keep up the appearance of the community and to ensure a maximum life of siding, we have established a Reserve allowance for repairs and some replacement every painting cycle.

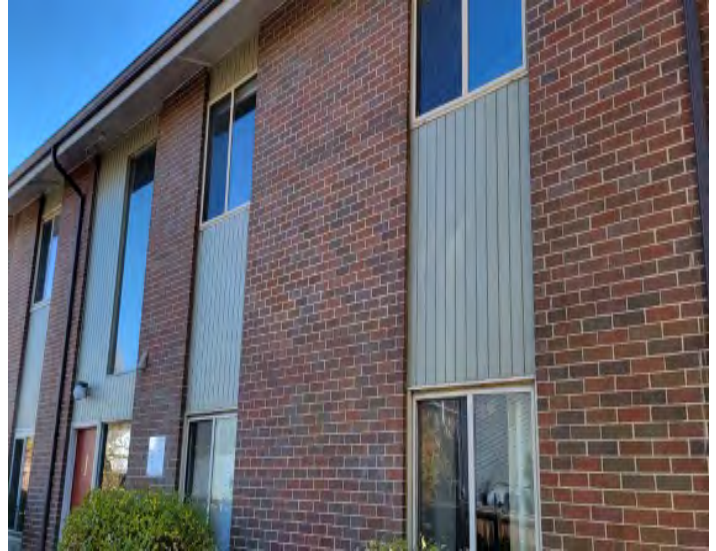
Comp #: 306 Brick - Replace

- Typically, this material has an extended life expectancy and complete replacement is unlikely.
- There are times where minor repairs may become necessary, but this is unpredictable when and how much would occur.
- Repairs should be handled as a maintenance issue on an as needed basis.
- Reserve funding is not required for this component at this time.
- If it later turns out that frequent repairs are necessary, then funding could be added in future Reserve Study updates.

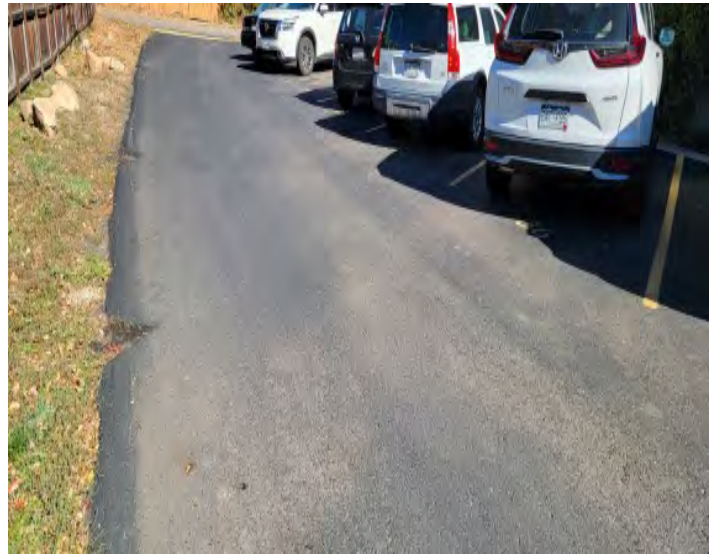
Comp #: 401 Asphalt - Overlay (2018/2019)

- The average life expectancy for asphalt surfaces ranges between 20 - 27 years for surfaces that are maintained on a regular schedule.
- Maintenance includes crack fill and repairing small potholes annually as an operating expense.
- In addition, asphalt should be seal coated every 2 -3 years, depending on the level of traffic and snow removing techniques.
- At time of site observation, all but the north parking spaces have been redone.
- The cost is less than what the association spent in 2018 and 2019 because it is not expected that 5" - 7.5" would need to be removed next time. This estimate is for a 2" mill and overlay, so a lot less labor and material.

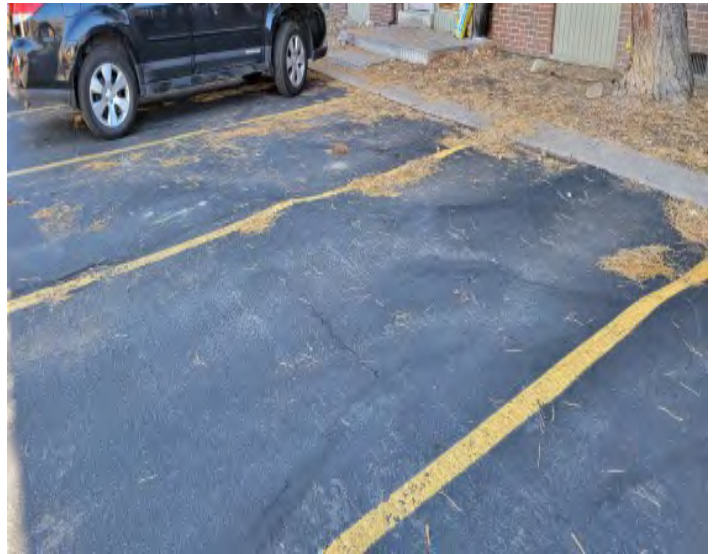
Comp #: 401 Asphalt - Overlay (North)

- The parking spaces on the north side of the property are in poor condition and these areas will need to be replaced to rid the uneven areas and possible liability concerns.
- The average life expectancy for asphalt surfaces ranges between 20 - 27 years for surfaces that are maintained on a regular schedule.
- Maintenance includes crack fill and repairing small potholes annually as an operating expense.
- In addition, asphalt should be seal coated every 2 -3 years, depending on the level of traffic and snow removing techniques.
- At time of site observation, all but the north parking spaces have been redone.
- The cost estimate reflects the assumption that at least 5" - 7" will need to be removed and replaced. Once this is complete, the future resurfacing cost can be decreased to a more typical level.

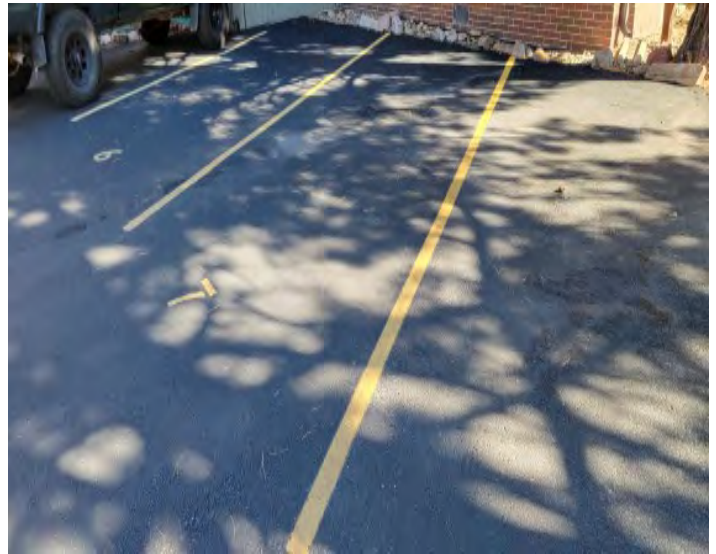
Comp #: 402 Asphalt - Seal Coat/crack fill

- Once asphalt is overlaid, industry professionals recommend a seal coat to maximize life of asphalt. It does not appear that the new areas overlaid in 2018/2019 have been seal coated since installation. We are recommending the north parking spaces are replaced this year, then the entire surface areas should be sealed prior to the next winter season.
- It is important to maintain a proper seal cycle to protect the integrity of the asphalt and prevent extensive cracking, development of potholes, and loss of emulsion, which will lead to advanced deterioration.
- Depending on the type of snow removal techniques and the level of traffic, we suggest seal coating every 2 - 3 years.
- In between seal cycles, the asphalt should be inspected and any cracking that develops should be filled, along with any minor repairs to prolong the life of the surface.

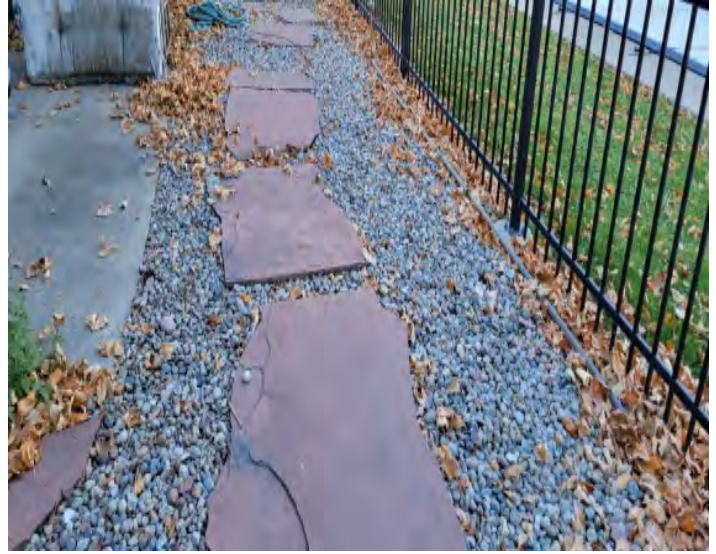
Comp #: 405 Flagstone Path - Repair/Replace

- No unusual conditions observed at time of inspections.
- It should be expected that these flagstone slabs are known to flake and deteriorate over time.
- Due to small area, it is easy to make repairs without affecting the design of the pathway.
- Therefore, we suggest handling repairs on an as needed basis using operating funds.
- As a result, at this time, Reserve funding is not required for this component.

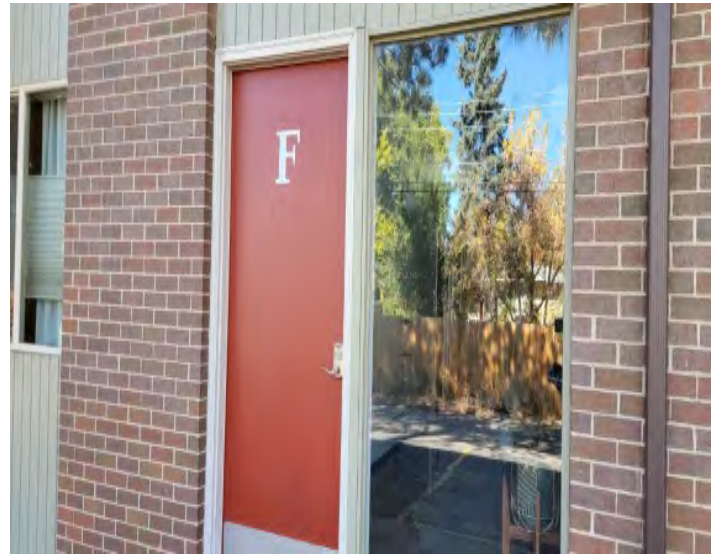
Comp #: 501 Common Doors - Replace

- Conditions vary, but the majority of the doors are in need of replacement or getting close to the end of the life expectancy.
- Since the majority of doors need replacement, we recommend replacing all at the same time for best cost estimate and to maintain a consistent appearance for the community.
- Future life expectancies will depend on the quality of the door installed and the level of maintenance over the years.
- NOTE: At the time of site observation, building D rear door does not open easily.
- Despite the age of the doors and some not operating smoothly, we have extended the replacement by a year to allow the association to address more important components.

Best Cost: **\$12,150**
 \$675/door; Estimate to replace with new doors

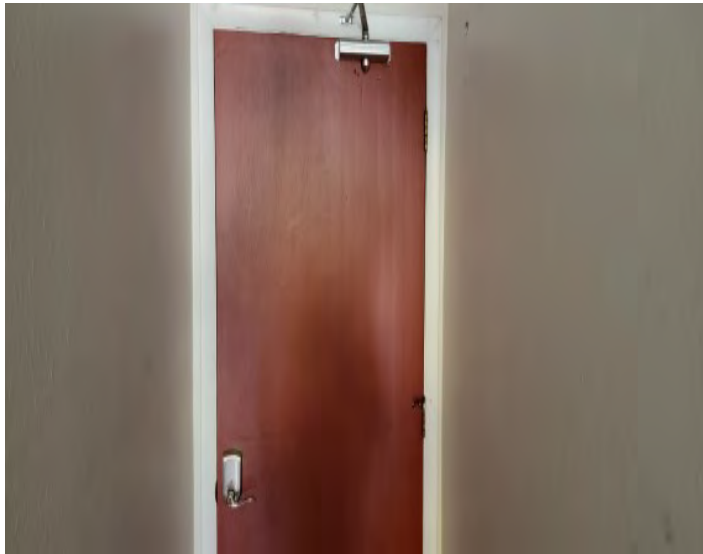
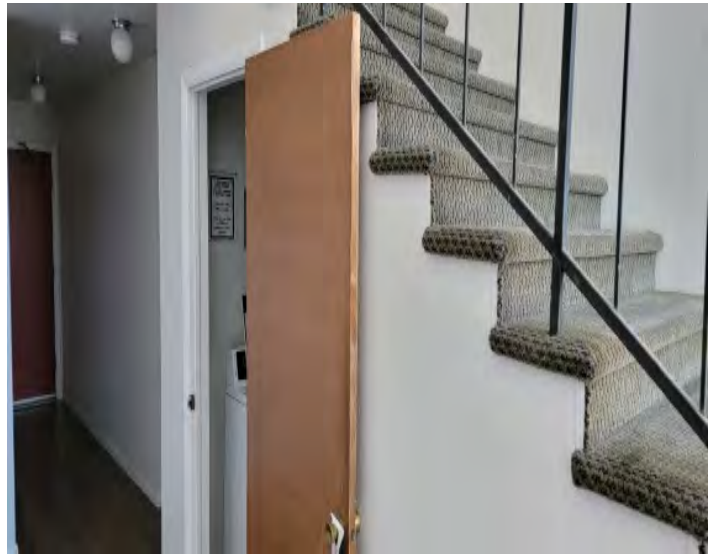
Comp #: 502 Interior Doors - Replace

- Doors are older and dated in appearance, but functional.
- Replacement will depend on the aesthetic importance of bringing the style up to current trends.
- At this time, we suggest treating replacement on an as needed basis as a separate issue from Reserves.

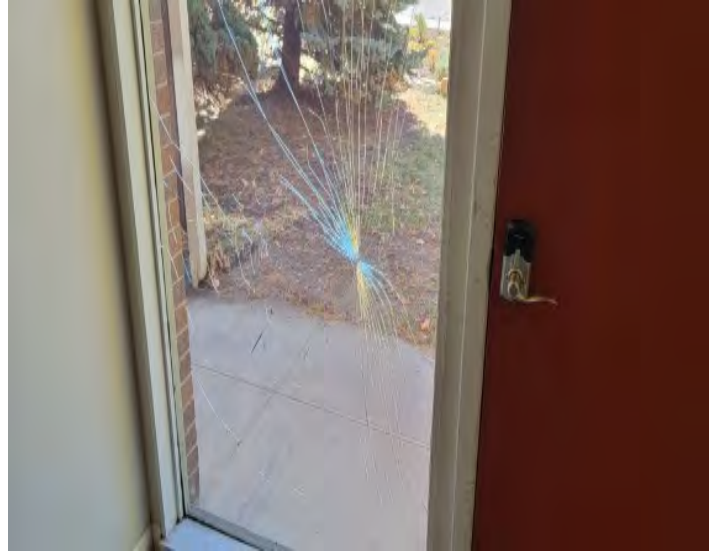
Comp #: 506 Windows - Replace

- The majority of the windows are single pane, however, building I has dual pane windows.
- These are inefficient when it comes to energy savings, and replacement should occur to increase efficiency.
- Building E has a 5x7 broken window, but assume this has been replaced by now.
- The exact cost of window replacement will depend on the quality of window installed.

Best Cost: **\$58,400**
 \$800/opening; Average estimate to replace

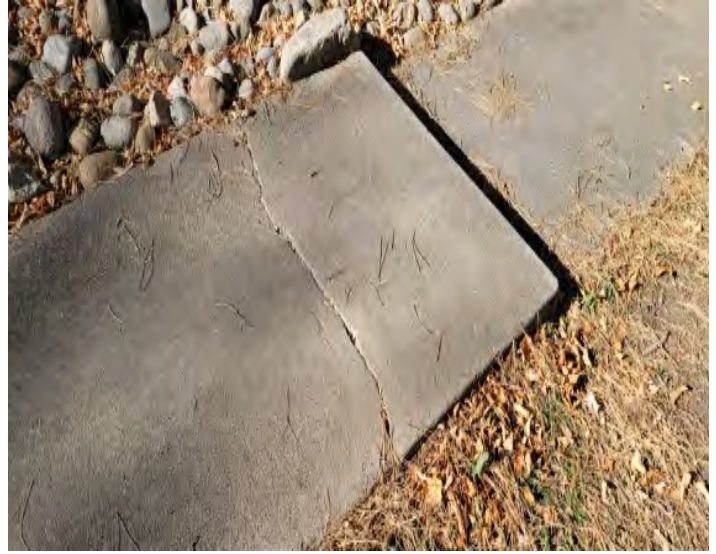
Comp #: 601 Concrete Sidewalks/Patios/Pool Deck - Repair

- While it is unlikely that all concrete surfaces will fail at the same time and completely need replacement, it is likely that major repairs will be needed periodically.
- We suggest establishing Reserve funding for periodic major repairs, as opposed to minor repairs annually.
- Each time a contractor comes out to the property to fix an area, a "trip charge" is usually built into the repair bill.
- Therefore, by doing larger areas at the same time, the cost is cheaper on a per square footage basis.
- This line item is for periodic major repairs and should not be misinterpreted as complete replacement.
- Despite the current condition, we have extended the replacement by a year to allow the association to address more important components.

Best Cost: **\$7,065**
Est. to replace 10% of area every 3 years

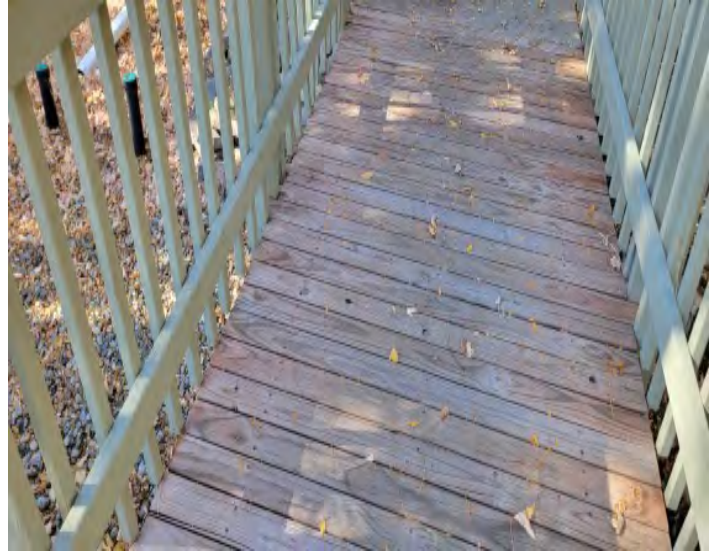
Comp #: 606 Wood Bridges - Replace

- Bridges are sturdy and in good condition. It is unknown if any repairs or rebuilding has taken place recently, but there were no concerns noted at the time of our site visit.
- Wood decks/bridges will have a life expectancy of 20 - 25 years under normal conditions and proper maintenance
- Remaining life is based on the observed conditions and assumption that major repairs, not replacement, took place within the past several years.

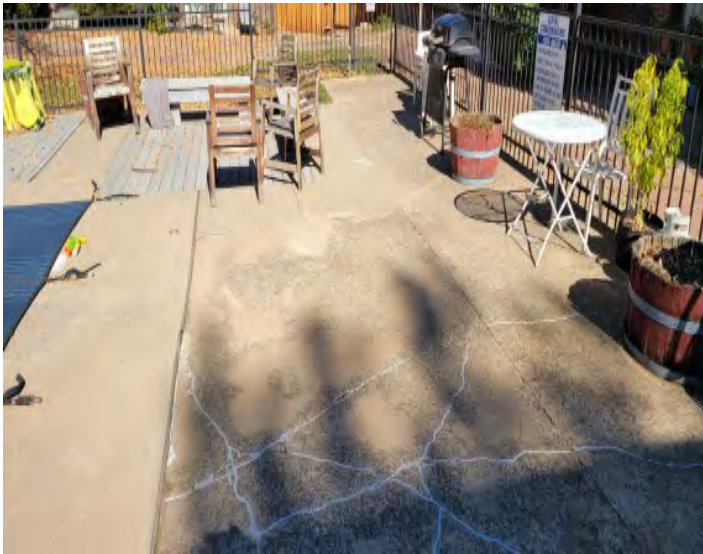
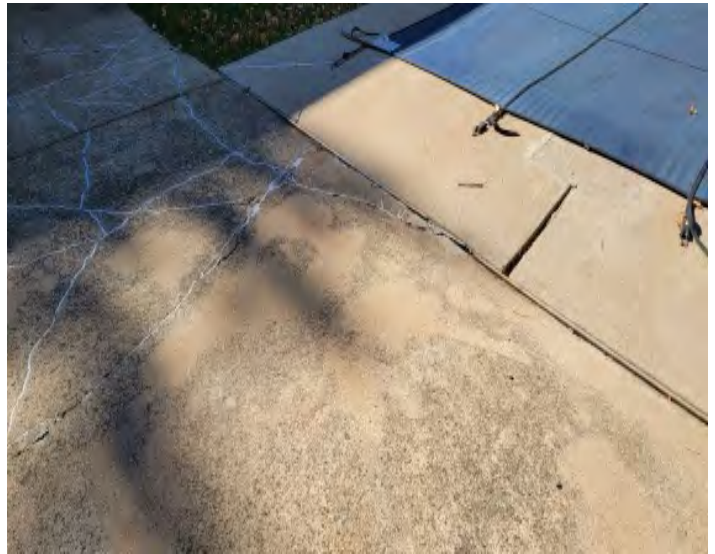
Comp #: 607 Pool Deck - Replace

- In general, the concrete pool deck is in poor condition and needs to be replaced to restore appearance.
- When replacement is completed, we will adjust this line item to address issues as periodic major repairs and partial replacement, similar to concrete sidewalks.

Estimate to replace

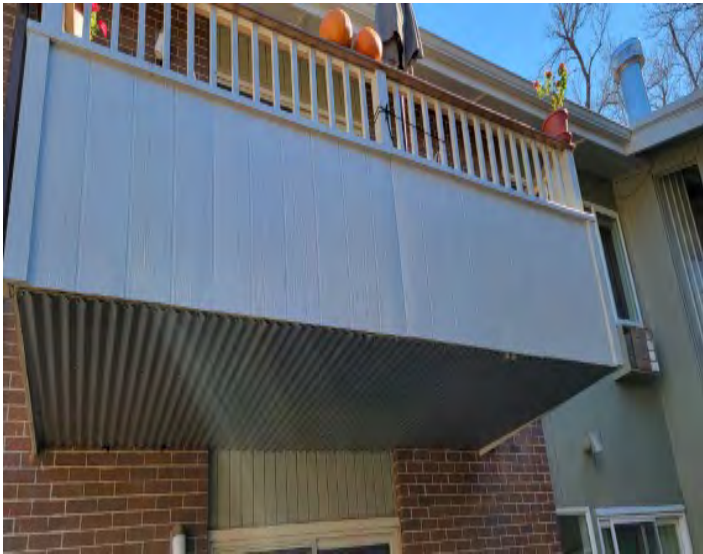
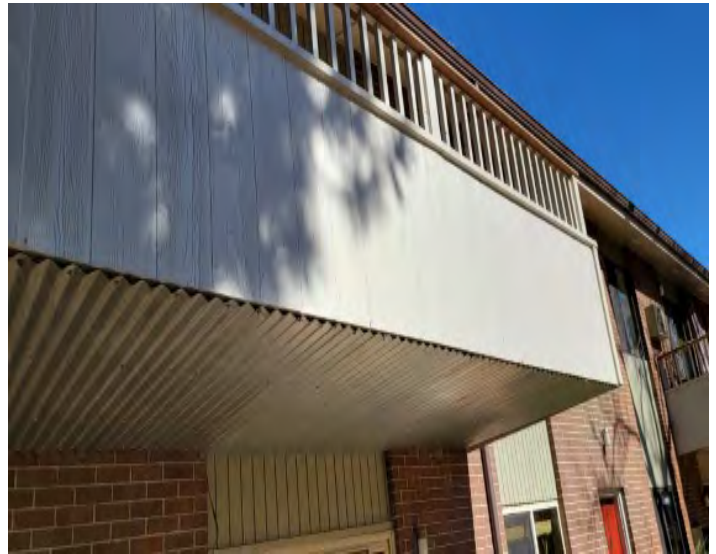
Comp #: 607 Wood Balconies - Replace

- All wood decks/balconies have been replaced within the past several years. Unable to directly access decks at time of site visit due to privacy reasons.
- A dry below system was installed to protect the lower patio unit from dripping water during rain or snow melt off, so we were unable to determine what materials were used during replacement, but we assume it is a composite material
- Composite decking material has a life expectancy of 20 - 25 years, depending on the level of use and care

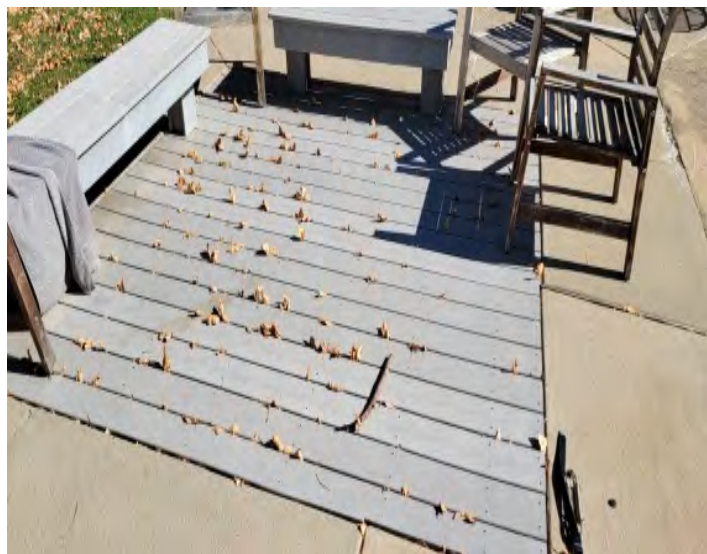
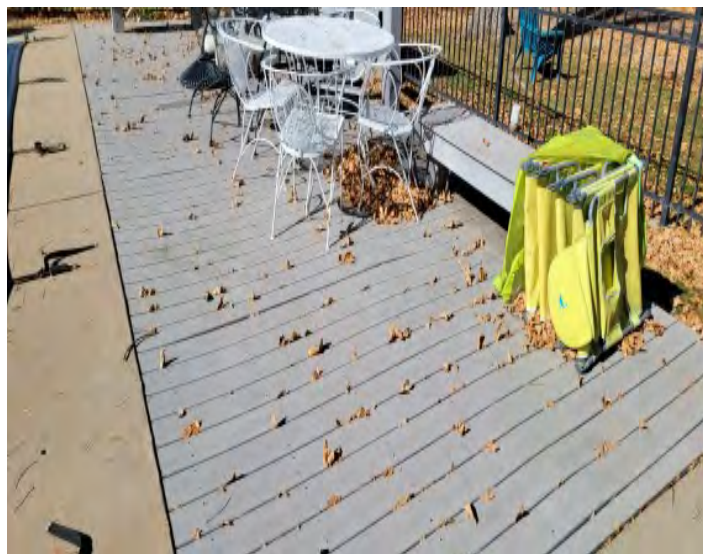
Comp #: 609 Composite Deck - Replace

- Most composite deck manufacturers offer a 25-year limited warranty from against defects.
- However, over a period of time, the material begins to fade, scratch, warp, and eventually will become aesthetically unpleasing.
- Therefore, due to the level of use and exposure to the elements, we recommend establishing a replacement cycle of 18 - 20 years.
- We recommend replacing the rail and decking at the same time.

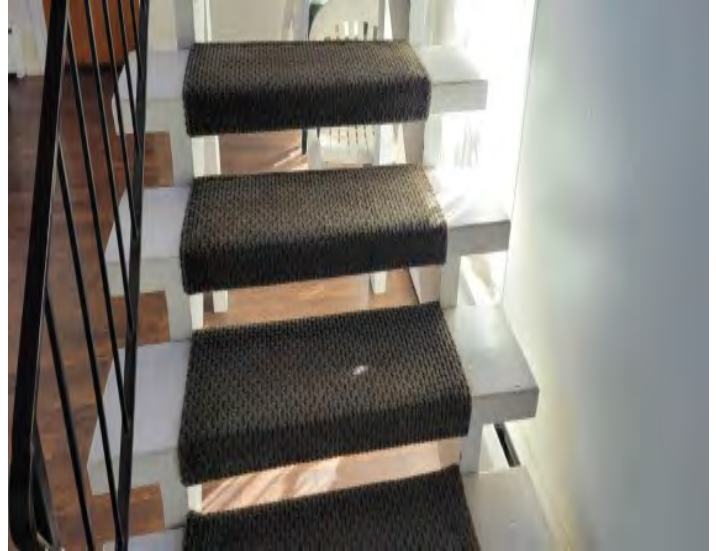
Comp #: 611 Stairway Systems - Major Repairs

- In 2018, a stairway landing was replaced due to unknown reason.
- During recent site visit, we observed most of the iron handrails to be unstable and is possibly a safety concern to hold the weight of a person if someone loses their balance.
- As a result of the current conditions and based on the age of the community, we have added an allowance for major repairs to the stair systems, as well as the iron handrails.

Best Cost: **\$20,000**
Allowance for major repairs every 5 years

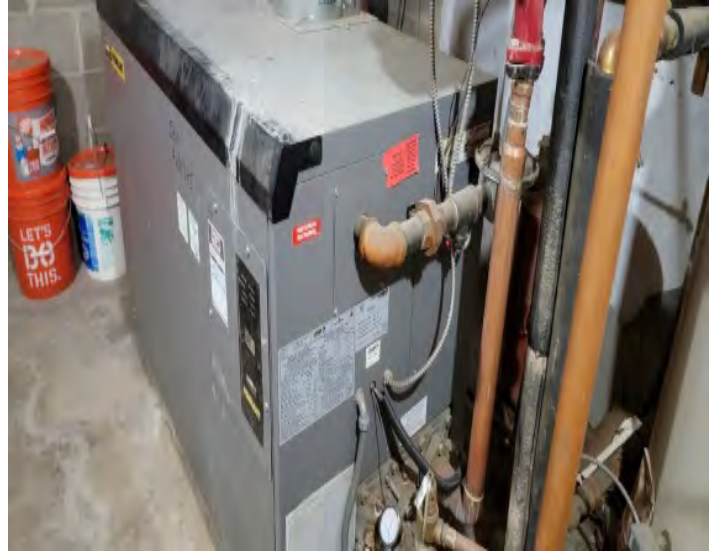
Comp #: 701 Large Boiler - Replace (A)

- The average life expectancy for boiler systems typically ranges from 20 - 25 years, depending on the level of maintenance and the quality of the water running through the system
- Boiler is approximately 11 years old, so the association should anticipate replacement within the next 10 - 15 years.

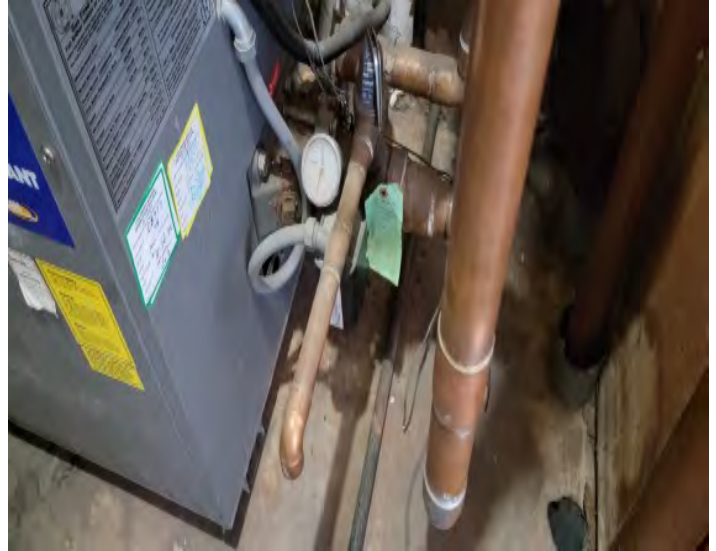
Comp #: 701 Large Boiler - Replace (H)

- The average life expectancy for boiler systems typically ranges from 20 - 25 years, depending on the level of maintenance and the quality of the water running through the system
- Boiler is approximately 19 years old, so the association should anticipate replacement within the next 5 - 6 years.

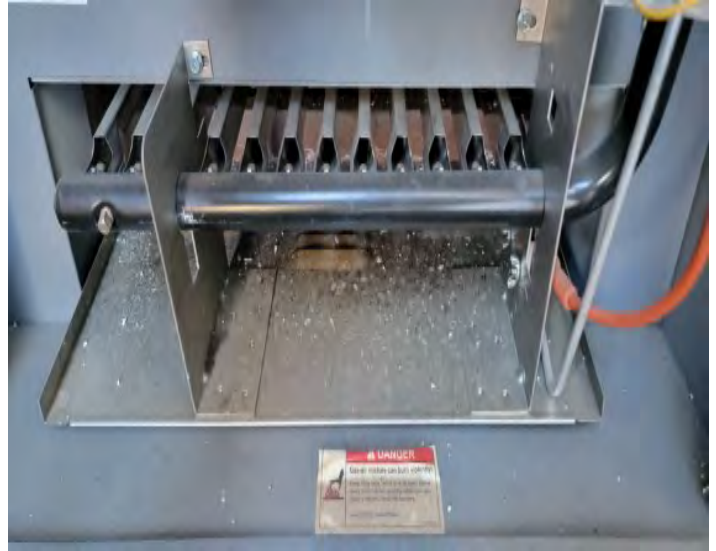
Comp #: 702 Small Boilers - Replace (H)

- The average life expectancy for smaller boiler systems typically ranges from 15 - 20 years, depending on the level of maintenance and the quality of the water running through the system
- Despite the date code on the label, boiler is in good condition and looks newer than a 2005 unit
- Boiler is approximately 18 years old, so the association should anticipate replacement within the next couple years, however, we have extended the remaining life a few years based on observed condition.

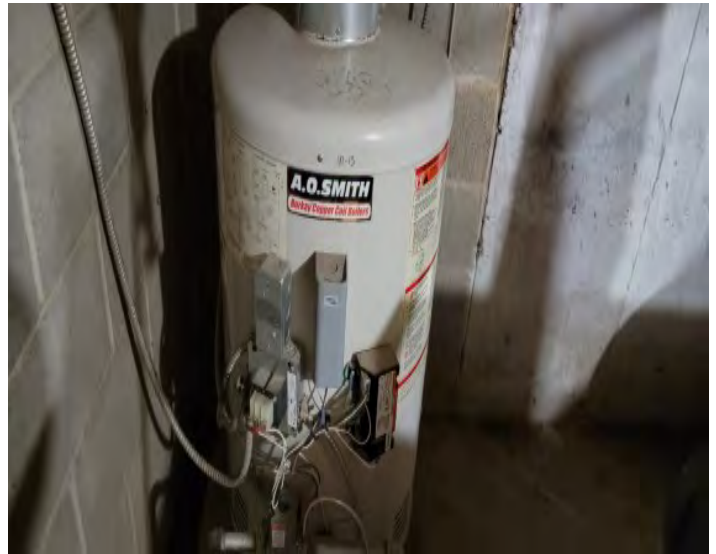
Comp #: 702 Small DHW Boiler - Replace (A)

- Average life expectancy for these units ranges from 12 - 18 years
- Remaining life is based on the approximate age of the unit

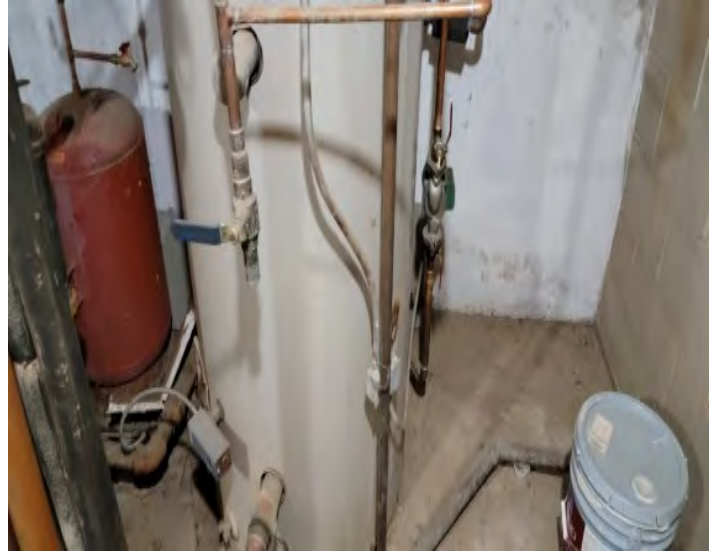
Comp #: 703 Hot Water Storage Tank - Replace (A)

- The average replacement cycle for storage tanks ranges between 12 - 18 years, depending on the quality of tank and the quality of the water in the system.
- Tanks should be flushed once a year to rid any sediments that may build up. Flushing should be addressed as an operating expense.

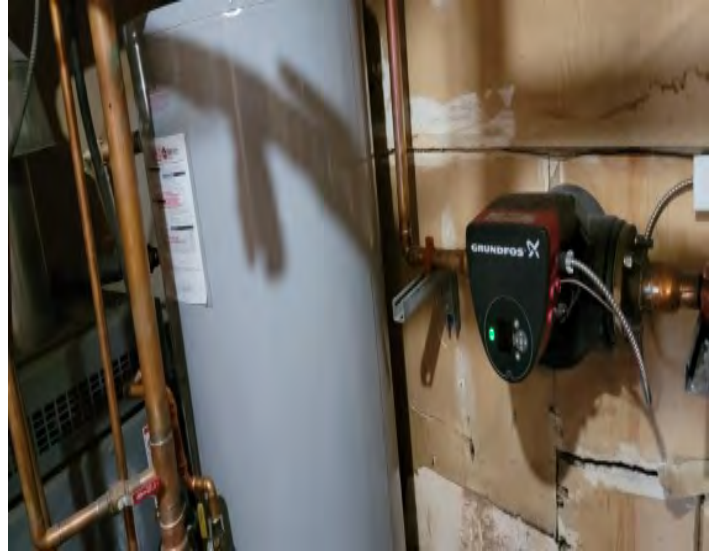
Comp #: 703 Hot Water Storage Tank - Replace (H)

- The average replacement cycle for storage tanks ranges between 12 - 18 years, depending on the quality of tank and the quality of the water in the system.
- Tanks should be flushed once a year to rid any sediments that may build up. Flushing should be addressed as an operating expense.

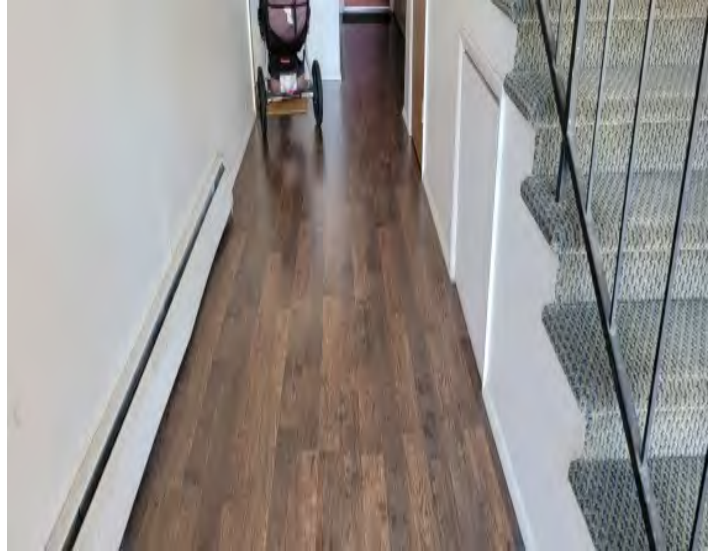
Comp #: 705 Baseboard Heaters - Replace

- No unusual conditions reported or observed during inspection.
- These units have an extended life expectancy and should be replaced on an as needed basis with operating funds.
- At this time, separate Reserve funding is not necessary for this component.

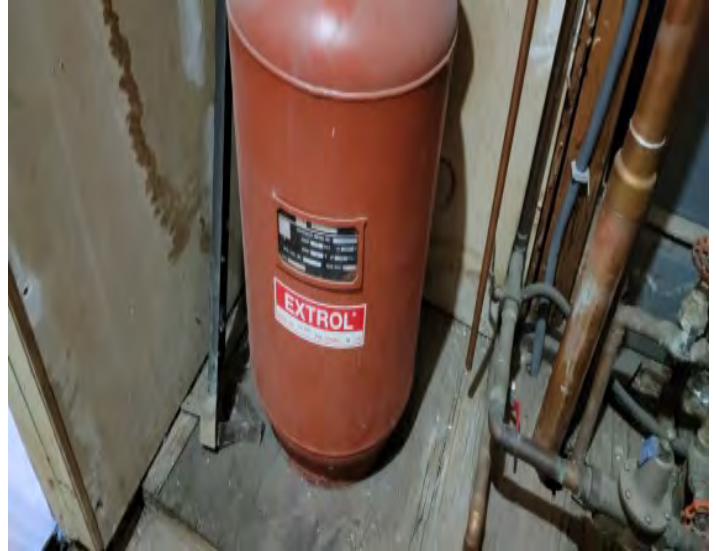
Comp #: 721 Expansion Tank - Replace

- Under normal conditions and without sudden pressurization, these tanks typically have an indefinite life expectancy.
- However, due to the recent failures at similar properties, we have included Reserve funding to replace tanks every 15 - 20 years.
- If no problems arise in the future, then extend the life expectancies in future Reserve Study updates.

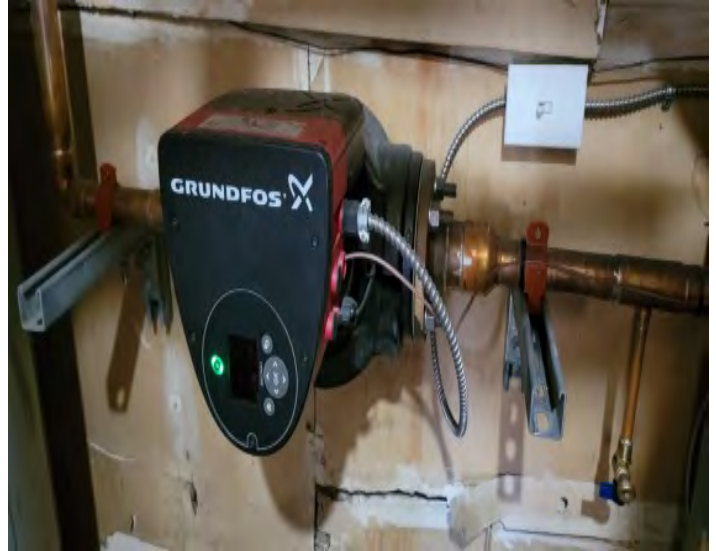
Comp #: 726 Miscellaneous Equipment - Replace

- Due to varying life expectancies of miscellaneous items (circ pumps, mixing valves, plumbing repairs, flue pipes, etc.), we have included an allowance for periodic repairs and upgrades to miscellaneous equipment every 5 years

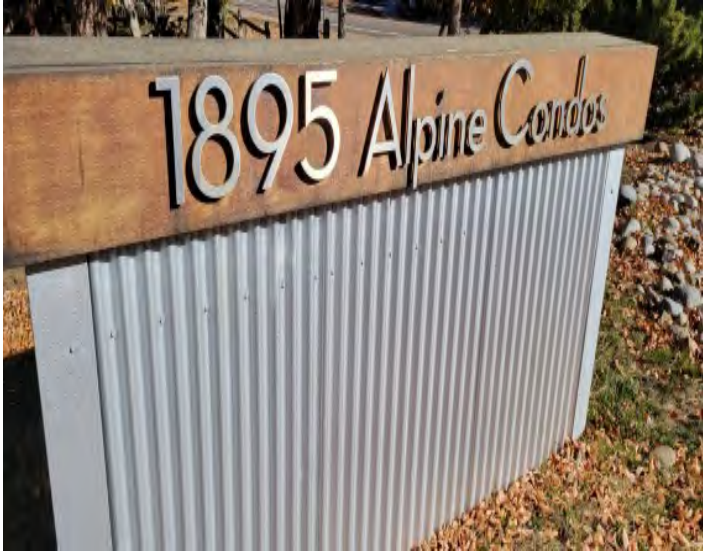
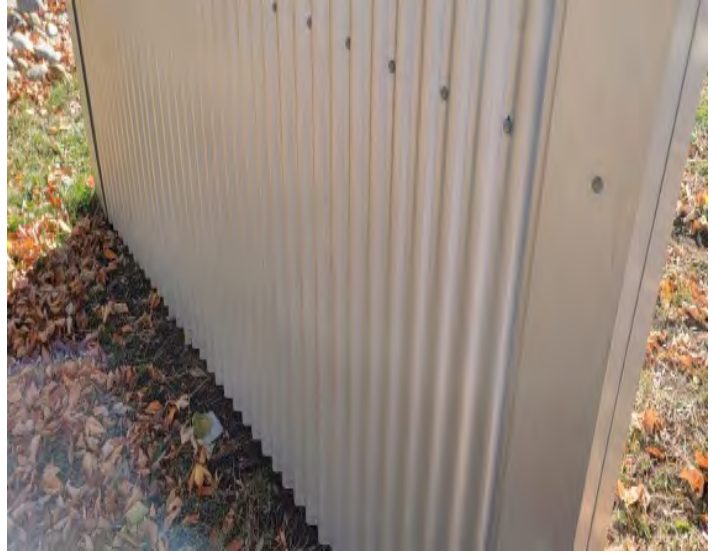
Comp #: 801 Monument - Rebuild

- Sign has been replaced at some point within the past 5 years. Structure is stable and in good condition.
- Due to changes in decorative trends, we recommend reserving to update the monument every 15 - 20 years to ensure an appropriate and attractive appearance to the community entrance.

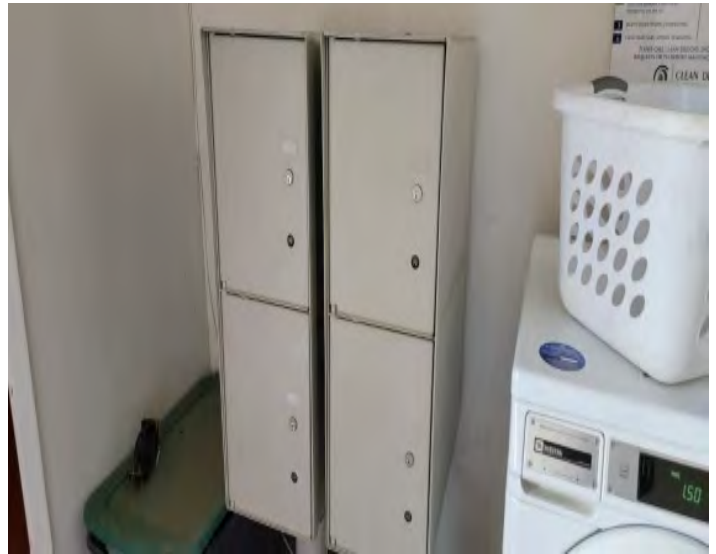
Comp #: 803 Mailboxes - Replace

- These are installed inside and protected from the elements.
- As a result, a longer replacement cycle should be expected.
- Based on our experience, these boxes will have a life expectancy of 25 - 30 years due to location and quality.
- Remaining life is based observed condition.

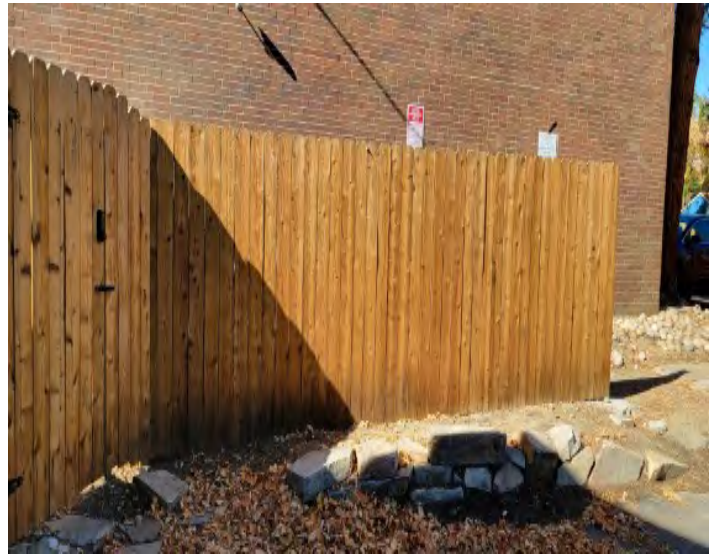
Comp #: 1001 Wood Fencing - Replace

- Fencing (approximately 25 LF) between A and F was recently replaced and is in good condition. Also, Fence had not been stained as of our site visit date, but it is expected that it will be stained.
- In general, conditions and ages of fences vary throughout the property.
- Due to varying ages and conditions, we have established Reserve funding to replace 60 LF every 6 years.

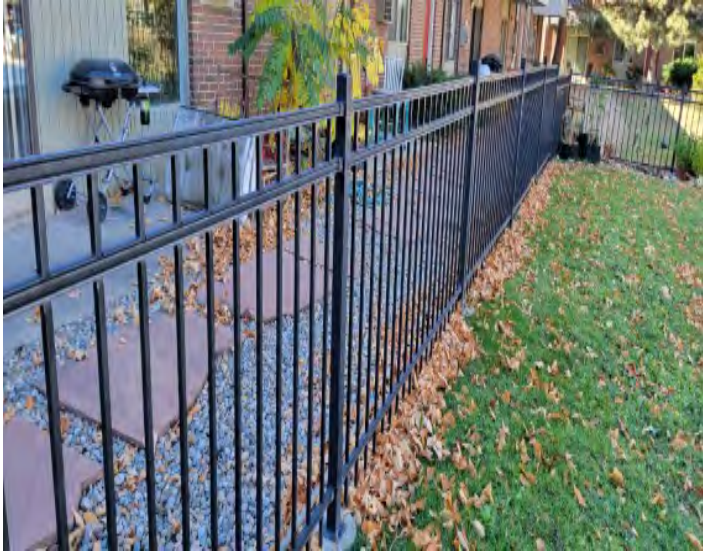
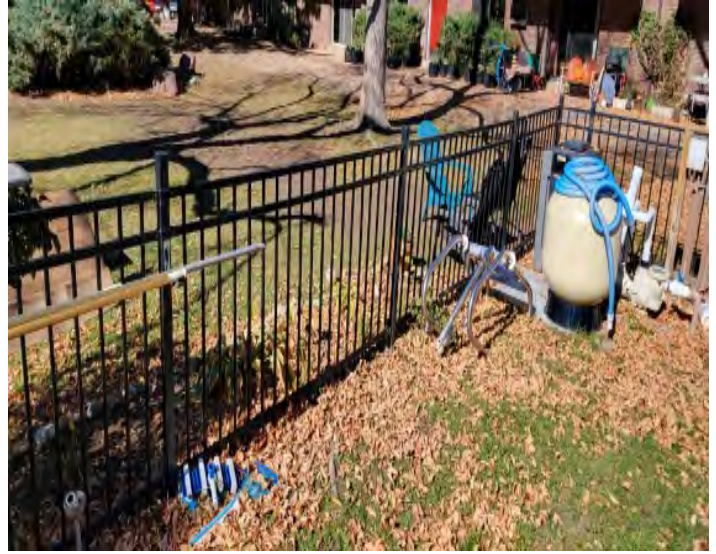
Comp #: 1002 Aluminum Fencing - Replace

- It was reported in past Reserve Studies that the aluminum fence was installed in May 2007 after our report was completed. Observed conditions support this claim.
- The average replacement cycle for this type of fencing typically ranges between 25 - 35 years, depending on maintenance levels and exposure to elements.
- Remaining life is based on the observed conditions and the age of the fence

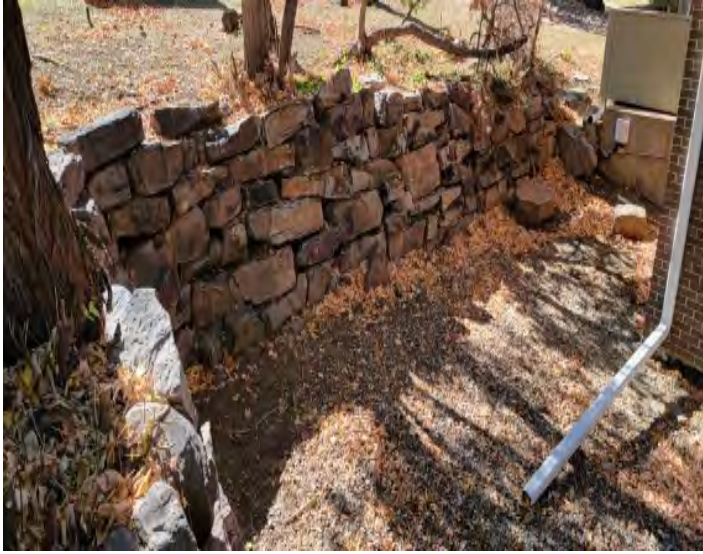
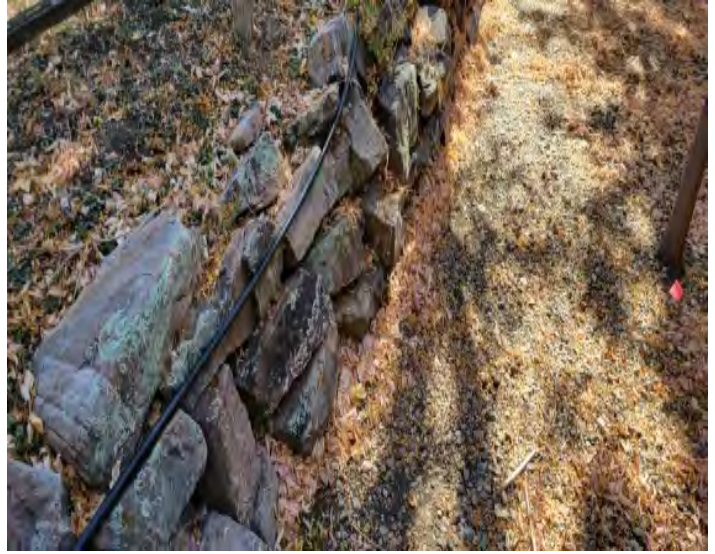
Comp #: 1005 Rock Wall - Replace

- This is a dry stack wall, and there were no signs of weaknesses or unstable areas during site visit.
- This type of material has an indefinite life expectancy and complete replacement is unlikely.
- Repairs, or restacking can be performed as needed with general operating funds.
- Therefore, Reserve funding is not required for this component.

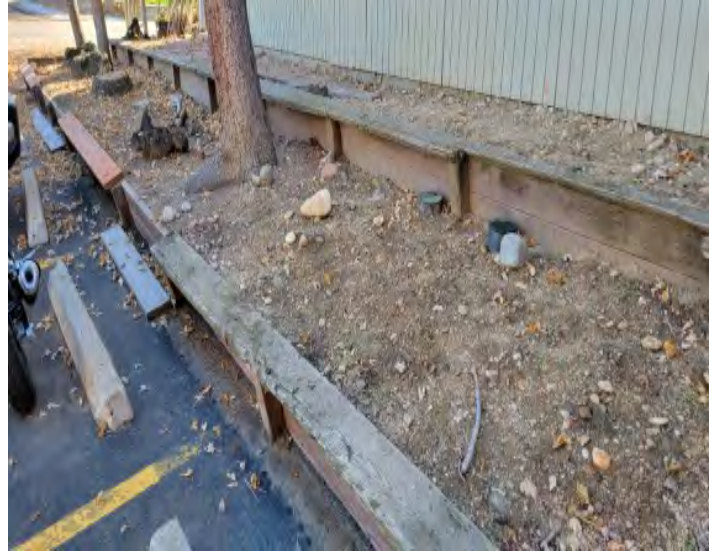
Comp #: 1007 Wood Retaining Wall - Replace

- Wood retaining wall is leaning badly and in poor condition.
- We recommend that the wall be replaced with a block retaining wall.
- Future life expectancy can be adjusted based on the type of wall that is installed.
- Despite the current condition, we have extended the replacement by a year to allow the association to address more important components.

Best Cost: **\$7,200**
 \$40/GSF; Estimate to replace with block wall

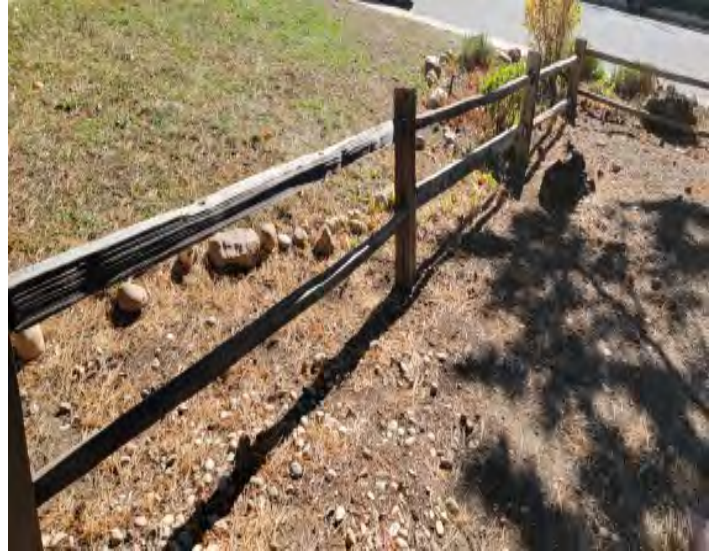
Comp #: 1009 Split Rail Fencing - Replace

- This type of fence is supposed to have an older and authentic appearance.
- Typically, sections can be replaced as needed to maintain the integrity of the fence and the new sections will eventually blend in with the older sections.
- At this time, separate funding is not required due to small area, or plan to replace as needed with operating.

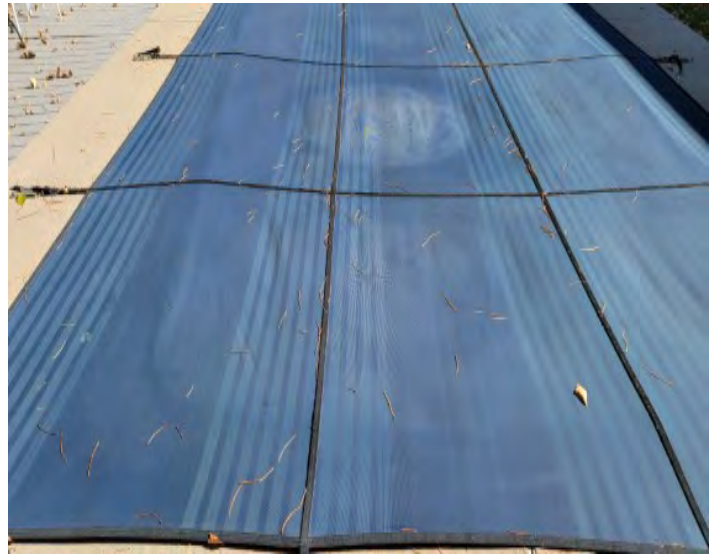
Comp #: 1101 Fiberglass Pool - Gel Coat

- Pool was winterized and covered at time of inspection, so we were unable to evaluate the entire surface.
- No records of the pool being recoated in the past several years.
- The major maintenance requirements is to gel coat the surface every 3 - 5 years, depending on the chemical levels and the amount of use.
- With no reported coating recently, we assume the surface needs to be recoated in the near future
- Despite the current condition, we have extended the replacement by a year to allow the association to address more important components.
