Level 1, Premium Reserve Analysis

Alpine Condominiums 1895 Alpine Boulder CO. 80308

FINAL VERSION

Date of Property Observation – October 28, 2022

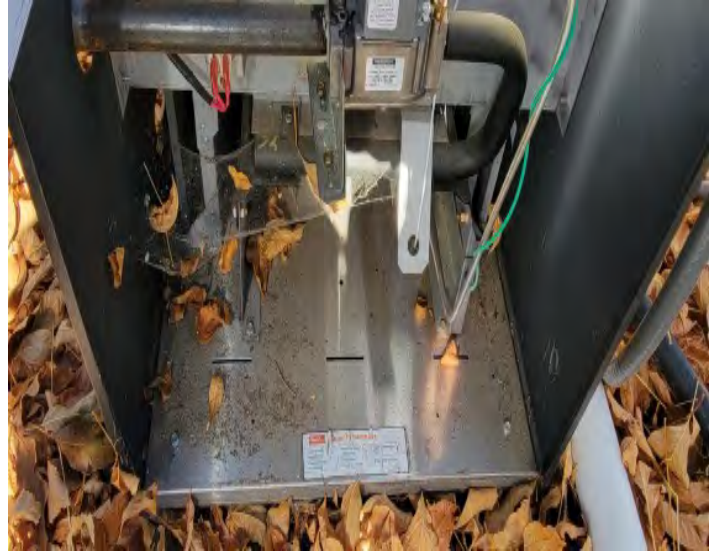
Comp #: 1104 Pool Heater - Replace

- Heater was replaced in 2022 and is in good condition.
- This type of pool heater typically has a useful life of approximately 10 to 12 years.
- Outside, unprotected installation shortens life expectancies of mechanical equipment
- Remaining life based on current age and condition.

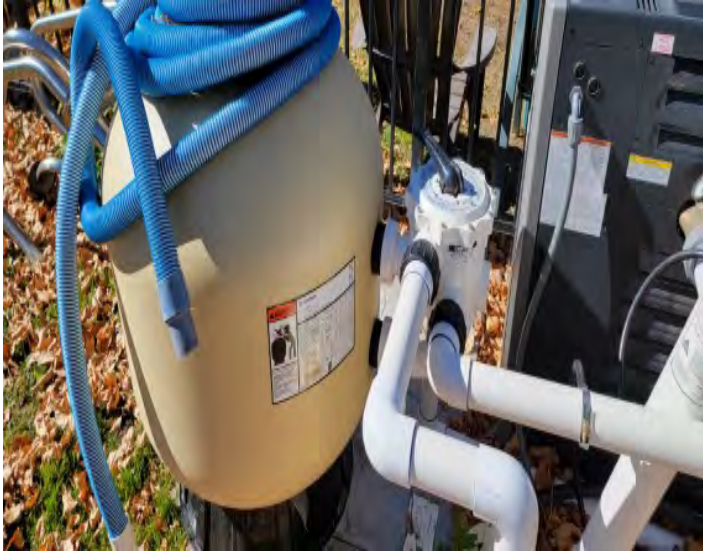
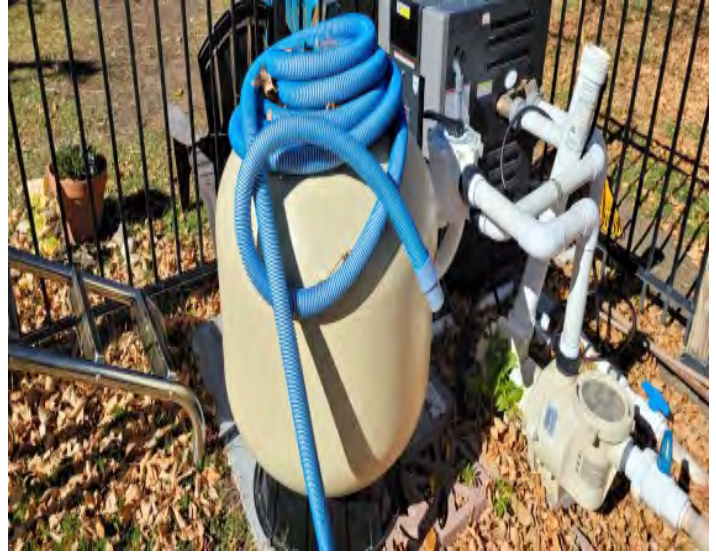
Comp #: 1107 Pool Filter - Replace

- Filter was replaced in 2022. No unusual conditions observed
- Fiberglass filter tanks typically have a life expectancy of 15 - 18 years under normal conditions and with proper maintenance.
- Shorter life expectancy can be expected with an outdoor/unprotected installation

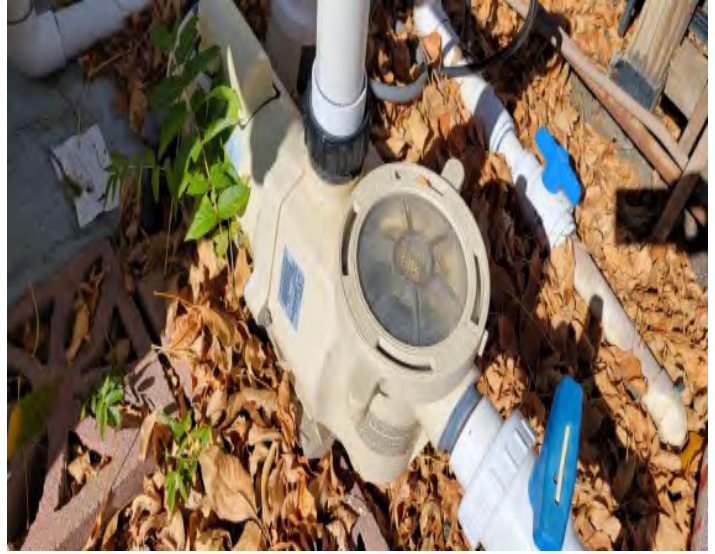
Comp #: 1117 Miscellaneous Equipment - Replace

- Major plumbing and miscellaneous equipment was replaced or repaired during complete equipment replacement in 2022
- While plumbing is not always required when equipment is replaced, some extra funds should be allocated for miscellaneous equipment
- We have added an allowance for miscellaneous equipment every 10 years
