Shady Hollow Townhomes Shady Hollow East and Shady Hollow West Boulder, CO 80304

Level 1 Reserve Analysis

Report Period – 01/01/15 – 12/31/15

Date of Property Observation - July 17, 2014

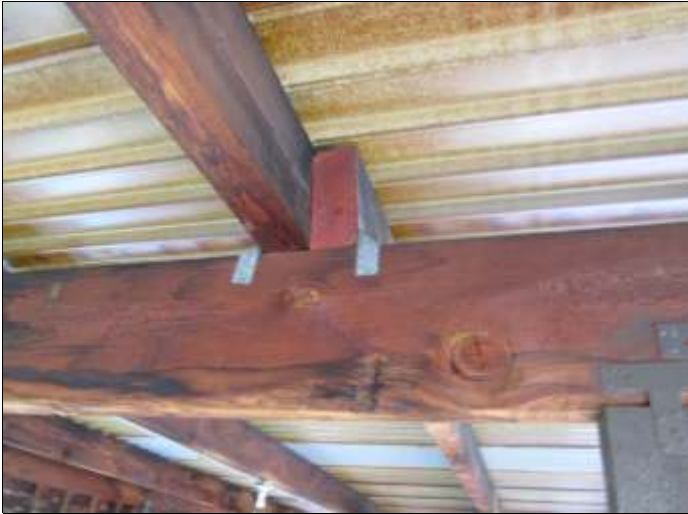
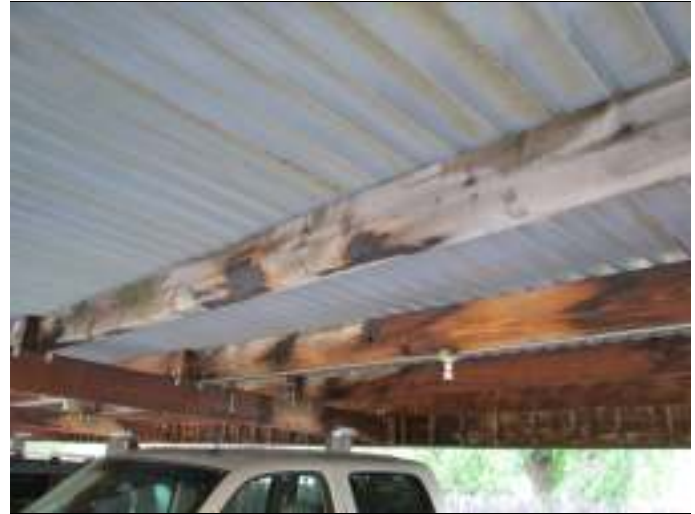
Comp #: 104 Flat Roof - Replace (West carports)

- The carports on the West side of the property are reported to be original structures and appear in poor condition in terms of aesthetics and do not match the architectural style of the new carports on the East side.
- The roofing was showing signs of rust and oxidation, however, due to our recommendation to completely reconstruct the carports to match the East side carports, we do not recommend replacing roofs at this time.
- The remaining useful life noted below is based on the assumption that the structures will be replaced in FY 2015.

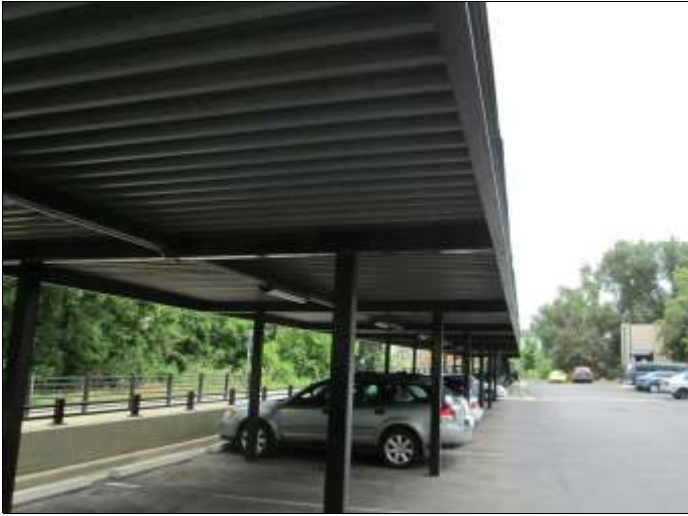
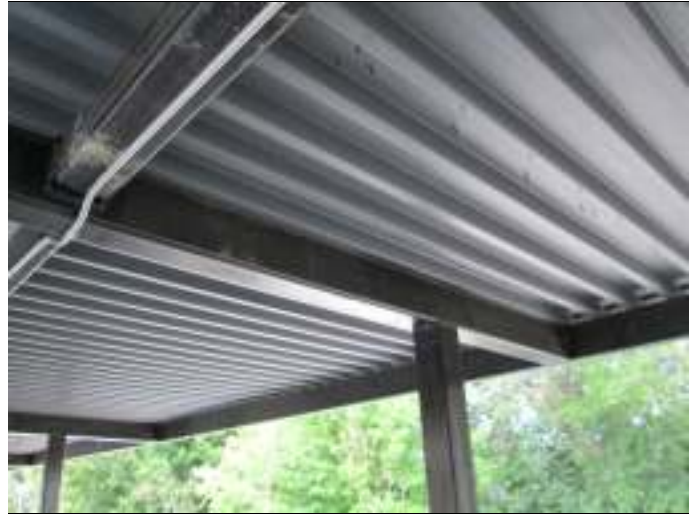
Comp #: 104 Flat Roof - Replace (East carports)

- Roofing on the carports appeared in good condition at time of observation with no signs of major problems.
- These carports were installed approximately 5 years ago and the roofing is a heavy gauge metal deck with EPDM membrane roofing that should have an approximate useful life of 18 - 20 years.
- Reserve funding is for the roofs only as the carport structures should have an indefinite life expectancy if properly maintained.

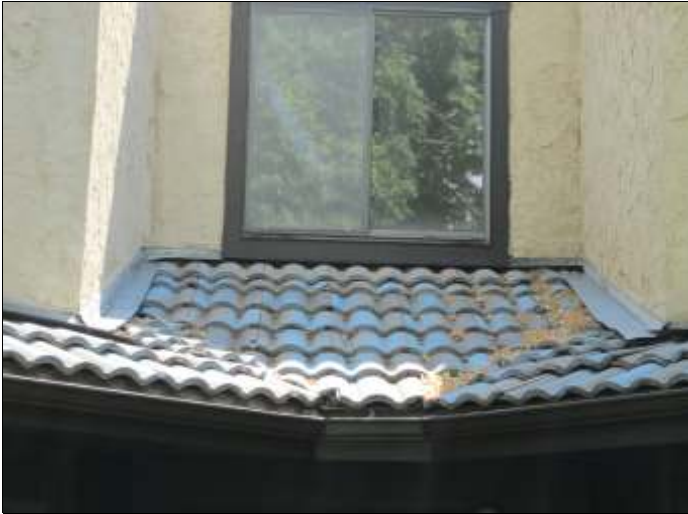
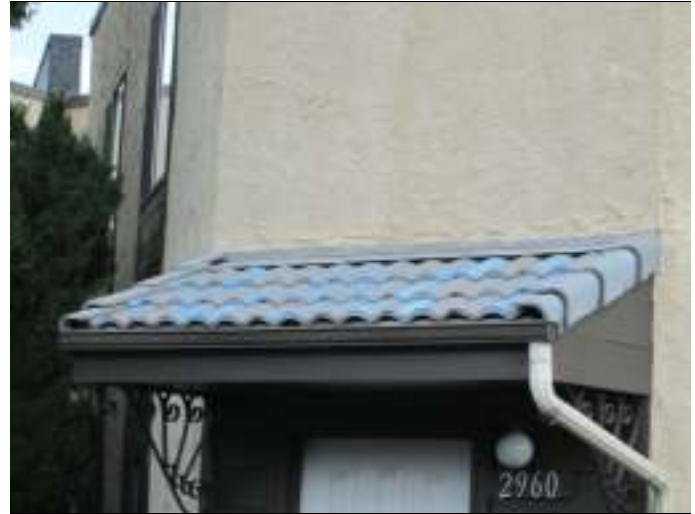
Comp #: 106 Tile Roof - Replace

- At time of observation, there were no signs of material failure or other overt signs of damage.
- The tile will not likely need to be completely replaced however, eventually, the underlayment will fail and need to be replaced.
- This project is labor intensive and complete underlayment replacement should be planned every 35 - 40 years.

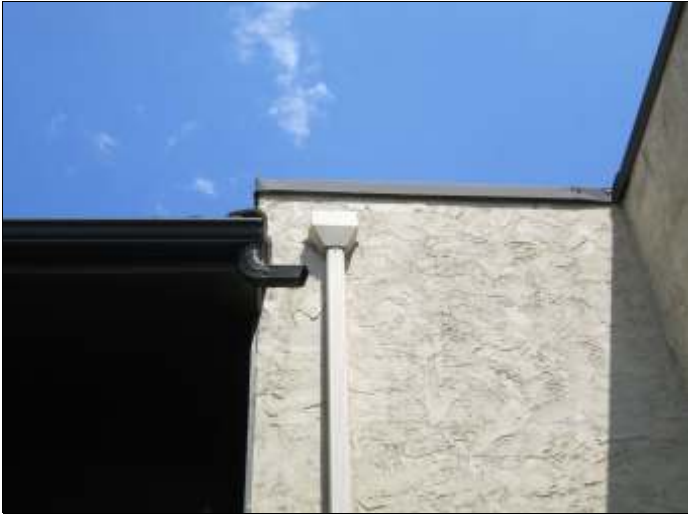
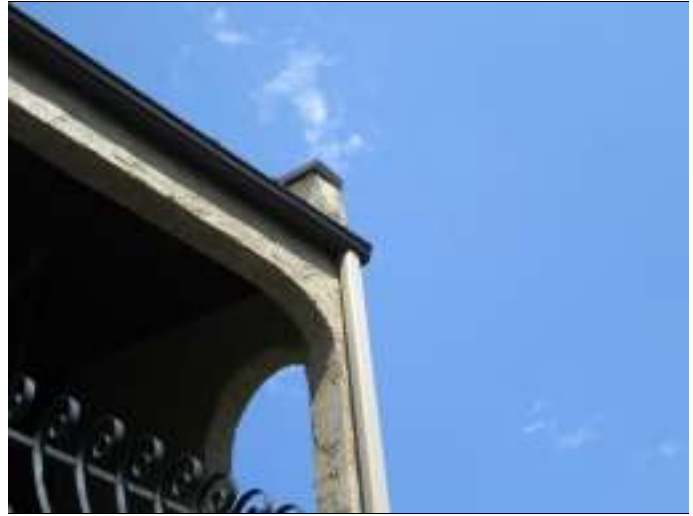
Comp #: 120 Gutters/Downspouts - Replace

- It was reported that there were some minor issues with blocked and/or poorly sloped lines at time of preparing this report.
- Make minor repairs to the rain gutters and downspouts on an as needed basis while reserving to completely replace every 20 years.

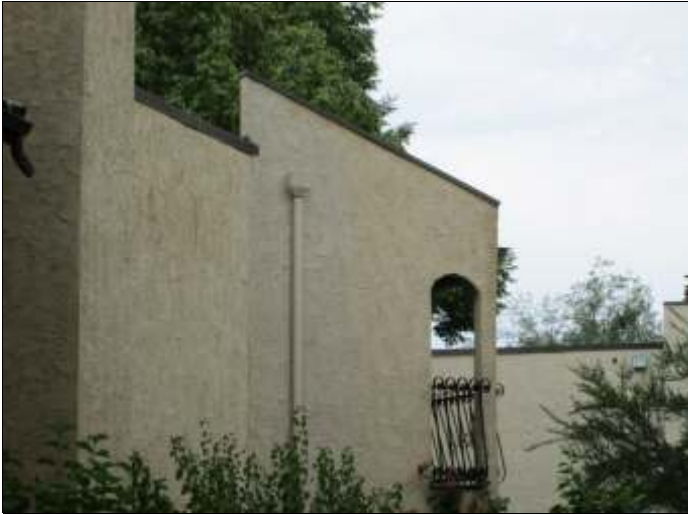
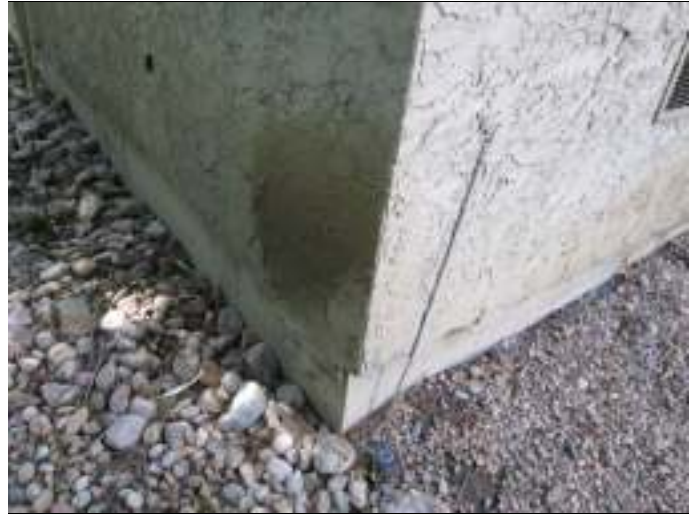
Comp #: 201 Stucco Surfaces - Repaint (East)

- Stucco was dry, discolored and many areas of mis-matched and faded paint were apparent.
- It was reported that the stucco has never been painted since time of construction; it is recommended to repaint stucco at least every 12 years to maintain appearance and to protect the material from direct contact with the elements.
- To maintain appearance and function, expect to repaint every 12 years.

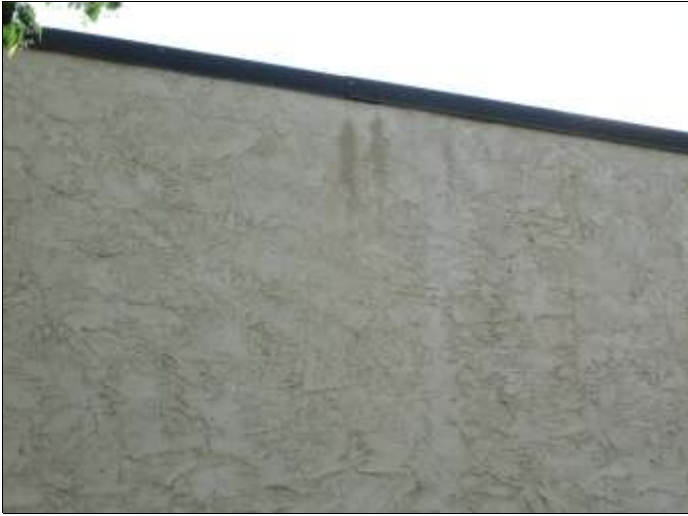
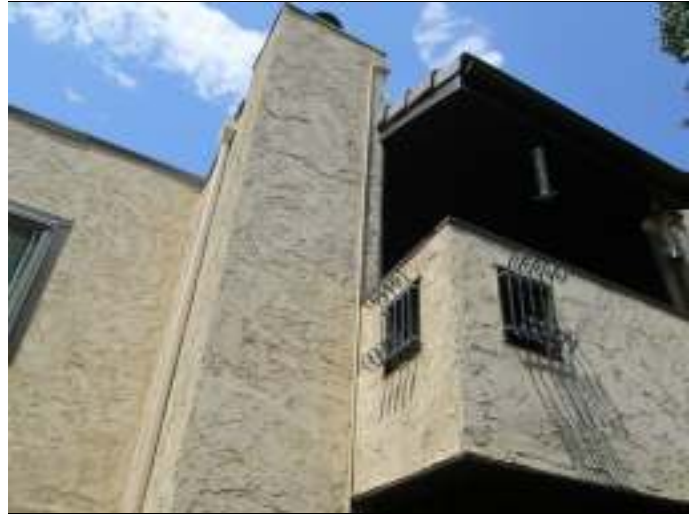
Comp #: 201 Stucco Surfaces - Repaint (West)

- Stucco was dry, discolored and many areas of mis-matched and faded paint were apparent.
- It was reported that the stucco has never been painted since time of construction; it is recommended to repaint stucco at least every 12 years to maintain appearance and to protect the material from direct contact with the elements.
- To maintain appearance and function, expect to repaint every 12 years.

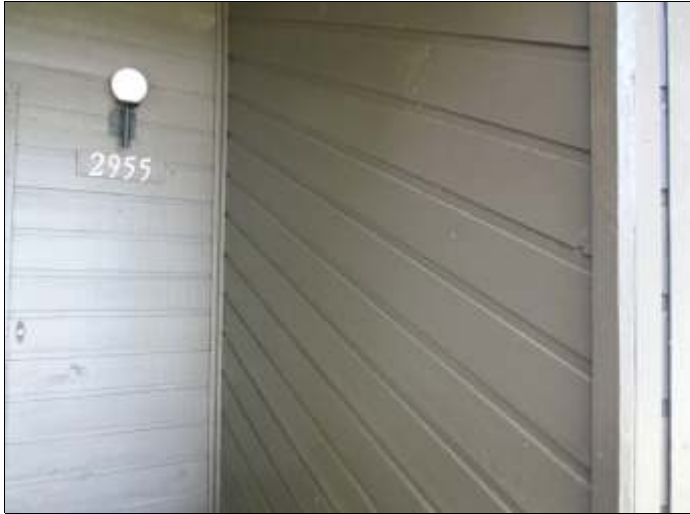
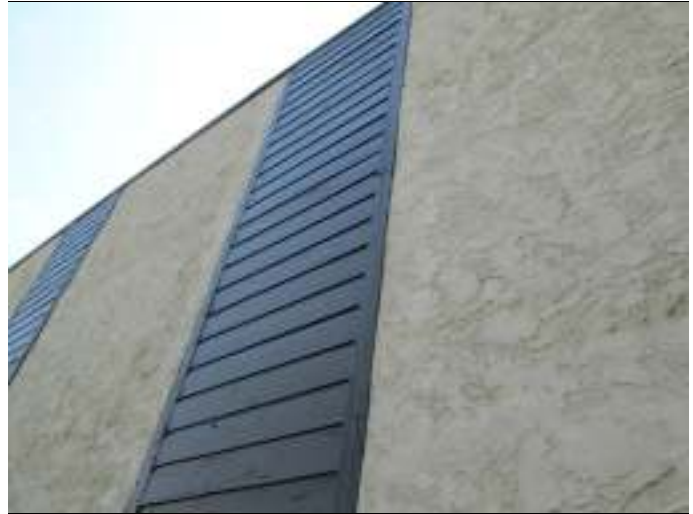
Comp #: 204 Exterior Wood Surfaces - Repaint

- Wood surfaces throughout the property appeared in good condition with no signs of overt damage or unusual deterioration.
- It was reported that all the wood surfaces were repainted within the last 1 - 2 years.
- In order to protect the wood materials and to ensure a proper appearance, we recommend repainting every 5 - 7 years.

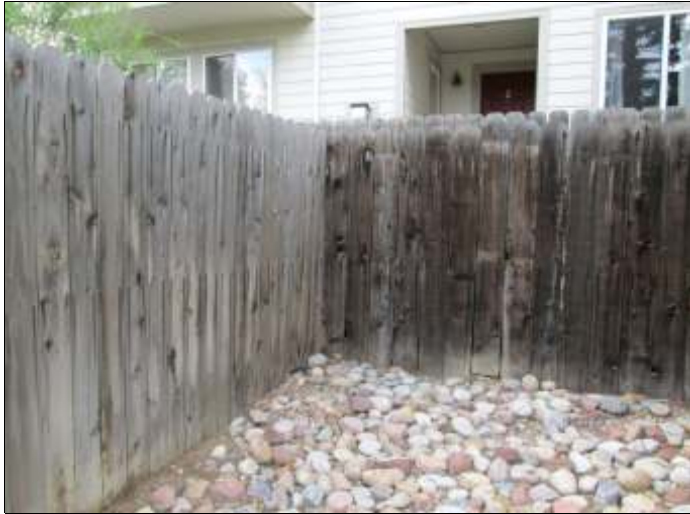
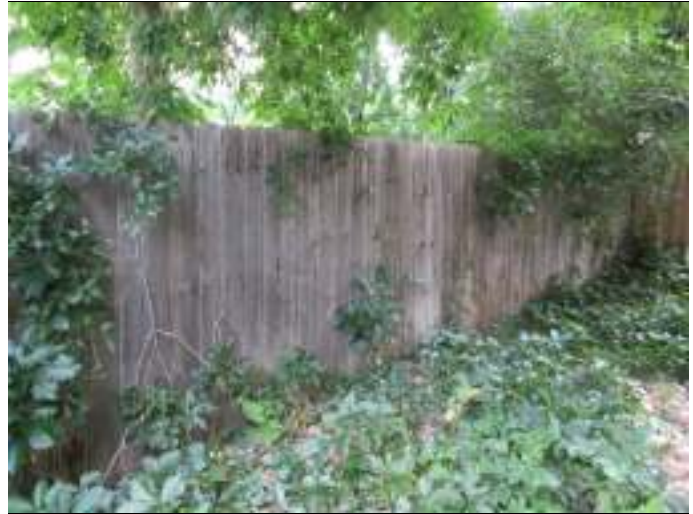
Comp #: 209 Perimeter Fencing - Replace

- The fence was dry and in need of stain as soon as possible.
- The fence should be pre-stained when installed in 2015, therefore, the remaining useful life of fence staining is programmed to occur 4 years after fence replacement.
- In order to maximize the useful life of the fence material, we recommend restaining every 3 - 4 years.

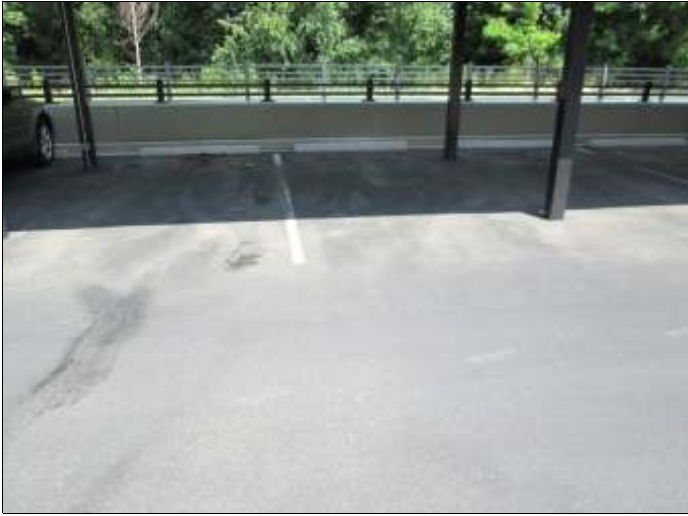
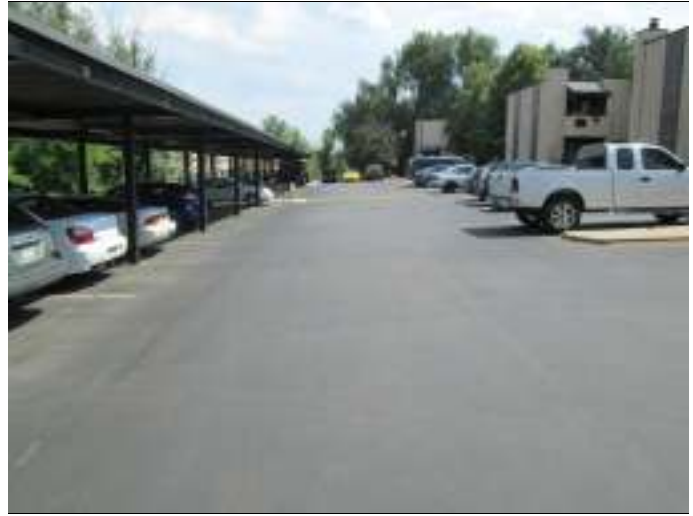
Comp #: 401 Asphalt - Major Overlay (East)

- This line item is for major replacement of asphalt pavement or a roto mill and resurfacing, the decision regarding which applications and products to use is ultimately up to the BOD and include but are not limited to: double chip seal, mill and overlay, cape seal, hot chip seal or complete reconstruction.
- The costs of these projects vary depending on the product chosen, we have provided an average cost for major replacement or substantial application of a new surface
- Research your options and consult a reputable contractor prior to deciding on a product for street/parking resurfacing.

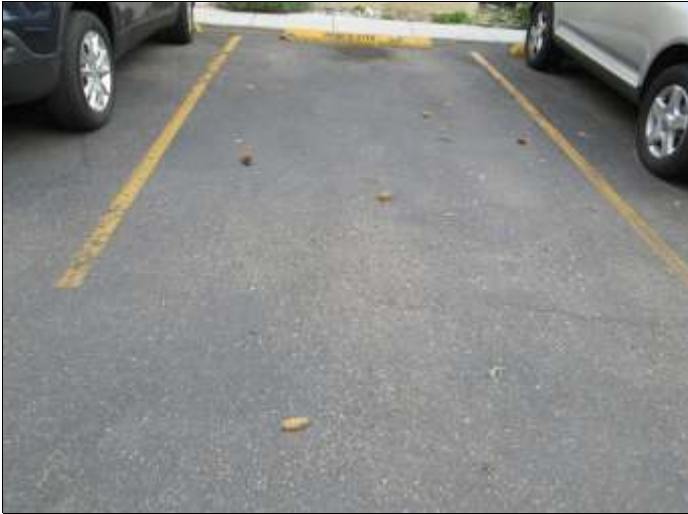
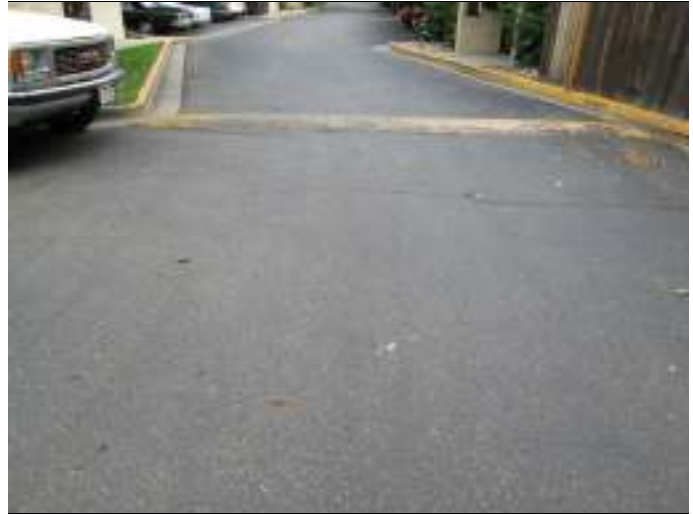
Comp #: 401 Asphalt - Major Overlay (West)

- This line item is for major replacement of asphalt pavement or a roto mill and resurfacing, the decision regarding which applications and products to use is ultimately up to the BOD and include but are not limited to: double chip seal, mill and overlay, cape seal, hot chip seal or complete reconstruction.
- The costs of these projects vary depending on the product chosen, we have provided an average cost for major replacement or substantial application of a new surface
- Research your options and consult a reputable contractor prior to deciding on a product for street/parking resurfacing.

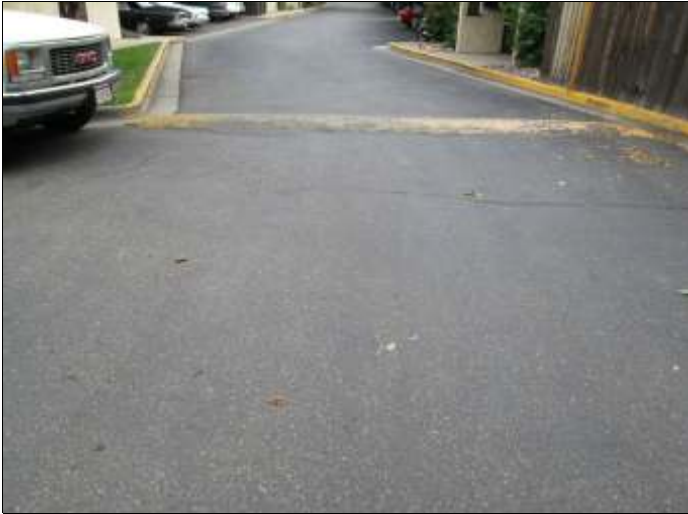
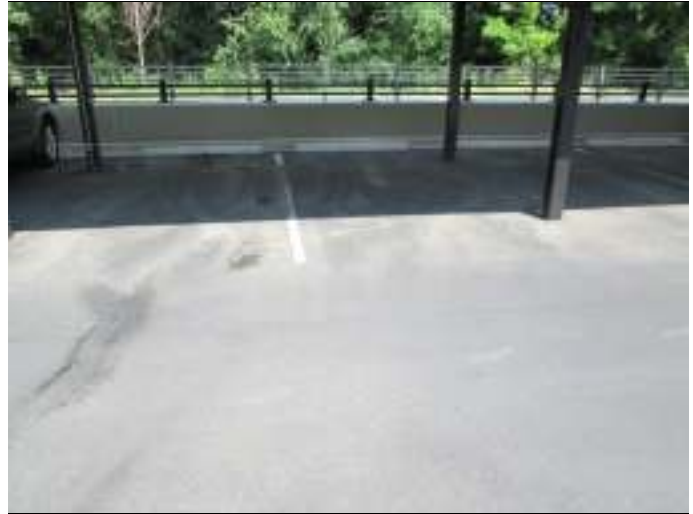
Comp #: 402 Asphalt - Surface Application

- Surface treatments are used to extend the useful life of asphalt and to help maintain aesthetics; there are a broad range of products to choose from so we recommend consulting a reputable contractor for your community's needs.
- The recommendation is an allowance for the mid range surface treatments that are available in today's market.
- Expect to seal coat, chip seal or slurry seal your asphalt every 4 - 5 years, as the asphalt ages it may be necessary to adjust the frequency and or cost of these projects.

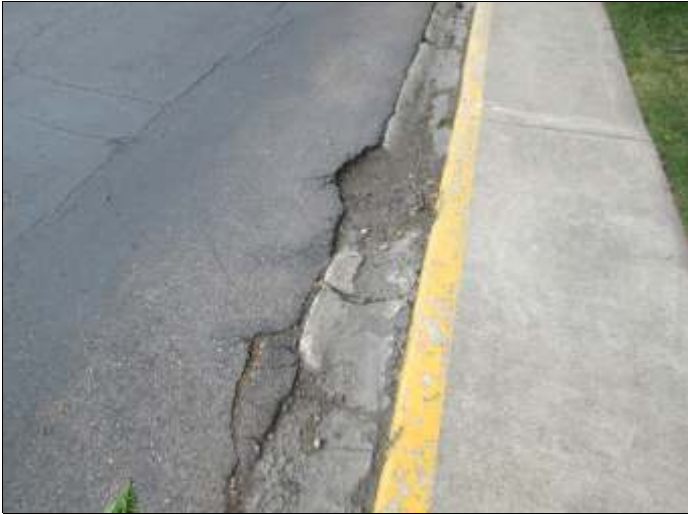
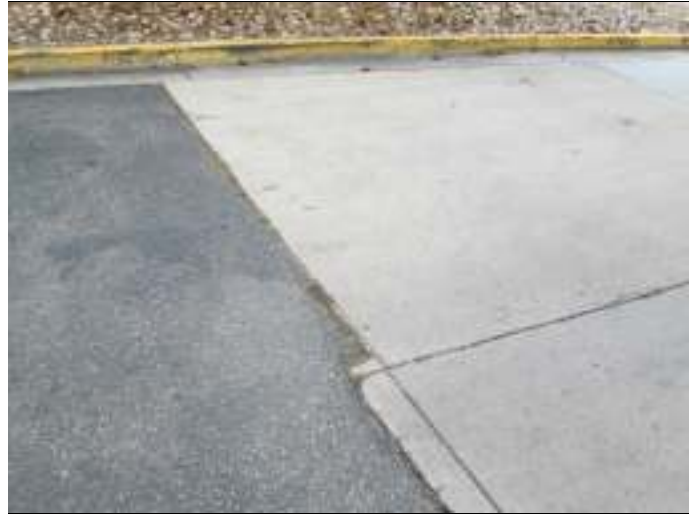
Comp #: 403 Concrete - Repair/Replace

- It is unlikely that all concrete will fail and need to be replaced at the same time, therefore, we recommend reserving to replace approximately 10% of the area (835 GSF) every 5 years.
- Coordinate this project with other concrete and/or asphalt projects for best cost estimates based on quantity of work.

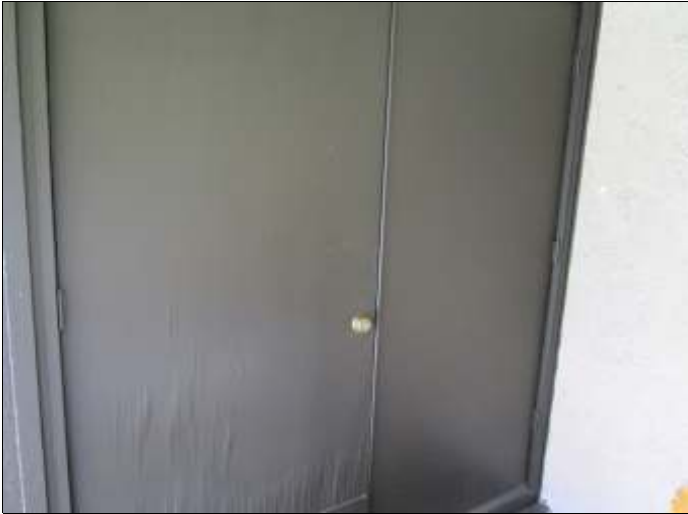
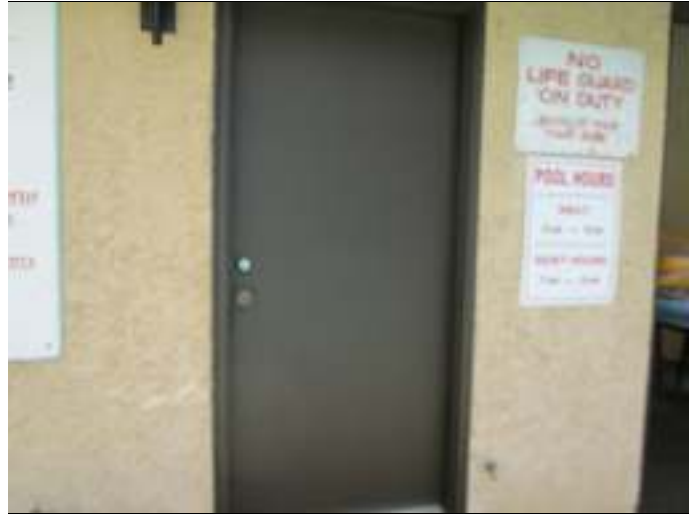
Comp #: 503 Doors - Replace

- Doors appeared to be in good condition at time of observation with no signs of problems and no reported issues.
- Due to the low quantity of doors on the property, we do not recommend reserving for complete replacement.
- Replace doors individually on an as needed basis using operating funds.

NOTE: The left side of the double doors requires repainting, it appears there was some moisture has worked its way behind the paint on the door.

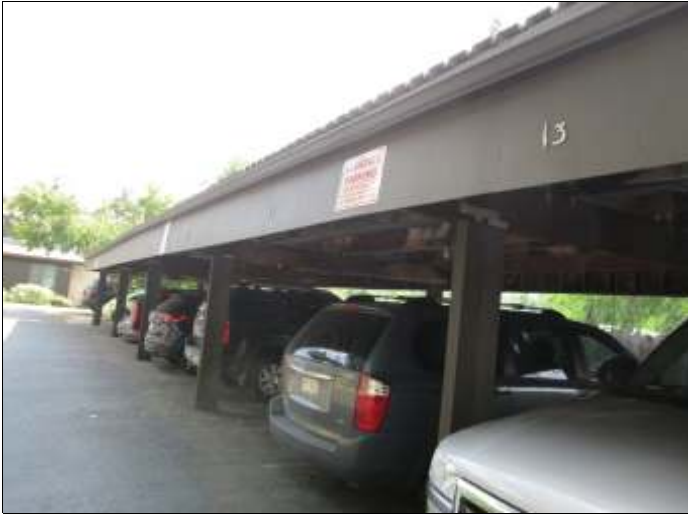
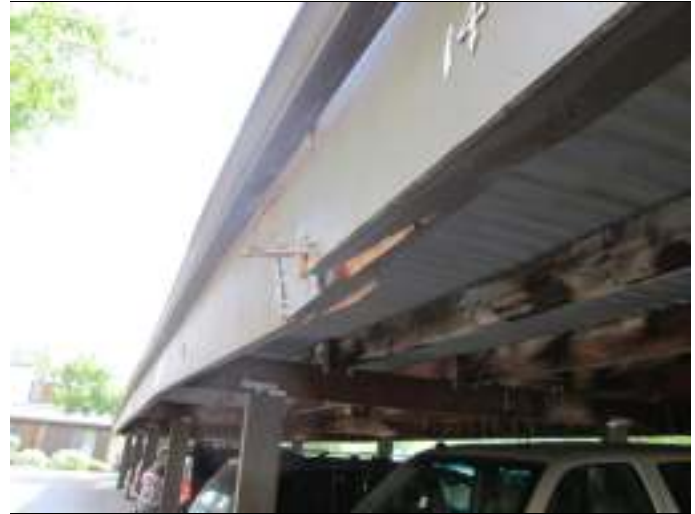
Comp #: 508 Carports - Replace (West)

- These carports are original from time of construction and appear outdated especially when compared to the newer style of carport installed on the East side of the property.
- In order to maintain curb appeal and a consistent appearance on the property, we recommend reserving to replace these carports as soon as possible.
- The "99" year useful life indicates this line item as a one-time expense as we do not expect these will require complete replacement in the future.

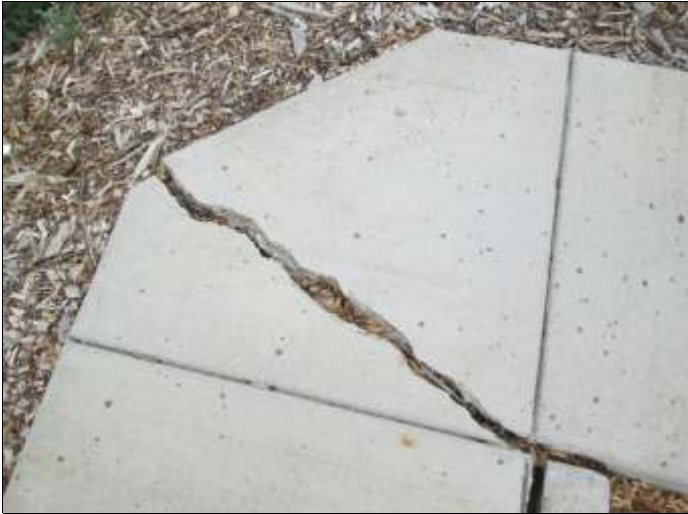
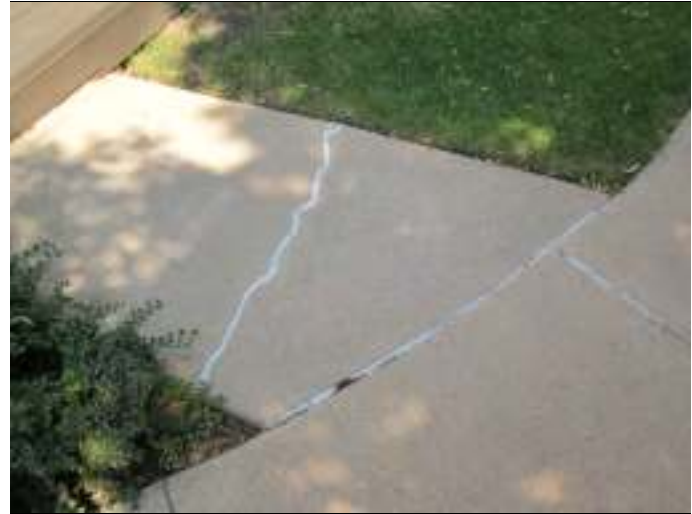
Comp #: 601 Concrete Sidewalks/Decks - Repair

- Similar to other concrete assets within the community, it is unlikely that all will fail at the same time, therefore, we recommend reserving to replace approximately 10% of the total area (1,485 GSF) every 5 years.
- Coordinate this project with other concrete and/or asphalt projects for best cost estimates based on quantity of work.

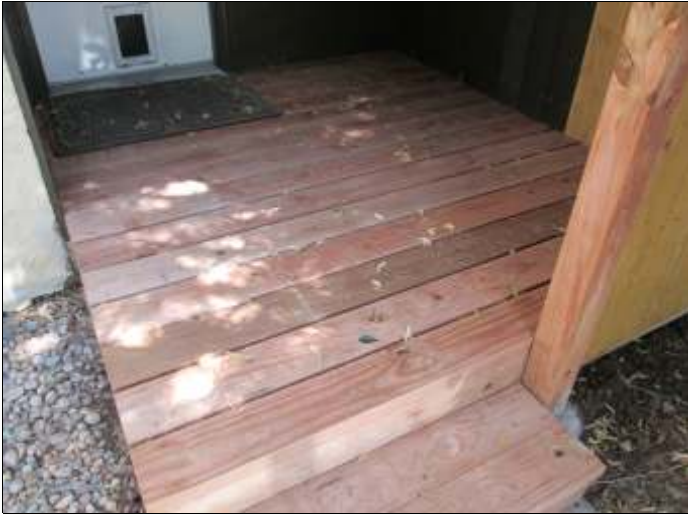
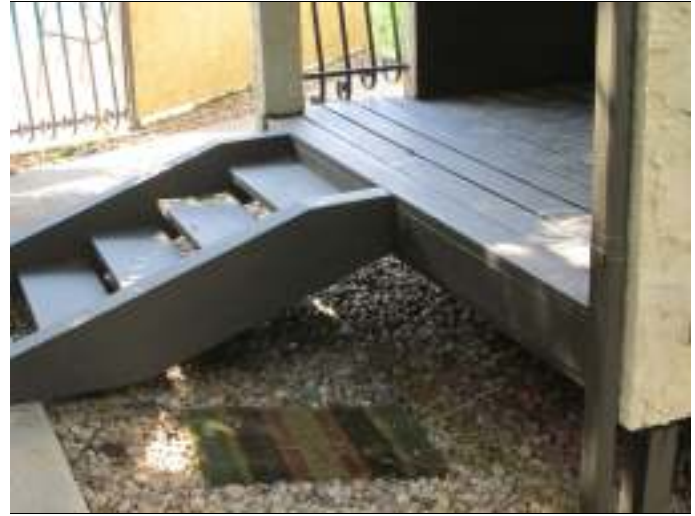
Comp #: 607 Wood Deck - Major Repairs

- The majority of decks on site appeared in good condition with some decks that were replaced with all new material.
- We do not expect the association will reach the point where all decking will require replacement at one time, therefore, we recommend reserving an allowance to make major repairs to decking every 4 years.
- It appears the association paints the decking as opposed to staining, costs for repainting decks is included with component #204 of this report.

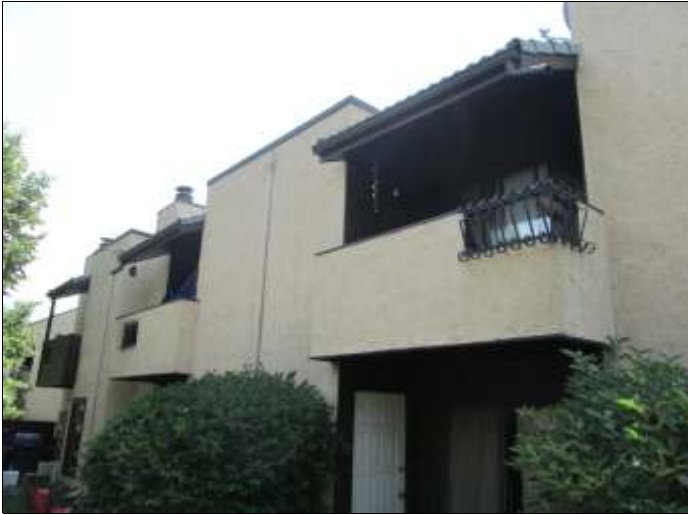
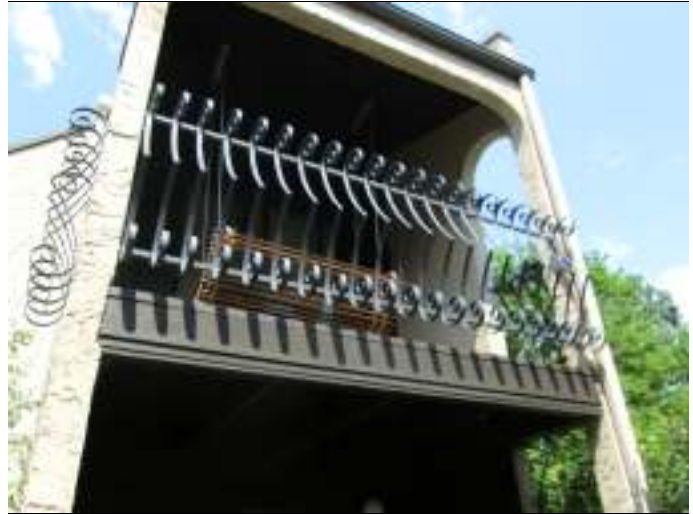
Comp #: 611 Balconies - Major Repairs

- Due to privacy concerns and the height of the balconies, we were unable to observe conditions of the balconies.
- There were no reports of problems with the balconies at time of preparing this report.
- Similar to property decking, it is unlikely that all balconies will fail and require replacement, therefore, we recommend reserving an allowance to make major repairs to balconies every 8 - 10 years.

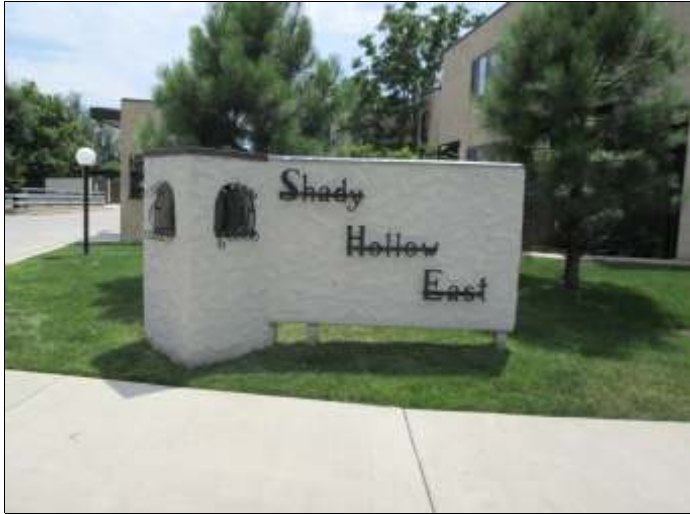
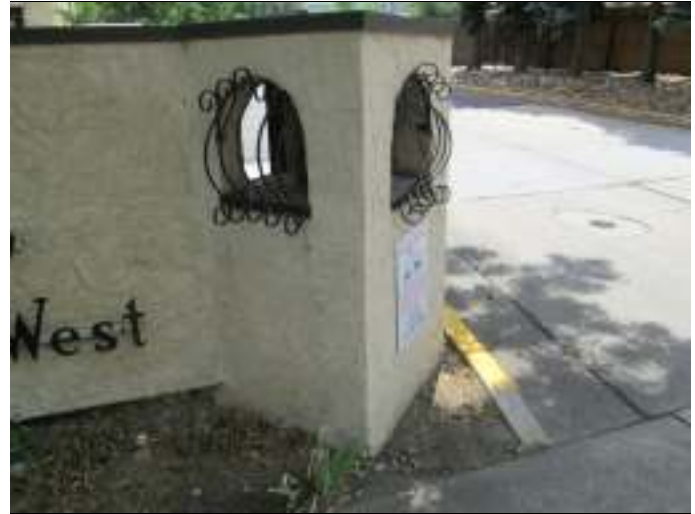
Comp #: 801 Monuments - Rebuild

- This line item is for periodic updates of the entry monuments and the surrounding area (landscaping, resulting irrigation redesign, re-positioning, etc.)
- In order to ensure that the community has an appropriate and current appearance, we recommend reserving for significant refurbishment to the monuments every 18 - 20 years.

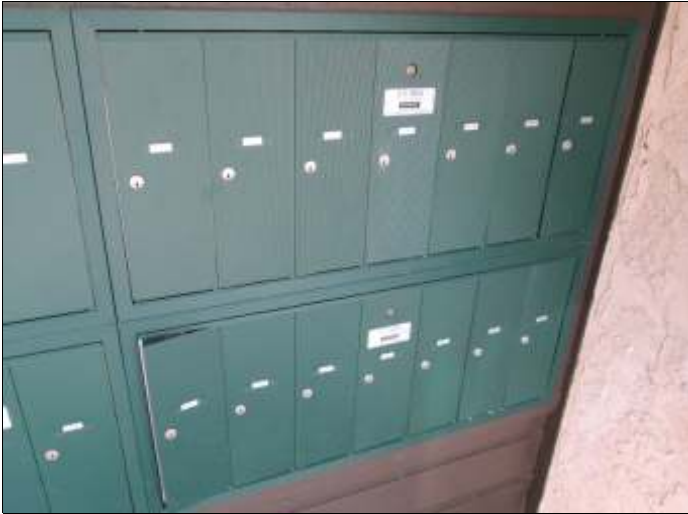
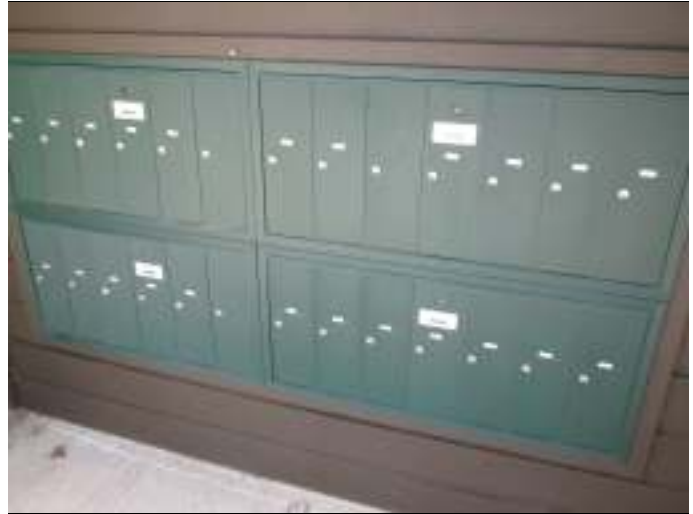
Comp #: 803 Mailboxes - Replace

- Mailboxes appear to be fairly new and are in good condition at time of observation.
- Due to these boxes being mostly protected from the elements, we expect a useful life of approximately 20 years.
- Make minor repairs between replacement cycles on an as needed basis using operating funds.
- Costs include removal and replacement.

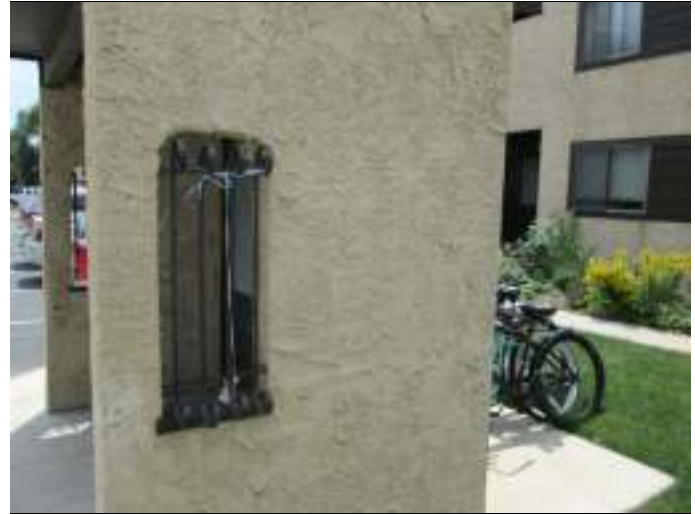
Comp #: 804 Mail Box Kiosks - Replace

- The mailbox kiosks have been well maintained and complete replacement is unlikely.
- Stucco and siding repairs and painting are included with other line items in this report.
- No separate reserve designation is necessary for this component at this time.

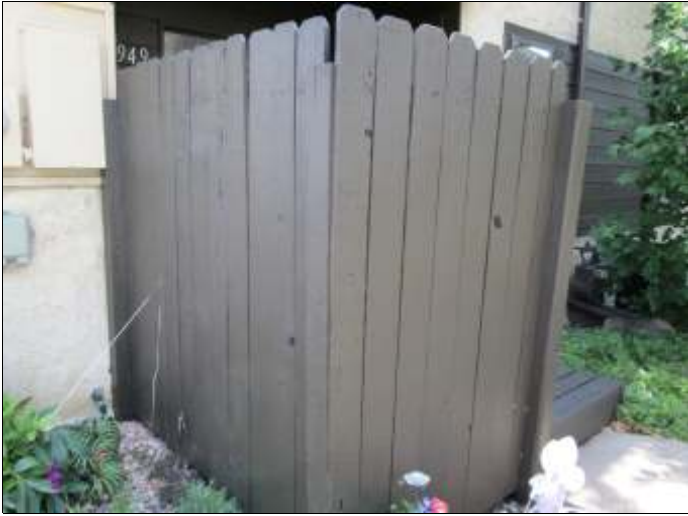
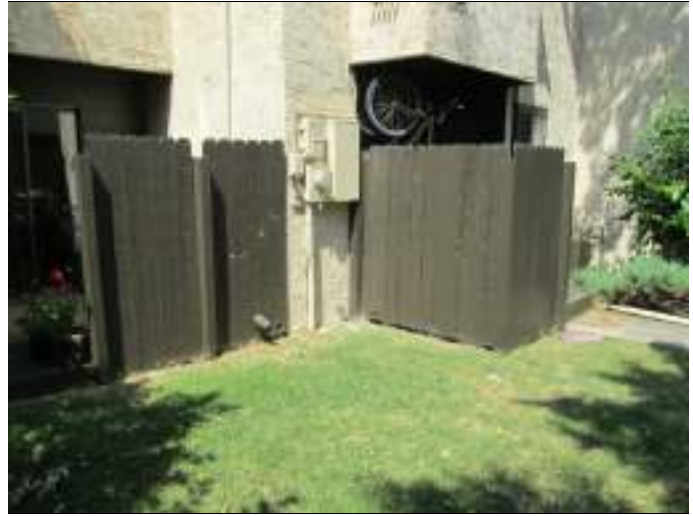
Comp #: 1001 Wood Fencing - Replace

- Fencing throughout the property appeared to be different ages and some small areas of fencing was undergoing replacement at time of observation.
- In order to ensure that the unit fencing continues to appear in good condition, we recommend reserving to partially replace every 6 - 8 years.

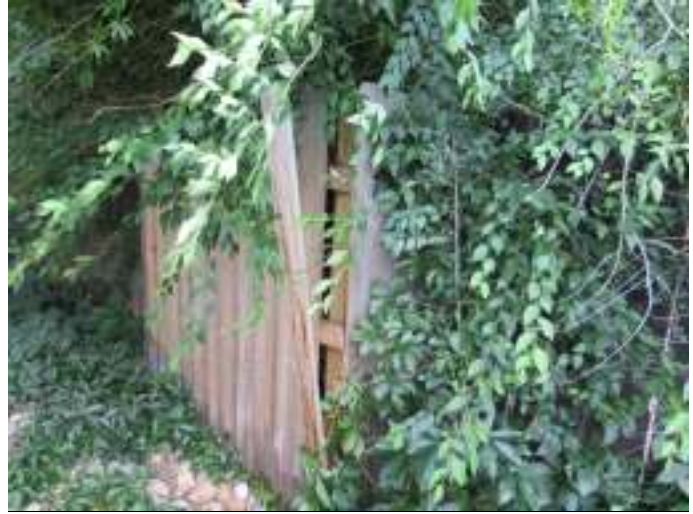
Comp #: 1001 Perimeter Fencing - Replace

- West perimeter fence appeared in poor condition with dry and damaged wood apparent in several areas.
- In order to restore appearance and function, we recommend replacing this fiscal year (2015).
- To maximize the life expectancy of this fence, restrain every 3-4 years while reserving to completely replace every 20 years.

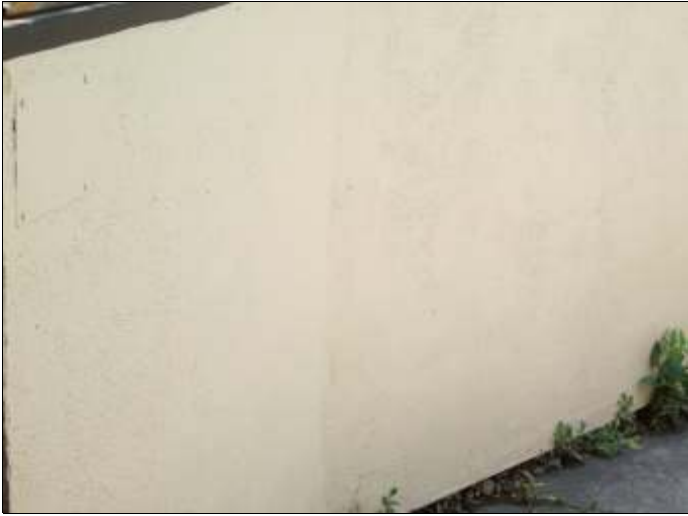
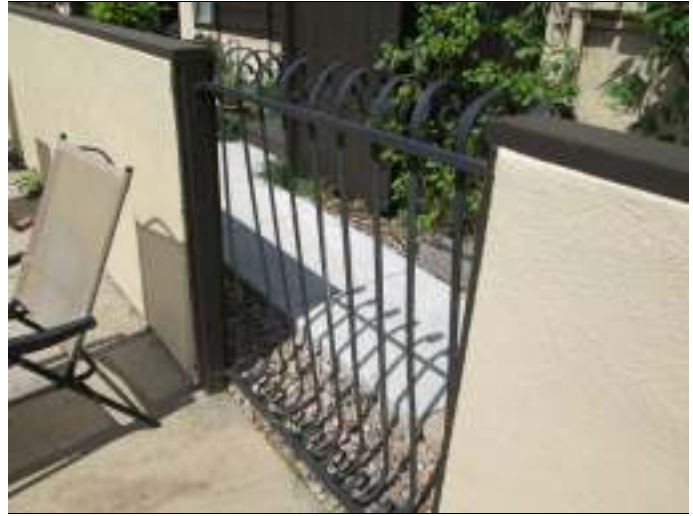
Comp #: 1002 Pool Fence - Major Repairs

- The pool fence interior surfaces appeared in better condition than the exterior, however, the problems with the exterior surfaces appeared to be superficial (needing to be painted).
- This line item is for periodic major repairs to the pool enclosure every 5 - 6 years.
- Paint the pool fence at same time as unit building repainting, no separate reserve funding necessary for repainting at this time.

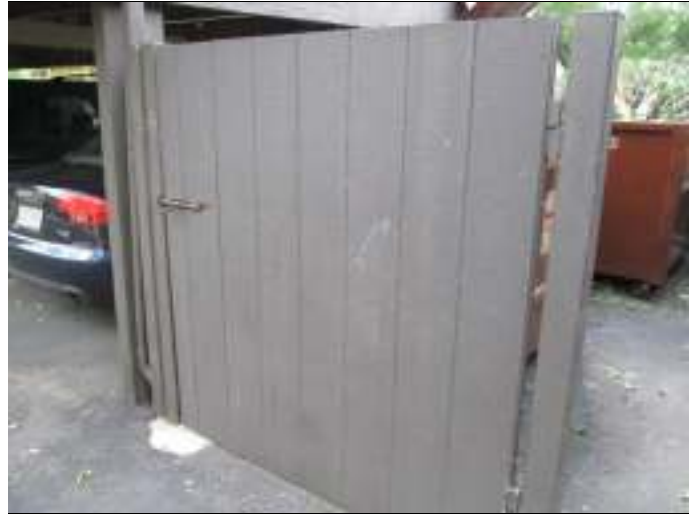
Comp #: 1010 Trash Enclosures - Replace

- Under normal conditions and with proper maintenance, we do not expect that the trash enclosures will need to be completely replaced.
- Funding on this line item is for gate replacement only; due to rubbish company's tendency to be very rough with trash enclosure gates, we recommend reserving to replace the gates every 6 years.

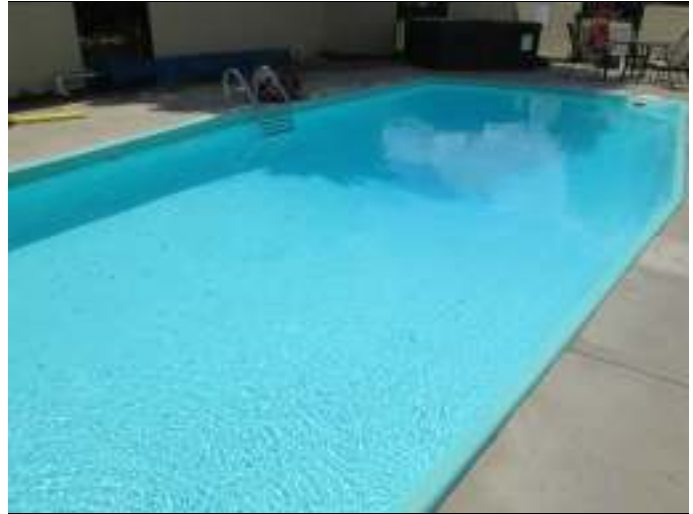
Comp #: 1101 Pool - Resurface

- The pool can be recoated, however, the repainting/resurfacing of fiberglass pools is very costly and only has a life expectancy of 4 - 5 years in a best case scenario.
- Due to the location of the pool and the fact that it is protected from the harshest UV rays in the late afternoon, we expect that the pool will not have any major issues in the foreseeable future.
- If deterioration rates change over time, we can add funding for resurfacing or shell replacement in future updates of this report.

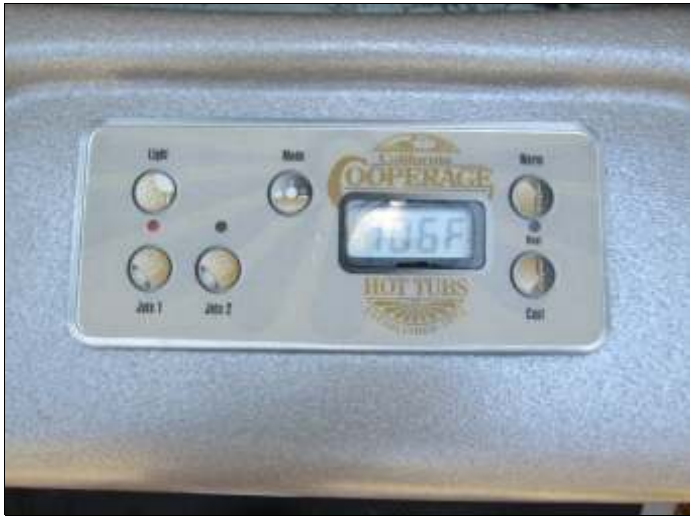
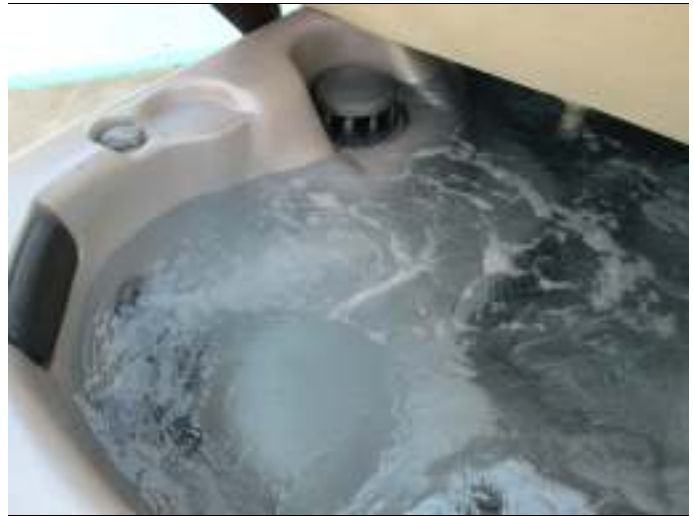
Comp #: 1102 Spa - Replace

- This hot tub is considered to be at or near the top-of-the-line according to a local supplier.
- The supplier recommended an approximate life expectancy of 20 years if properly maintained.
- Replace parts and continue to maintain at a high level using operating funds while reserving to completely replace every 18 - 20 years.

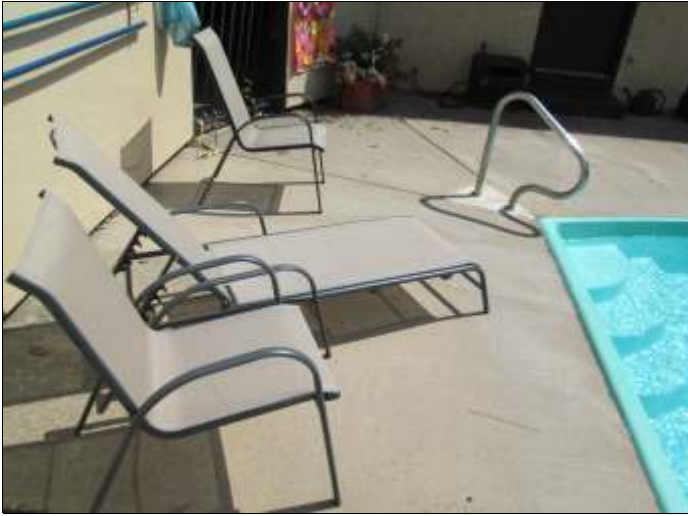
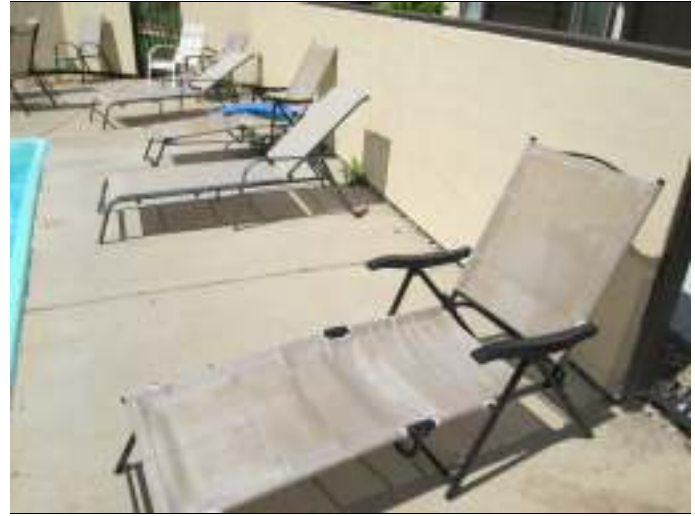
Comp #: 1121 Pool Furniture - Replace

- The current level of pool furnishings on site can be replaced with similar pieces from local retailers and can still be matched at this time.
- Due to the low quantity and relatively low cost of individual replacement, we do not recommend reserving for complete replacement at this time.

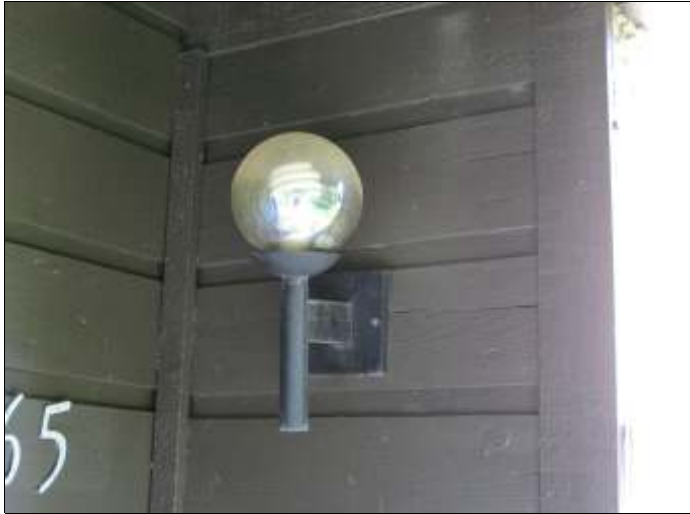
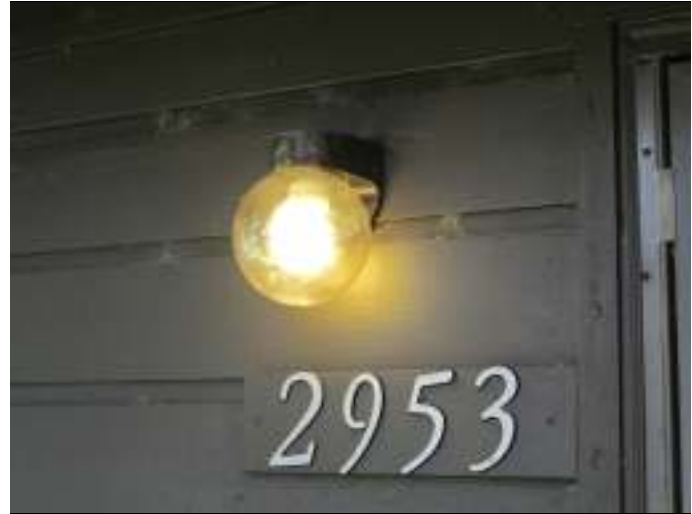
Comp #: 1602 Exterior Wall Mount - Replace

- Lighting appeared aged and types of fixtures differed from unit to unit; in order to re-establish a consistent and attractive appearance throughout the community, we recommend reserving to replace all fixtures at the same time.
- Expect to replace exterior fixtures every 16 years to ensure a safe and attractive appearance.

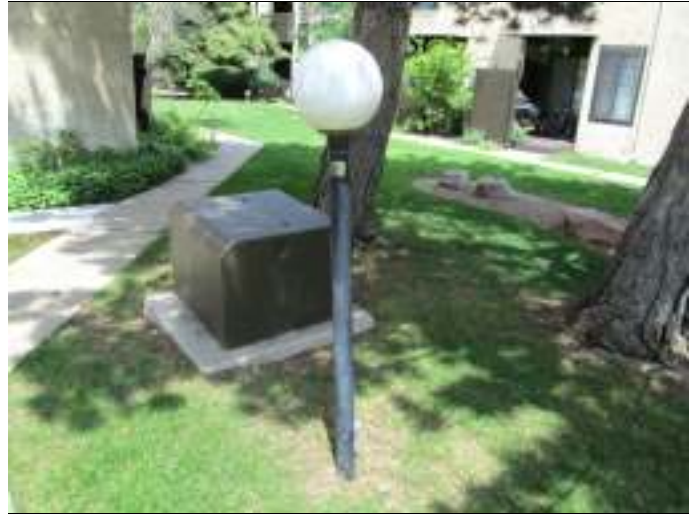
Comp #: 1604 Pole Lights - Replace

- Pole lights appear to be well maintained and there were no signs of damaged or faded globes.
- The globe lights are slightly dated in appearance, however, based on the overall good condition of the fixtures we have deferred replacement so the association can get maximum life out of the fixtures.
- Under normal conditions and with proper maintenance, expect to replace/update the fixtures every 18 - 20 years.
