Shady Hollow Townhomes Shady Hollow East and Shady Hollow West Boulder, CO 80304

Level 1 Reserve Analysis

Report Period – 01/01/15 – 12/31/15

Date of Property Observation - July 17, 2014

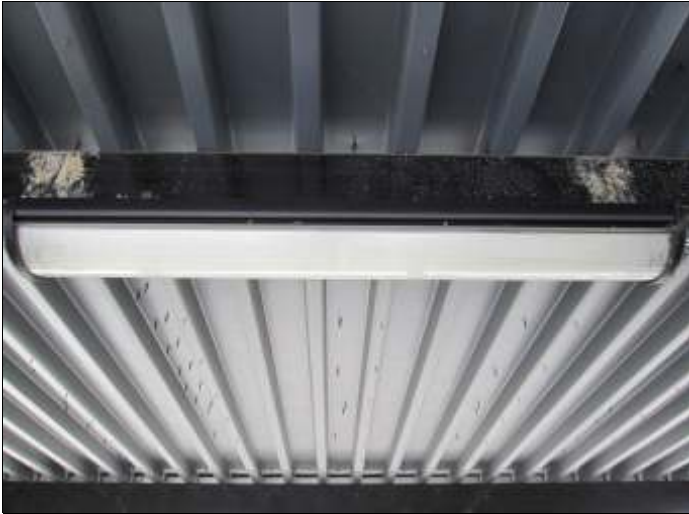
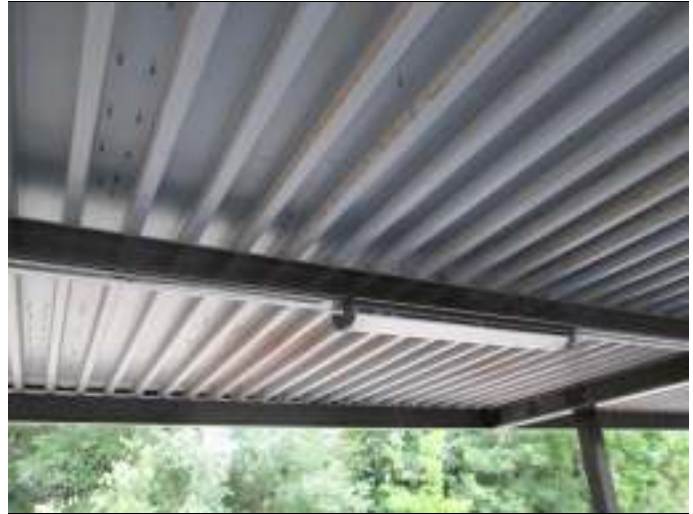
Comp #: 1608 Misc. Lighting - Replace

- Due to the low individual replacement cost and the ability to match existing fixtures with new, we do not recommend reserving to replace all fixtures at the same time.
- Replace these fixtures on an as needed basis using operating funds.

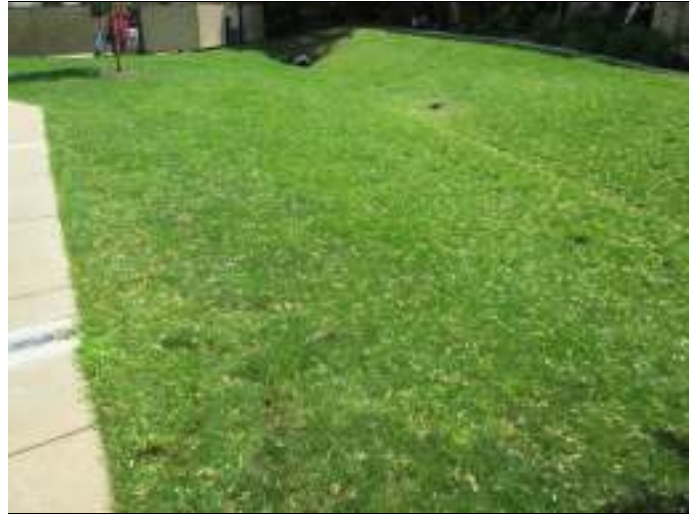
Comp #: 1701 Irrigation System - Rebuild

- It was reported upon review of the draft report that the irrigation system is in need of complete replacement.
- The costs below were reported during a phone conversation with the client.
- If the new system is properly maintained, expect a useful life of approximately 30 years under normal conditions.

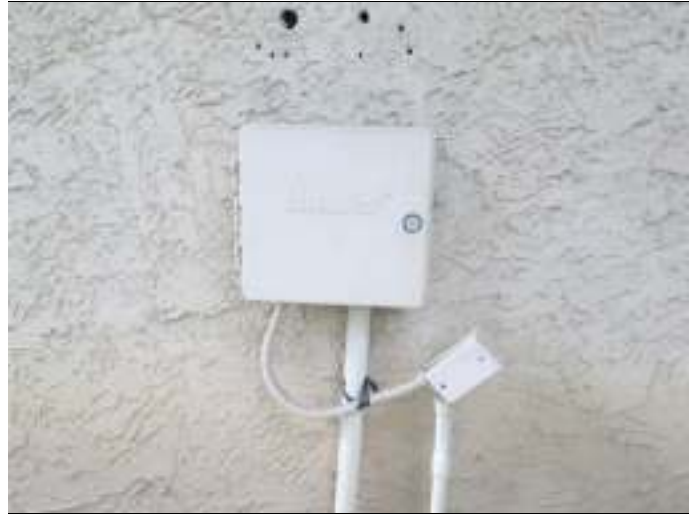
Comp #: 1703 Irrigation Controllers - Replace

- Expect to replace irrigation controllers every 10 - 12 years if properly maintained and under normal conditions.
- Funding is for replacement with evapotranspirative controllers as these are more efficient and can be controlled remotely by landscaping experts, saving the association irrigation water costs.

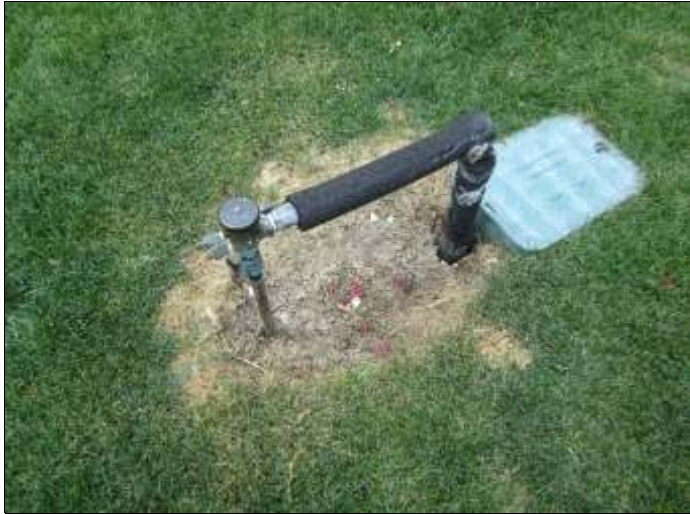
Comp #: 1706 Backflow Devices - Replace

- Due to the ability to rebuild and replace these devices for a relatively low cost and the fact that failure of the device is wildly unpredictable, we do not recommend reserving for replacement.
- Repair and/or replace these devices on an as needed basis using operating funds.

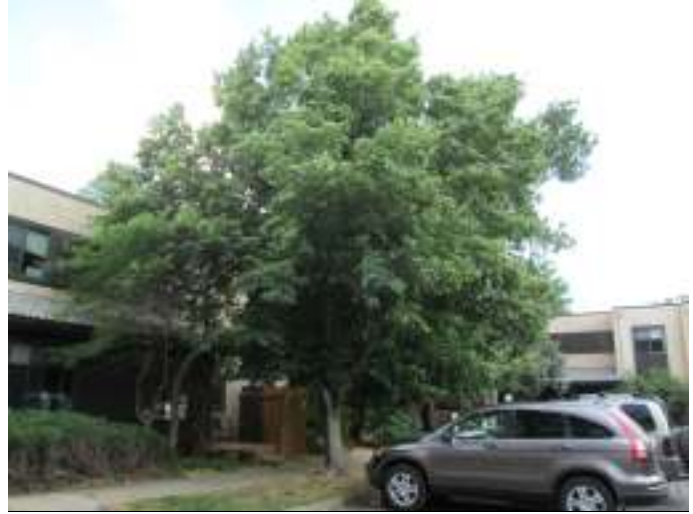
Comp #: 1801 Landscaping - Refurbish

- This line item, similar to irrigation repairs, is for projects that lie outside the scope of routine maintenance.
- In order to preserve an attractive curb appeal and to maintain the health of the plants and shrubs, we recommend reserving for refurbishment projects every 3 - 4 years.
- This line item is for cyclical refurbishment and should not be considered as complete landscaping replacement.

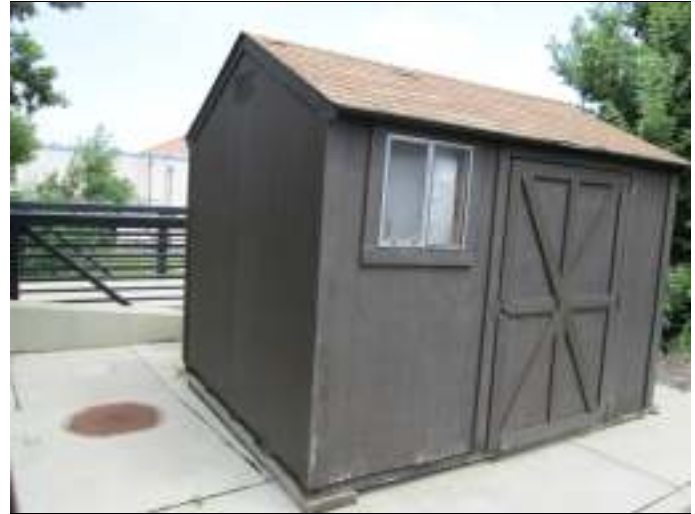
Comp #: 1904 Storage Shed - Replace

- The shed appeared in fair to poor condition at time of observation and replacement should be expected within the next 2 - 3 years to restore appearance and security.
- According to Tuff Shed, this shed should have a typical useful life of approximately 25 years if properly maintained.
