**Arapahoe Ridge Townhomes
5401 - 5481 White Place
Boulder, CO 80303**

Level 1 Reserve Analysis

Report Period – 01/01/15 – 12/31/15

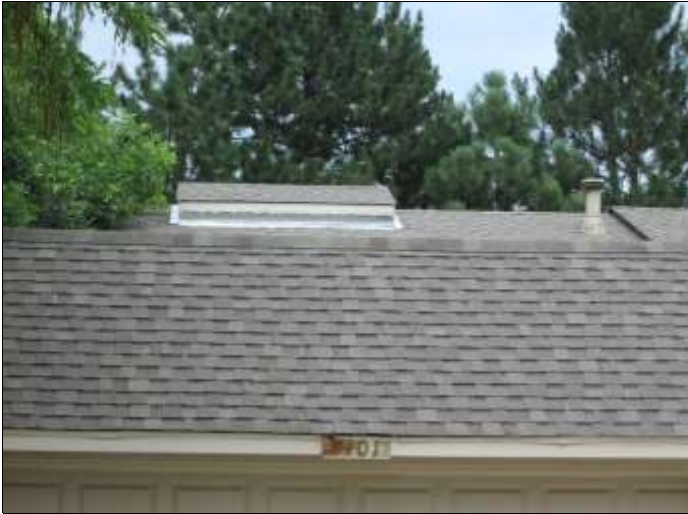
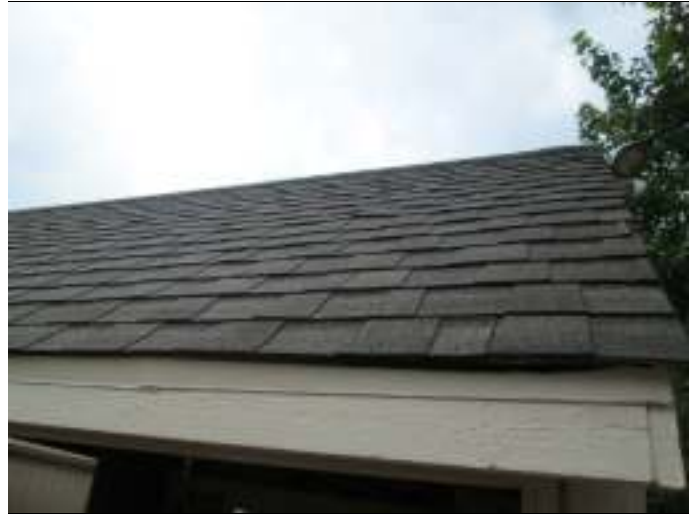
Comp #: 105 Comp Shingle Roof - Replace

- Roofs were reported to have been replaced in 2005 and appeared in good condition at time of observation with only minor loss of surface granules noted.
- Even though this roof may be rated as a 30 year roof, a life expectancy of 18 - 20 years is expected in this environment.
- Due to the potentially harsh winters, extensive freeze/thaw cycle, and likelihood of hail events over the useful life of the roof, we typically see associations replacing roofs sooner than the manufacturer's suggested useful life.

Location: Unit building roofs

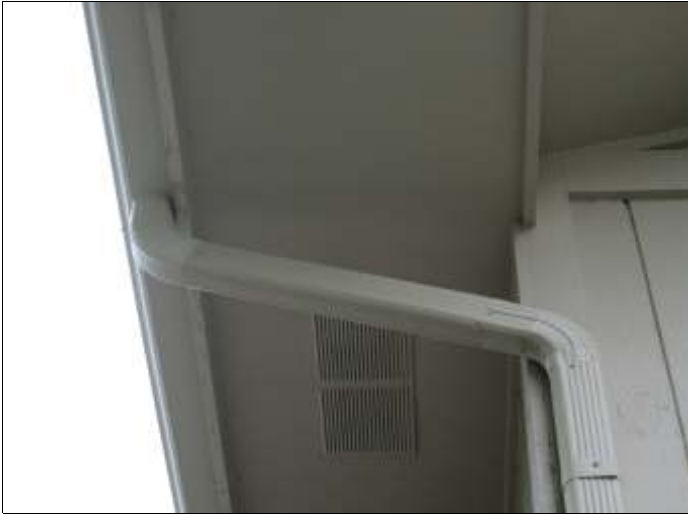
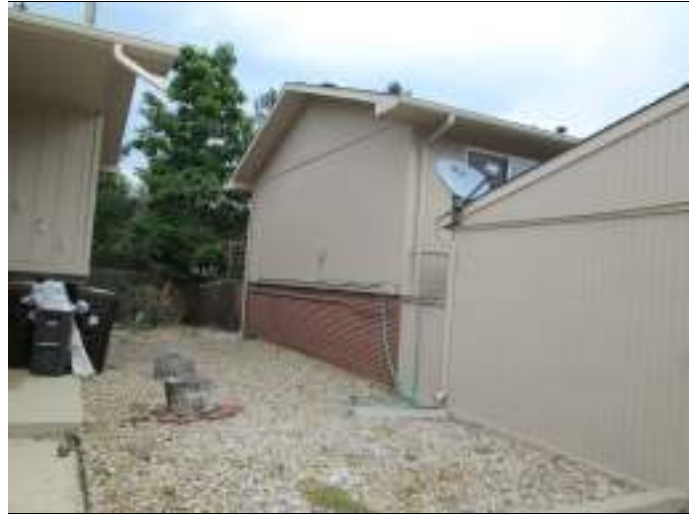
Comp #: 120 Gutters/Downspouts - Replace

- No reported problems or unusual conditions were noted at time of site evaluation.
- It is typical to replace gutters and downspouts at the same time as roofing materials. Therefore, the remaining life reflects the remaining life of the roof as well.
- We recommend cleaning debris out of lines at least once a year to prevent clogging and moisture retention that can lead to advanced deterioration.

Location: Unit building roof perimeter

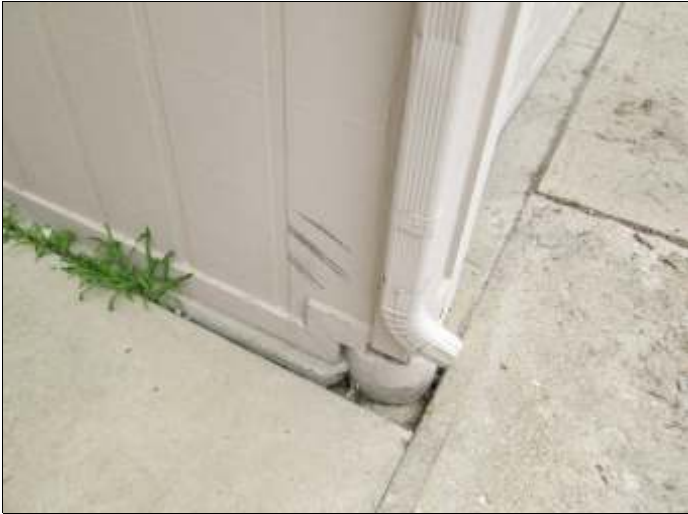
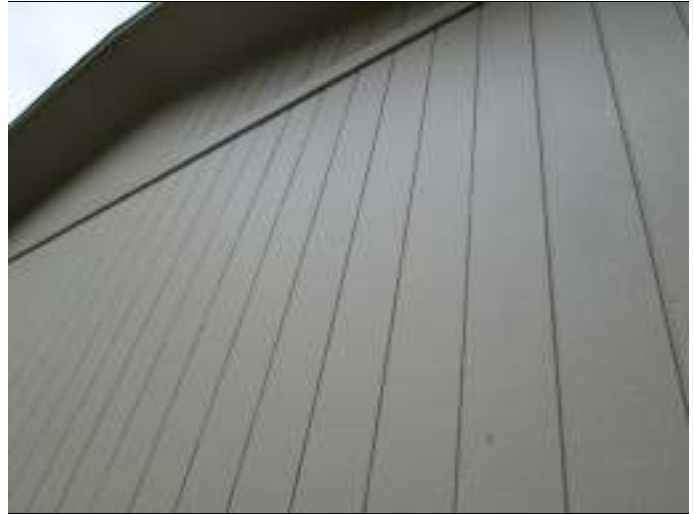
Comp #: 204 Building Ext Surfaces - Repaint (1)

- Paint on the unit buildings appeared in fair condition with evidence of fading noted in several areas, especially on South facing walls.
- It is generally recommended that hardboard siding is repainted every 5 - 7 years in this environment when properly maintained.
- Due to overall appearance, we have recommended the maximum useful life of 7 years for repainting.

Location: 5415-5431, 5465-5481 & 5435-5451

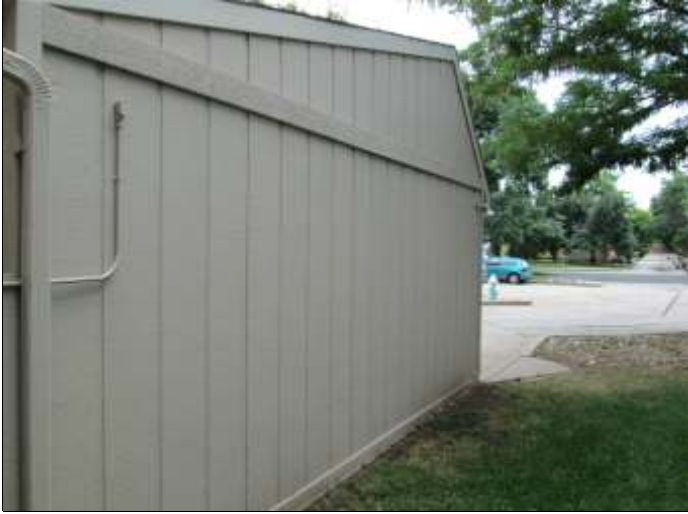
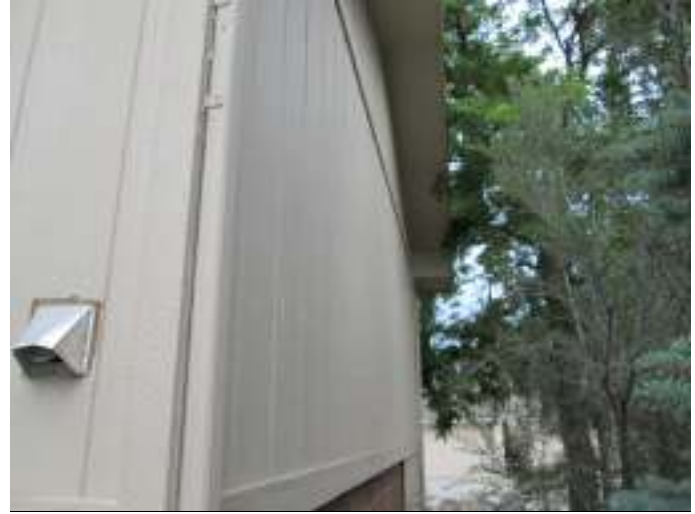
Comp #: 205 Building Ext Surfaces - Repaint (2)

- Paint on the unit buildings appeared in fair condition with evidence of fading noted in several areas, especially on South facing walls.
- It is generally recommended that hardboard siding is repainted every 5 - 7 years in this environment when properly maintained.
- Due to overall appearance, we have recommended the maximum useful life of 7 years for repainting.

Location: 5401 - 5421 and 5445 - 5471

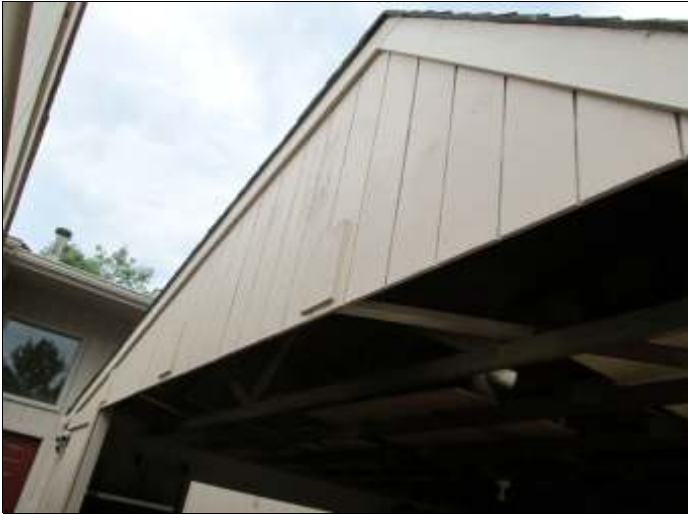
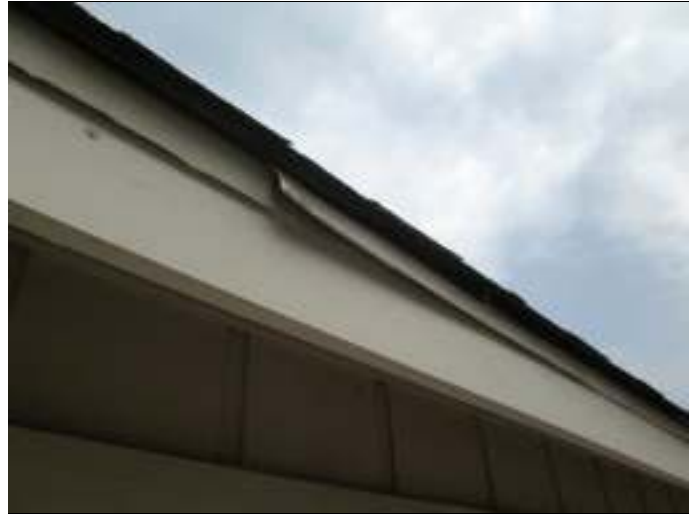
Comp #: 301 Hardboard Siding - Major Repairs (1)

- This line item is an allowance for major repairs to the siding and trim that is not considered part of routine paint prep.
- In order to avoid complete siding replacement in the future, we recommend reserving to make major repairs to the siding immediately prior to repainting.
- If deterioration rates change, we can adjust cost and/or frequency in future updates of this report.

Location: 5415-5431, 5465-5481 & 5435-5451

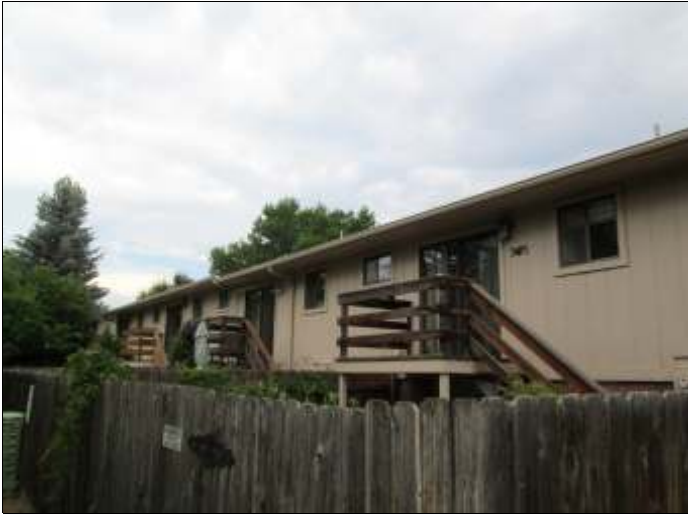
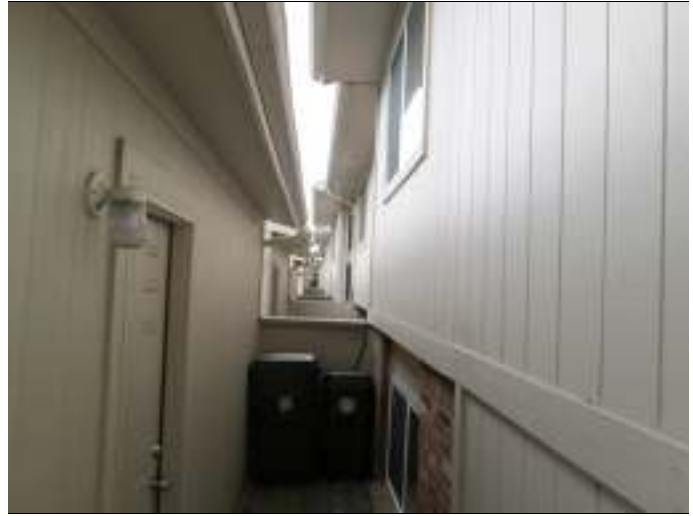
Comp #: 302 Hardboard Siding - Major Repairs (2)

- This line item is an allowance for major repairs to the siding and trim that is not considered part of routine paint prep.
- In order to avoid complete siding replacement in the future, we recommend reserving to make major repairs to the siding immediately prior to repainting.
- If deterioration rates change, we can adjust cost and/or frequency in future updates of this report.

Location: 5401 - 5421 and 5445 - 5471

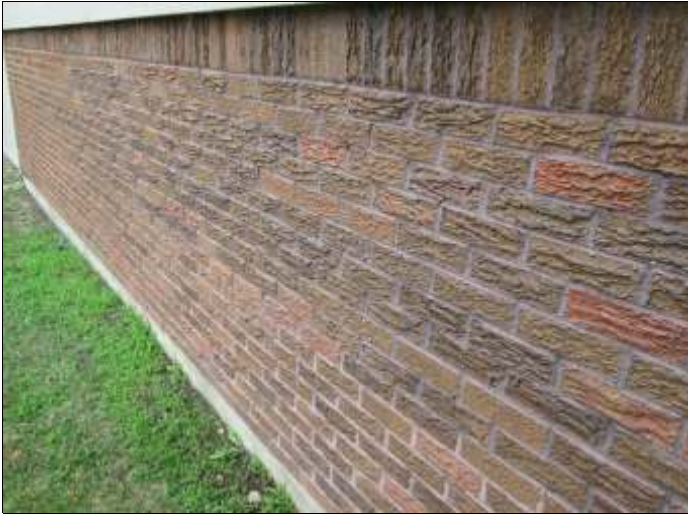
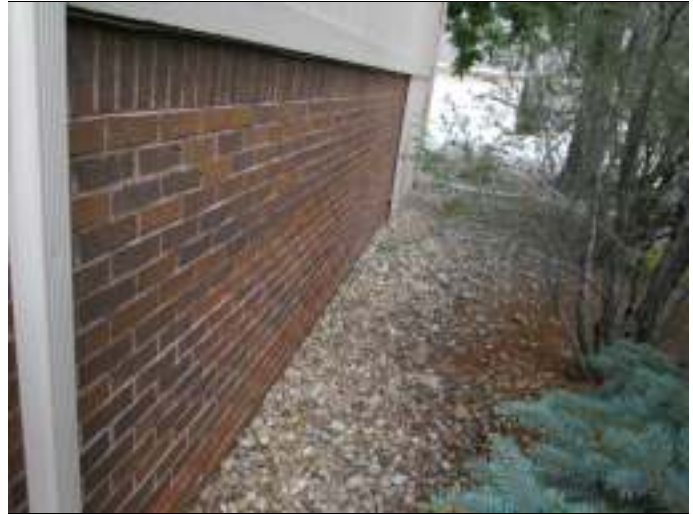
Comp #: 306 Brick - Replace

- Due to the long useful life and the unlikely event that all will fail and require replacement at the same time, we do not recommend reserving for replacement at this time.
- Reserve funding is not necessary for brick replacement at this time.

Location: Unit buliding exterior cladding

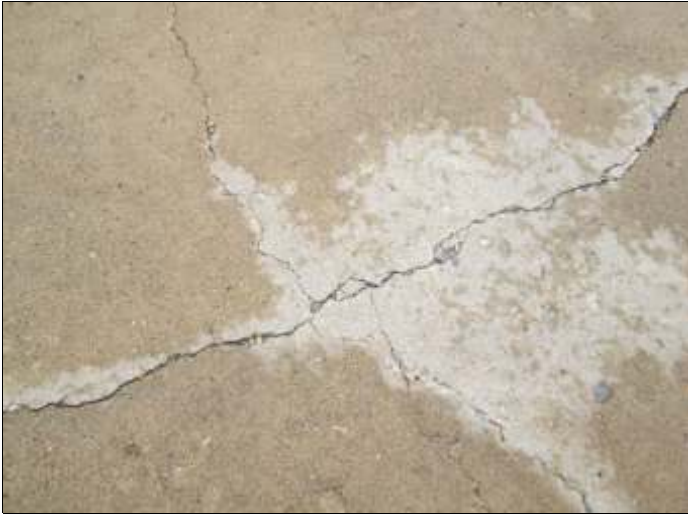
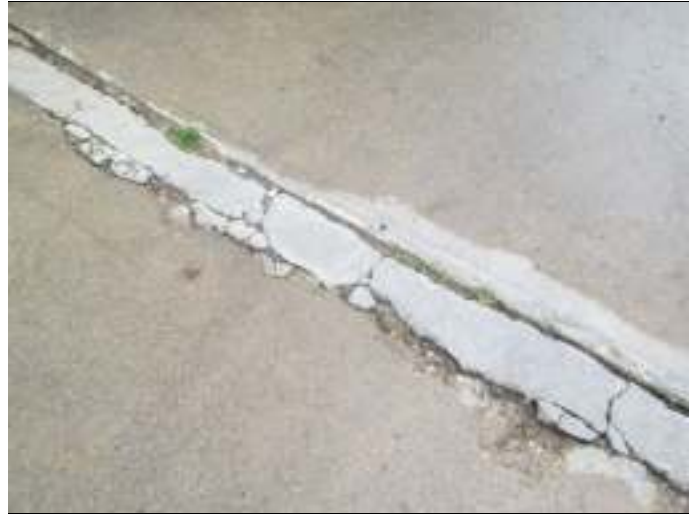
Comp #: 403 Concrete - Repair/Replace

- The concrete on site appeared in poor condition with extensive cracking, spalling, and signs of settling noted.
- It is unlikely that all concrete will fail and need to be replaced at the same time, therefore, we recommend reserving to replace approximately 15% of the area (2,540 GSF) every 5 years.
- Coordinate this project with other concrete and/or asphalt projects for best cost estimates based on quantity of work.

Allowance to replace 15% of area every 5 yrs.

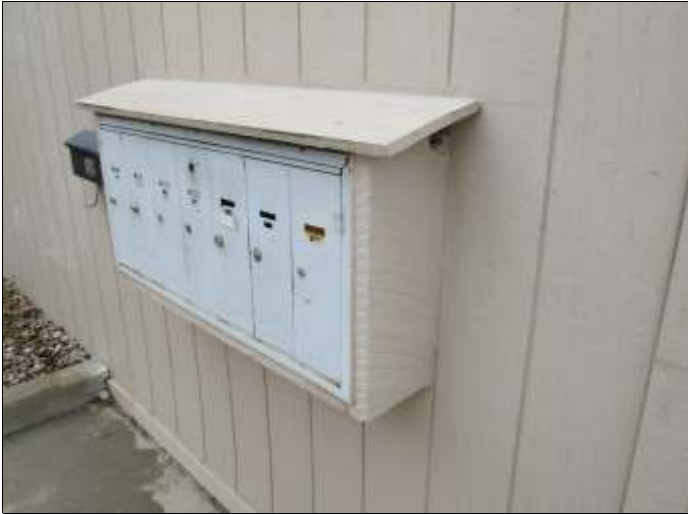
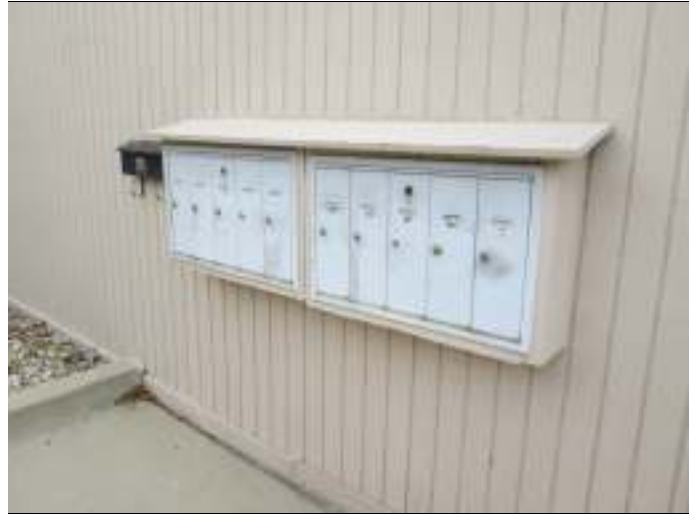
Comp #: 803 Mailboxes - Replace

- Due to the low quantity of mailboxes on site and the relatively low replacement cost of individual kiosks, we do not recommend reserving for replacement at this time (see general notes box for approximate costs).
- No reserve funding necessary for this component at this time.

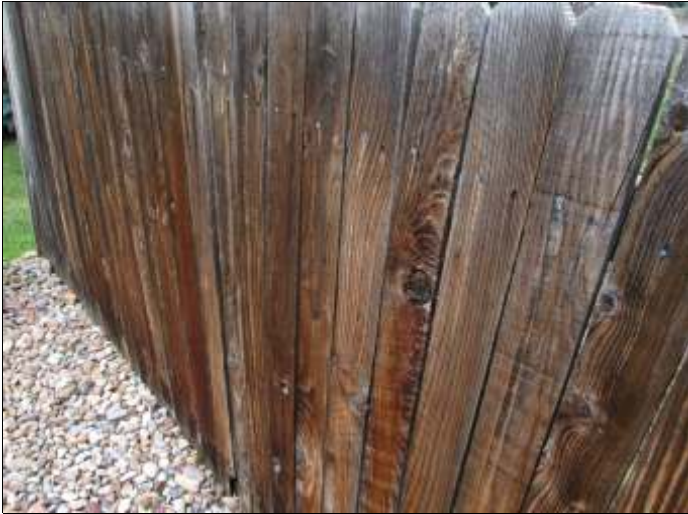
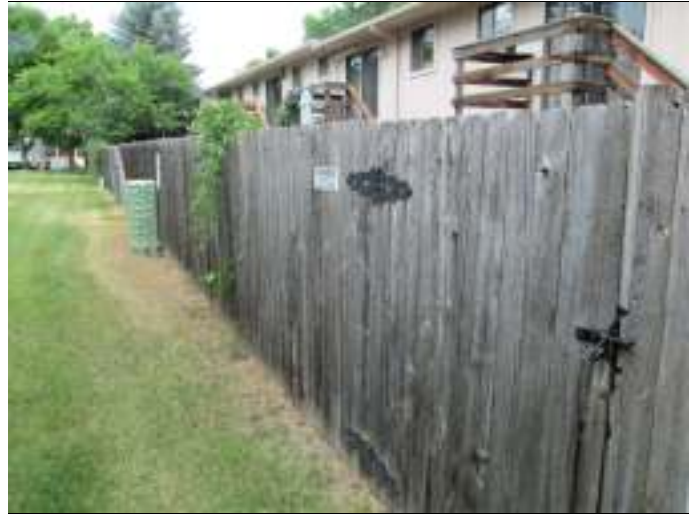
Comp #: 1001 Wood Fencing - Replace

- The fencing on site appeared in poor aesthetic condition at time of observation with a very distressed appearance however, the fence seemed stable and very few warped boards were noted.
- The typical useful life for a cedar fence is 20 - 25 years, however, based on current conditions we have extended the useful life to 30 years.
- Replacement costs for unit fencing can vary depending on the contractor due to the increased labor of installing new posts in the same location as the old posts (at corners, gates and the ends of fence lines).

Best Cost: \$30,850
\$33/LF; Estimate to replace

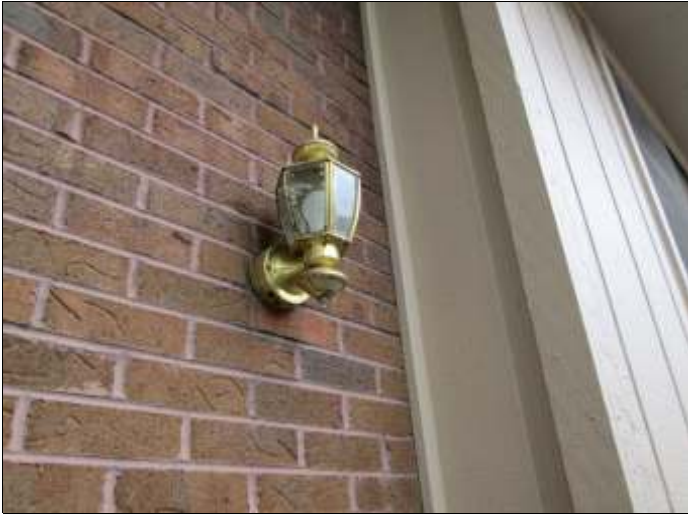
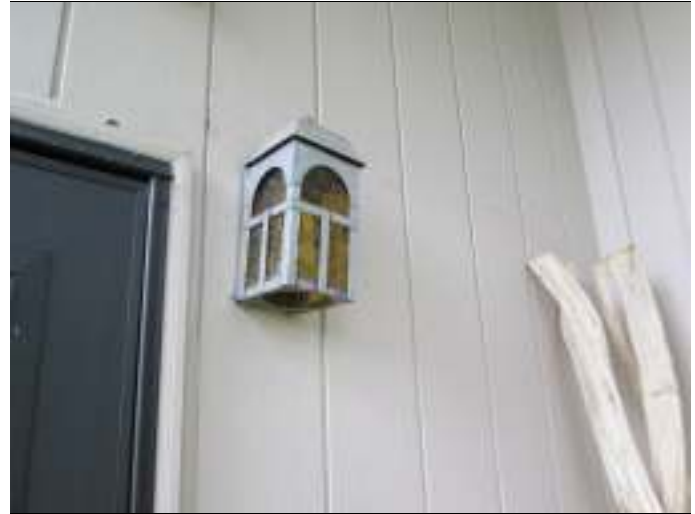
Comp #: 1602 Exterior Wall Mount - Replace

- Light fixtures differed from unit to unit leading us to believe that replacement is the responsibility of the individual homeowners.
- Due to the differing fixtures, we do not recommend reserving to replace the light fixtures at this time.
- If the association decides to assume responsibility for replacing the exterior fixtures, expect costs of \$4,250 - \$5,100 every 15 - 16 years.

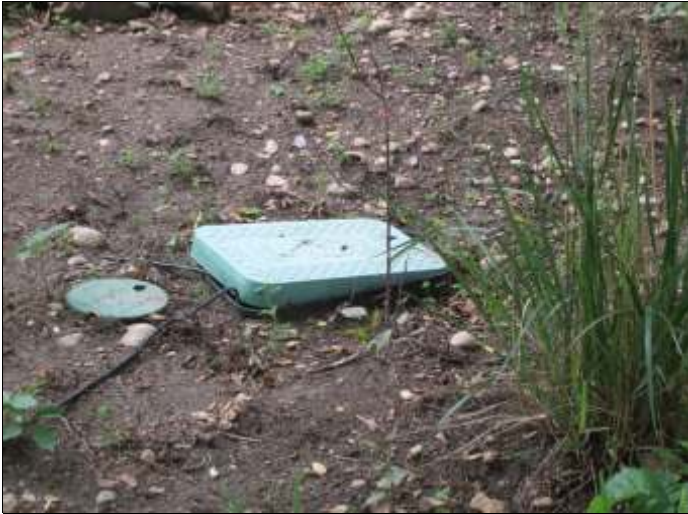
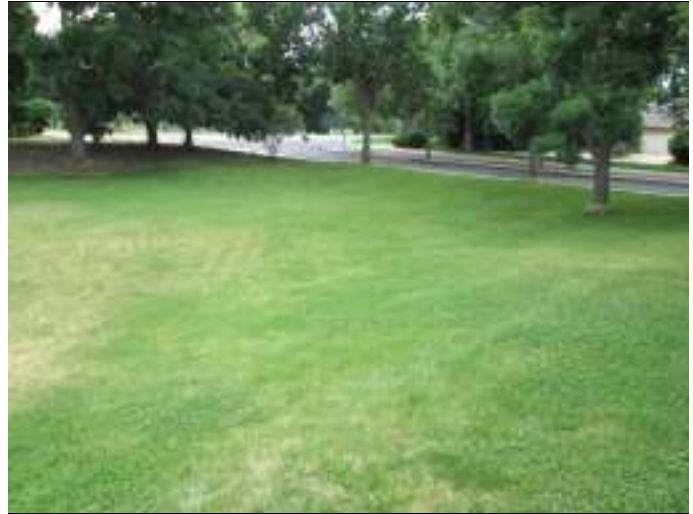
Comp #: 1701 Irrigation System - Major Repairs

- It was reported by the contractor that the system is aged but in good to fair condition.
- This line item is for repairs and replacement that lie outside the scope of routine maintenance: bulk sprinkler head replacement, bulk valve replacement, rerouting lateral lines, rewiring, etc.
- In order to ensure the funds are available for major repairs, we recommend reserving funds for these projects every 2 - 3 years.
- The funding on this line item is for major repairs and is not to be interpreted as complete irrigation system replacement.

Allowance for major repairs to the system

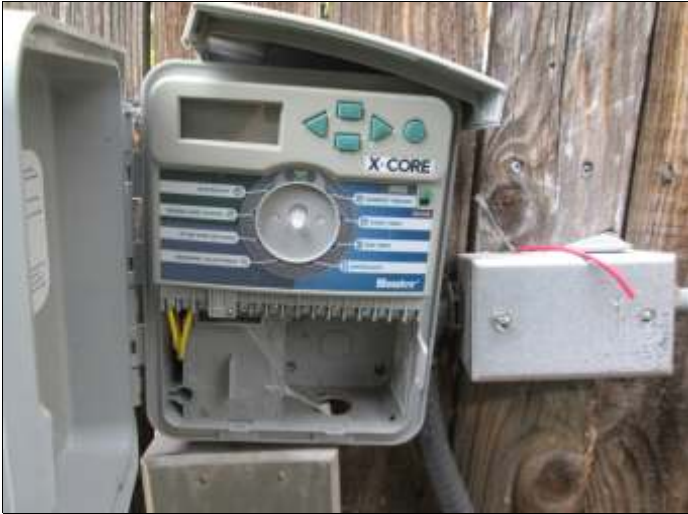
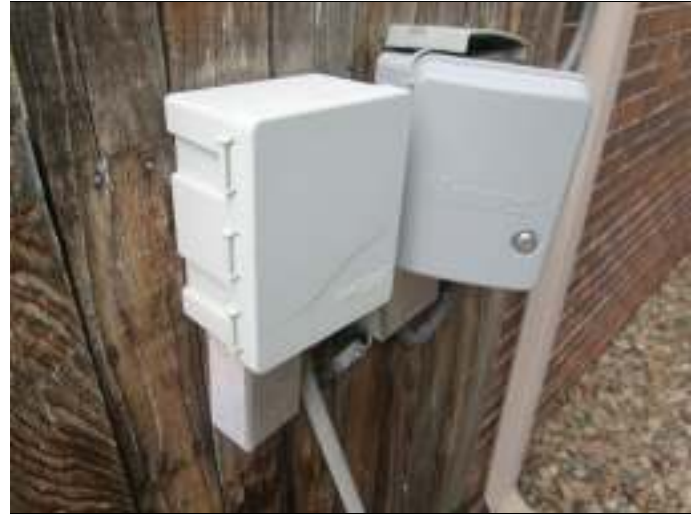
Comp #: 1703 Irrigation Controllers - Replace

- Due to the low quantity of controllers on site as well as the relatively low replacement cost of this controller, we do not recommend reserving for replacement at this time.
- Replace this controller on an as needed basis using operating funds, no reserve funds necessary.

NOTE: It was reported that there are an additional (3) battery operated clocks in the ground controlling the system, these can be replaced individually on an as needed basis using operating funds.

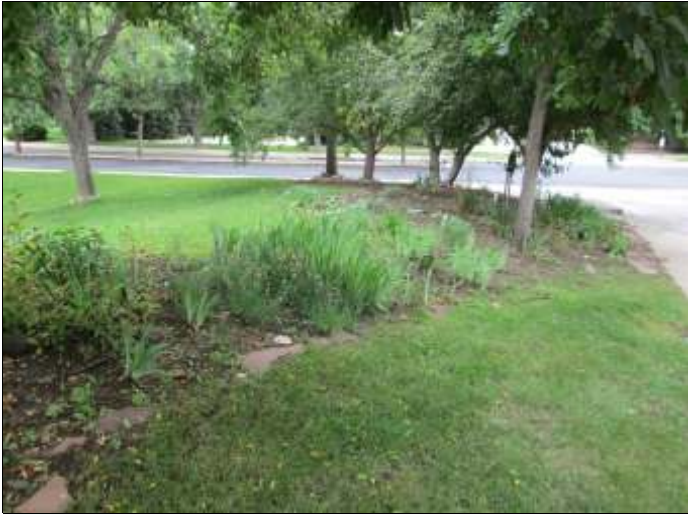
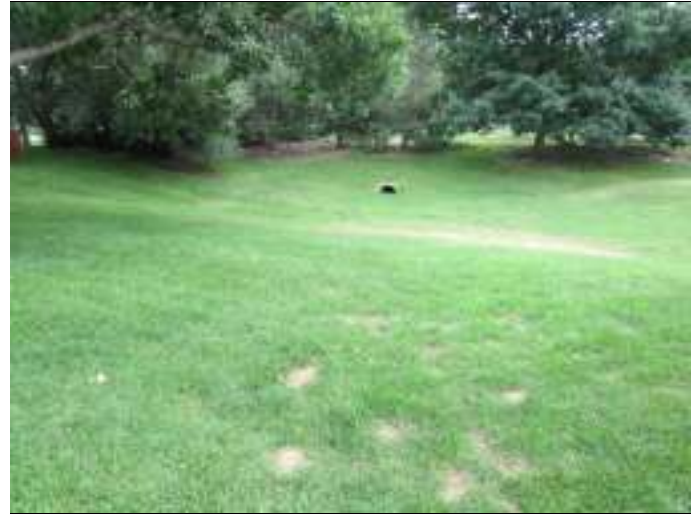
Comp #: 1801 Landscaping - Refurbish

- In researching this component with the association's contractor, it was reported that the only pressing issues are the trees with no concerns regarding the plants, shrubs and turf.
- At this time, we do not recommend reserving for landscape refurbishment; if deterioration rates change in the future, we can add funding for landscape refurbishment in future updates of this report.

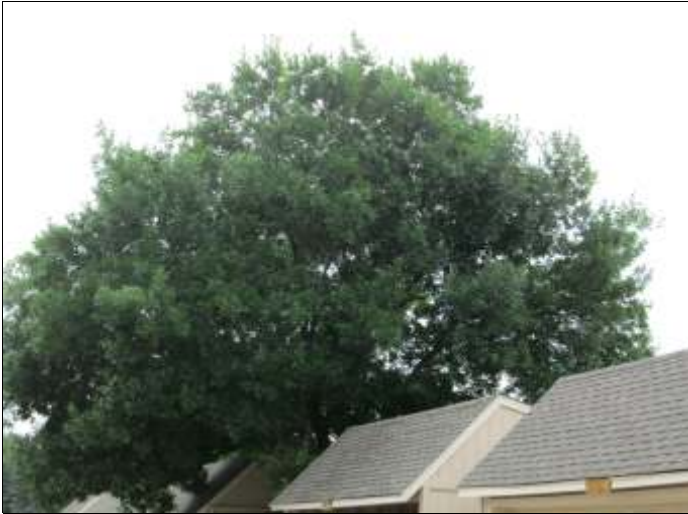
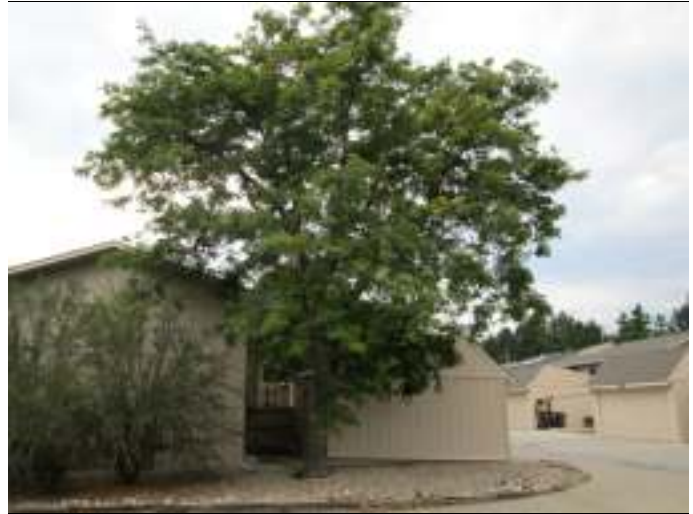
Comp #: 1804 Tree - Replacement

- It was reported that tree replacement is not a major concern for the association at this time, however, pruning and trimming is necessary for the preservation of the building exterior surfaces.
- Trimming and pruning should be done on an annual basis using operating funds, no reserve funding necessary.

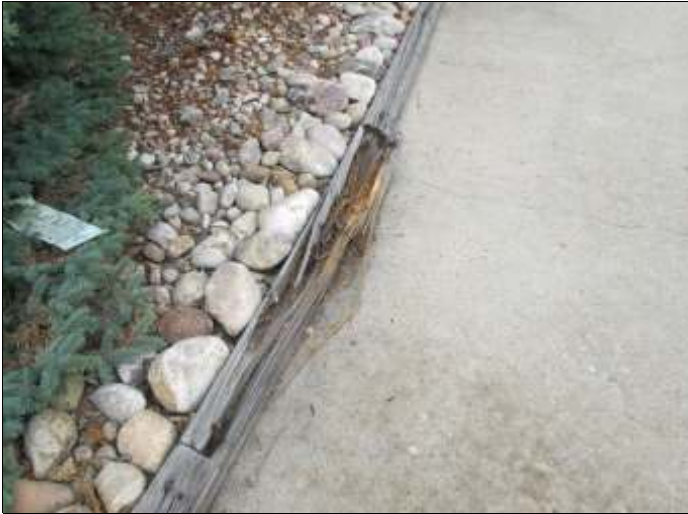
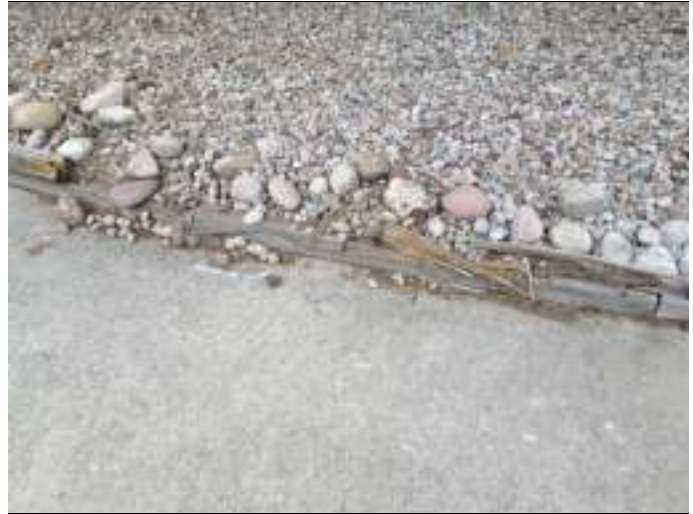
Comp #: 1805 Landscape Timbers - Replace

- These timbers are in very poor condition with extensive rot and signs of shifting timbers noted.
- We recommend replacing these timbers as soon as possible and within this fiscal year (2015) in order to restore appearance and function.

Best Cost: \$3,600
\$20/GSF; Estimate to replace
