Alpine Condominiums

Level 1 Reserve Analysis

Report Period – 03/01/07 – 12/31/07

Date of Property Inspection – January 10, 2007 and March 8, 2007

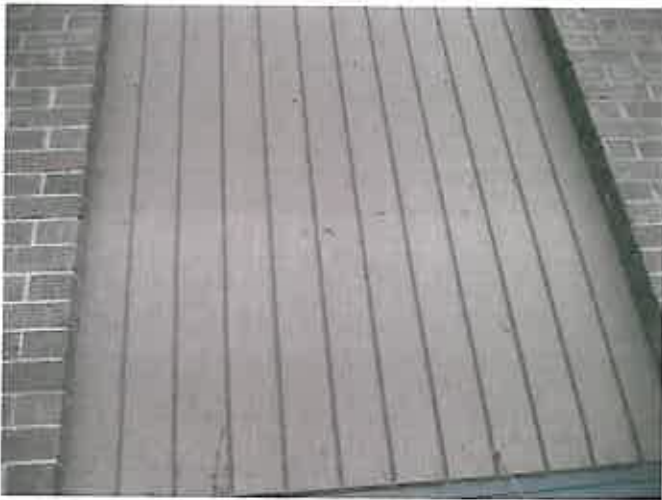
Comp #: 202 Wood Surfaces - Repaint

All wood surfaces between the brick (above the doors) and the trim was repainted in 2005 and is in good condition. In this climate, these surfaces should be repainted approximately every 3 to 5 years to maintain appearance and protect wood. Remaining life based on current condition and age of painted surface.

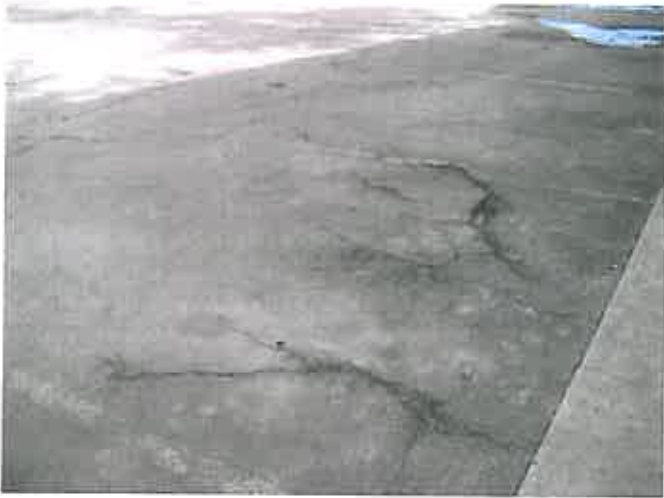
Comp #: 401 Asphalt - Overlay

The asphalt is generally in poor condition with severe cracking, and other signs of age and deterioration. The average life expectancy for asphalt surfaces ranges between 20 - 27 years for surfaces that are maintained on a regular schedule. Maintenance includes crack fill and repairing small potholes annually as an operating expense. In addition, asphalt should be seal coated every 2 -3 years, depending on the level of traffic and snow removing techniques. Based on observed condition, we suggest resurfacing with a 2" overlay this next year.

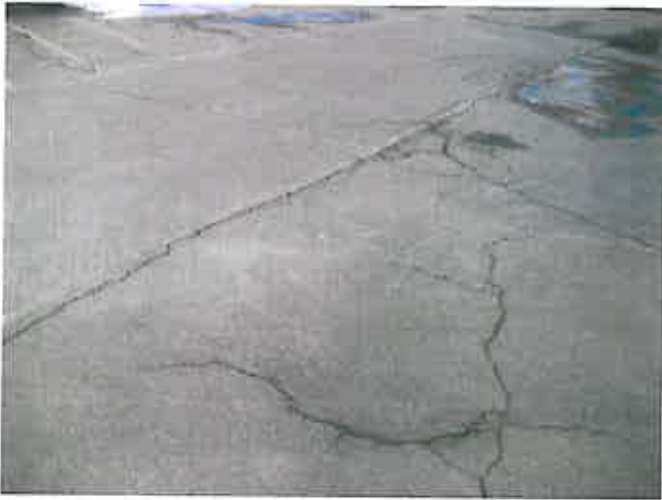
Comp #: 402 Asphalt - Seal Coat/crack fill

Current conditions are extremely dry, with severe cracking noted throughout. Based on current conditions, we believe an overlay is needed. Industry professionals recommend seal coating within 12 months of application of a new surface. In this environment, expect to seal asphalt every 2 - 3 years, depending on traffic levels and effects from weather. Sealcoating is applied to protect the asphalt from ultra-violet rays and water. This helps in slowing the process of oxidation and raveling. While acting as a protective barrier, it also maintains the appearance of the community to maintain or improve property values.

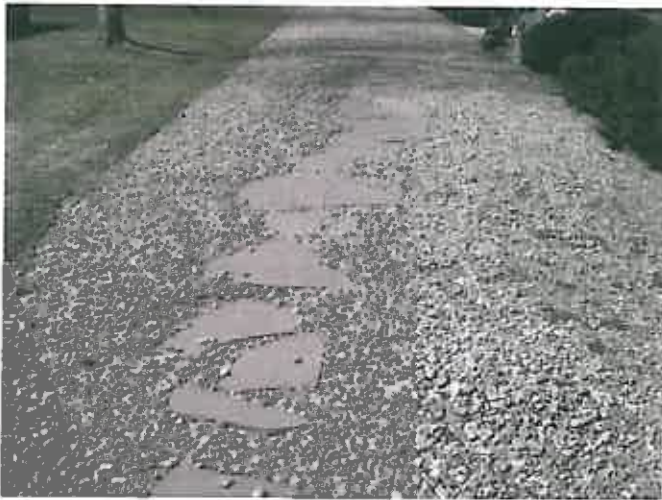
Comp #: 405 Flagstone Path - Repair/Replace

No unusual conditions observed at time of inspections. We suggest handling repairs on an as needed basis using operating funds. Therefore, at this time, Reserve funding is not required for this component.

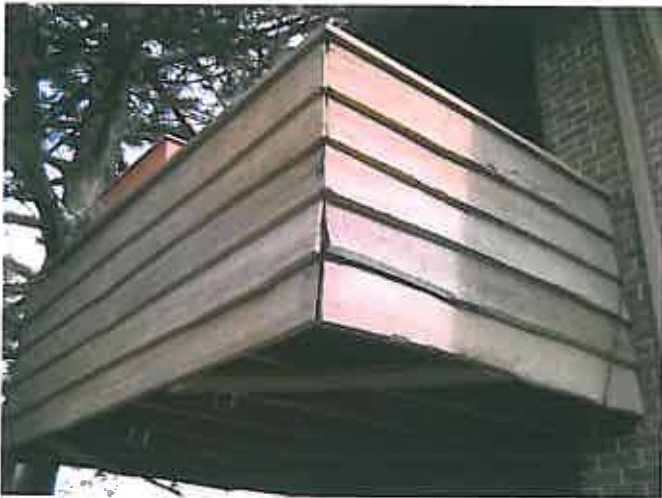
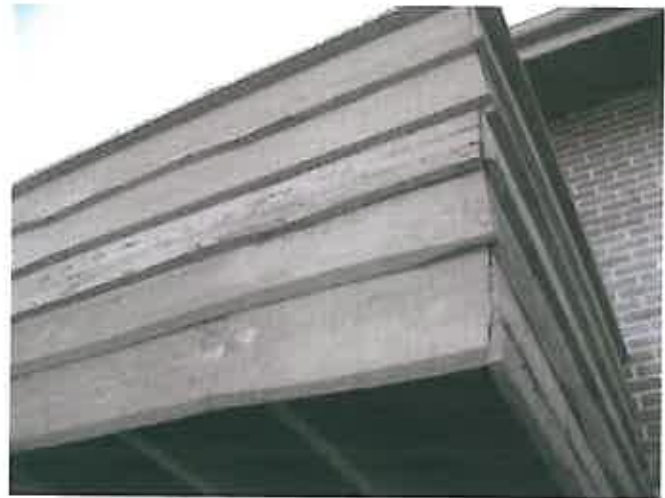
Comp #: 607 Wood Balconies - Replace (A)

Buildings (A) & (B) balconies could use repairs and new paint. One balcony on building (A) has been replaced recently (reported cost was \$3400). In general, the conditions of the balconies are poor and should be addressed soon. Reserve funding to address the siding is included in component #302, so additional funding is not required. This line item is for the deck material only. Due to the financial situation of the association, we have deferred this project a few years to allow the Reserve fund to strengthen. When replacement is required, we recommend using an alternative product that has a longer life expectancy and won't require maintenance as frequently.

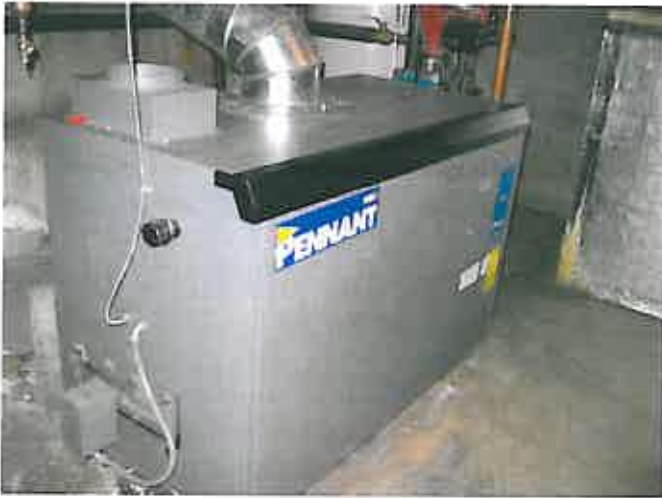
Comp #: 701 Large Boiler - Replace (A)

Boiler is new within the past few years and appears to be in very good working condition. According to manufacturer, these units typically do not require complete replacement. However, parts eventually become obsolete after numerous years and with advances in technology, replacement may become necessary at some point in the next 25 - 30 years.

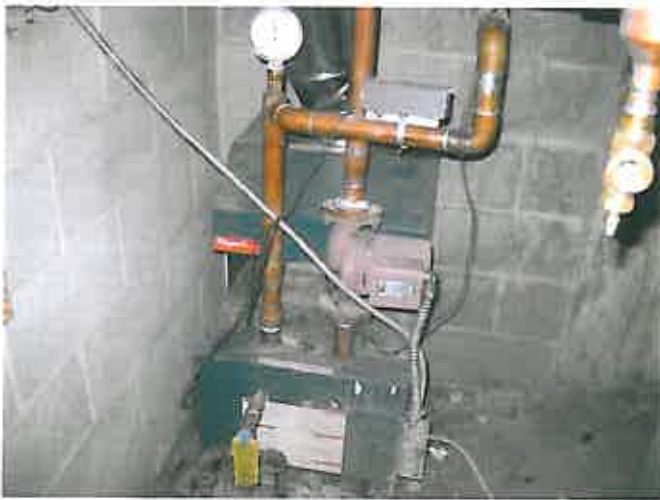
Comp #: 702 Small Boilers - Replace

These are most likely used for the baseboard heaters in the building corridors. These appear to be older and nearing the end of the life expectancy. There was evidence of rust and corrosion noted on the base of the heaters. Replacement cycle will depend on the level of use, maintenance, and quality of water running through the system.

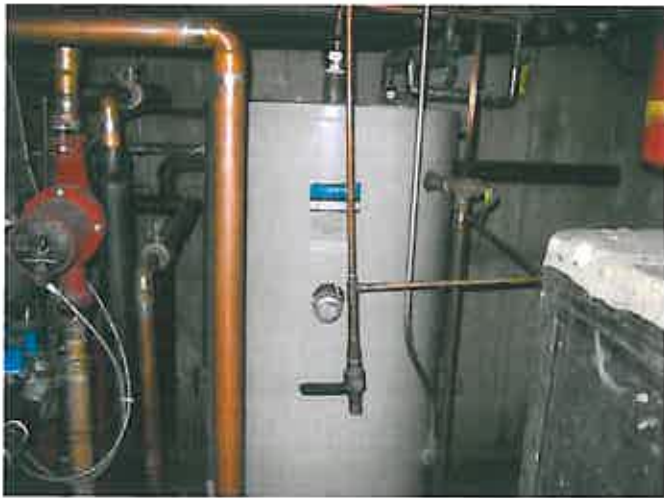
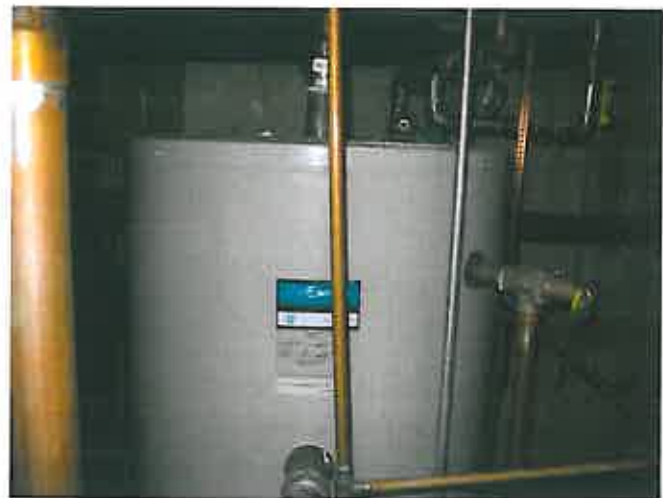
Comp #: 703 Hot Water Storage Tank - Replace

Unable to access the boiler in building B (adjacent to unit H) due to a locked door. Assume both storage tanks were replaced at the same time. The average replacement cycle for storage tanks ranges between 12 - 15 years, depending on the quality of tank and the quality of the water in the system.

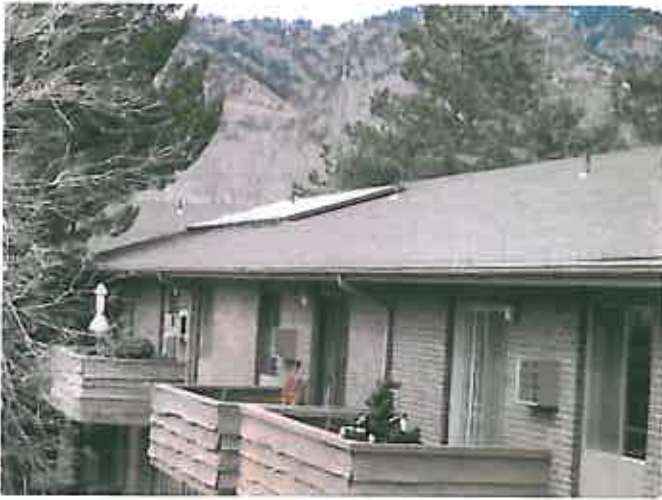
Comp #: 704 Solar Panels - Replace

It is unknown whether this system is still operable today. Reported these have not been used in many years and there are no plans to reinstate the unit. Therefore, at this time, Reserve funding is not required for this component.

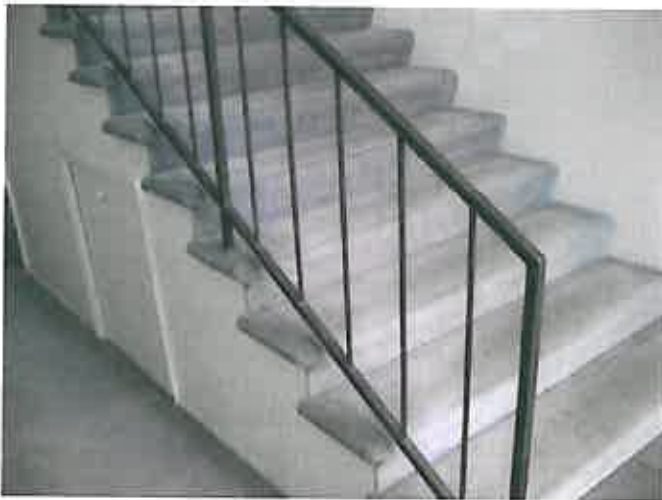
Comp #: 1002 Interior Iron Hand Rails - Replace

Iron Handrails are not to code because of distance between pickets. We suggest replacing immediately due to safety concerns. Despite this suggestion, the association wants to replace these on an as needed basis with general operating funds. It should be noted that this is strongly against our recommendation. If the association decides to do this as needed, we suggest replacement begins immediately. .

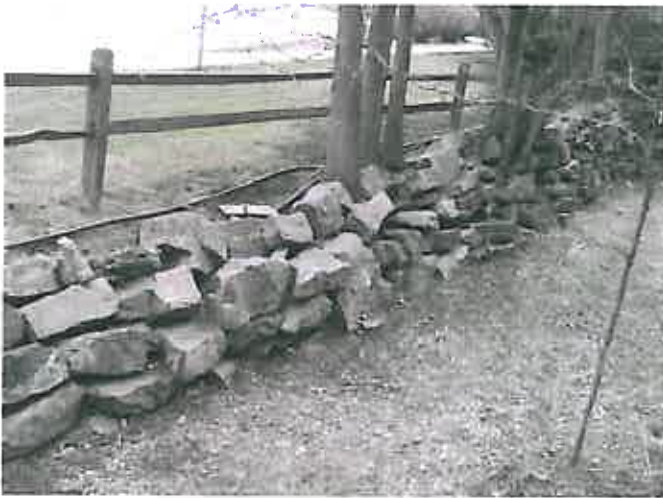
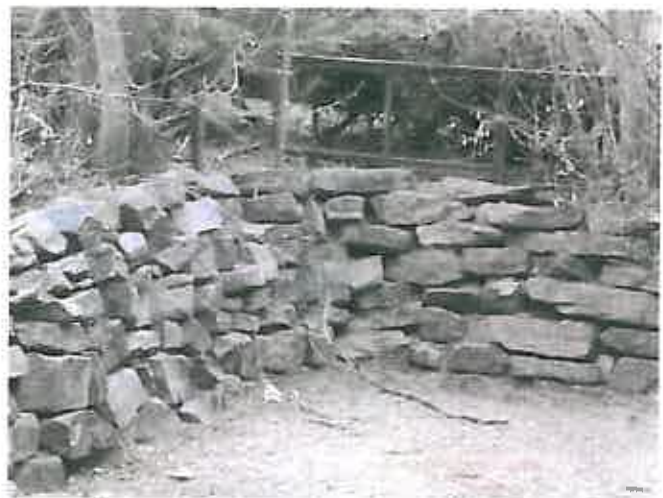
Comp #: 1005 Rock Wall - Replace

No significant cracking or structural problems noted at the time of inspection. As long as wall was installed conforming to county code this wall should have an extended useful life. This type of material has an indefinite life expectancy and complete replacement is unlikely. Therefore, Reserve funding is not required for this component.

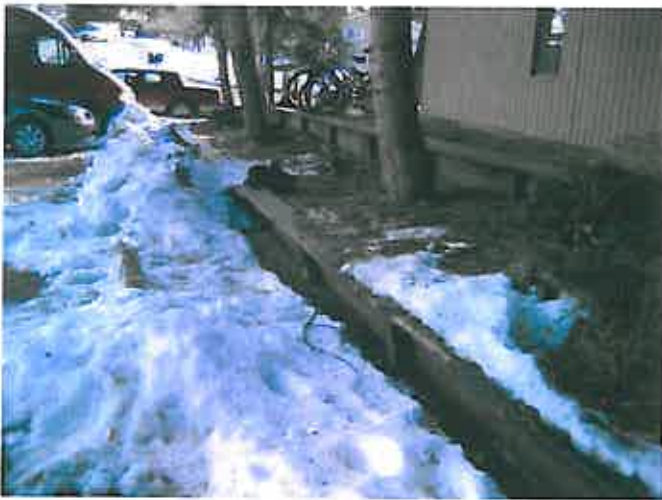
Comp #: 1007 Wood Retaining Wall - Replace

Wood retaining wall is leaning badly and in poor condition. We recommend that the wall be replaced with a block retaining wall. Per the clients request, we have extended the remaining life out 5 years to be replaced in 2012. Future funding requirements can be deleted if the association replaces with block. If association replaces with wood, then expect to replace every 15 - 18 years.

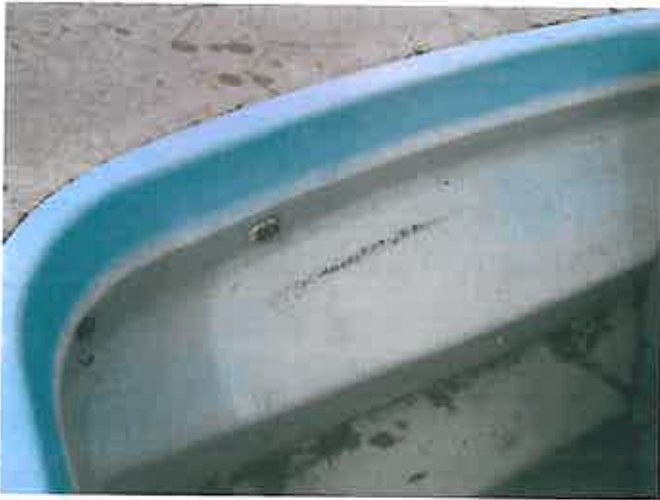
Comp #: 1101 Fiberglass Pool - Gel Coat

Pool appears to be older but still structurally in good condition. Acrylic pools have a limited warranty of 25 years, but according to local representative, the life should be indefinite (pools installed in 1950's are still in existence without any problems). The major maintenance requirements is to gel coat the surface every 3 - 5 years, depending on the chemical levels and the amount of use. Based on observed condition, we recommend performing a gel coat application before next pool season in 2008.

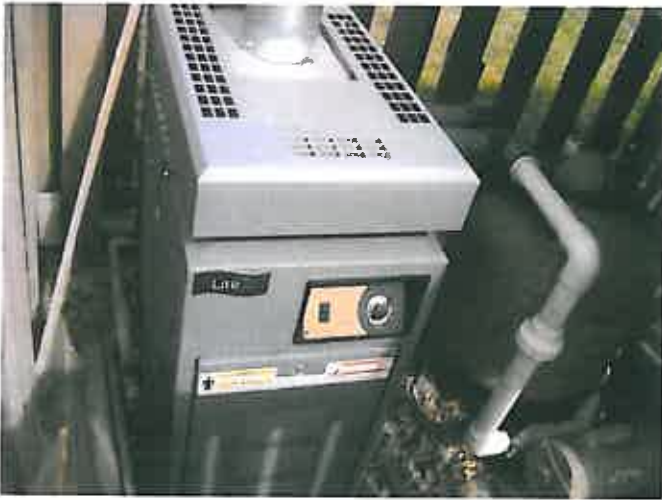
Comp #: 1104 Pool Heater - Replace

Heater appears to have been replaced within the past 2- 3 years and is in good condition. No significant carbon build-up or rust noted at inside base of unit. This type of pool heater typically has a useful life of approximately 10 to 12 years. Remaining life based on current age and condition.

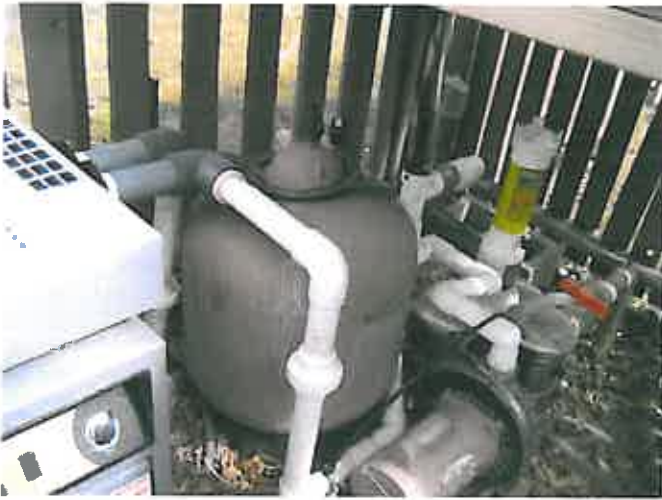
Comp #: 1107 Pool Filter - Replace

Pool was winterized at time of inspection, so we were unable to inspect for leaking. Reported that the filter is original (or very old) and nearing the end of its life expectancy. There were no signs of past leaks or any other unusual conditions during inspection. Plastic filter tanks typically have a life expectancy of 12 - 15 years under normal conditions and with proper maintenance. The remaining life is based on age and current condition.

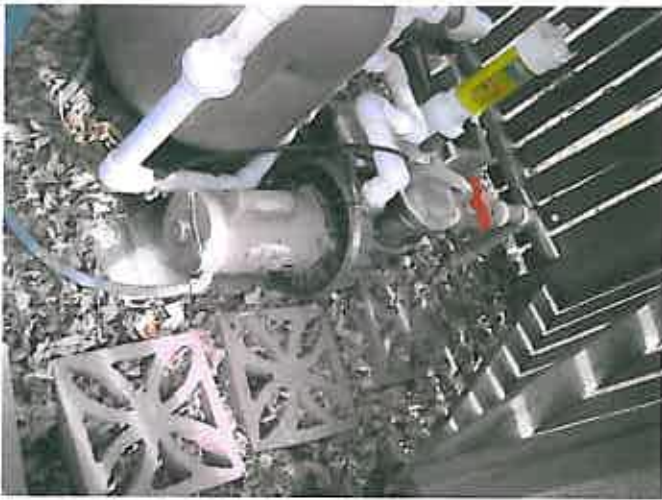
Comp #: 1110 Pool Pump - Replace

No unusual conditions observed during inspections. Pool was winterized at time of both inspections, so unable to observe in operating condition. According to service company, there were no problems toward the end of last year. Due to the minimal cost (less than \$600) to replace individual pumps we recommend repairing/replacing pumps as necessary as an operating issue. No reserve funding necessary for this component.

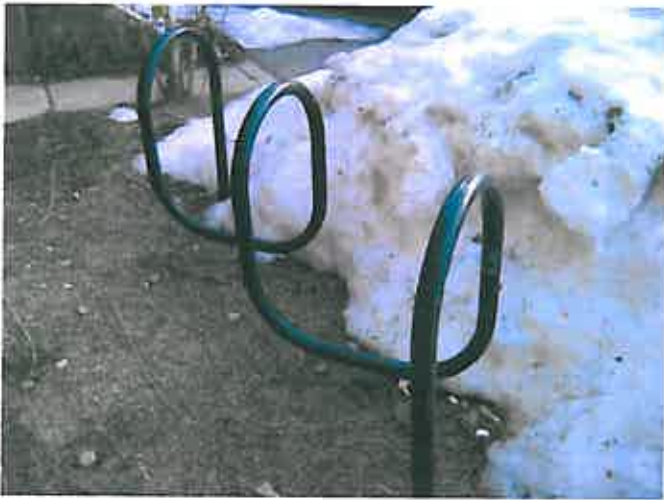
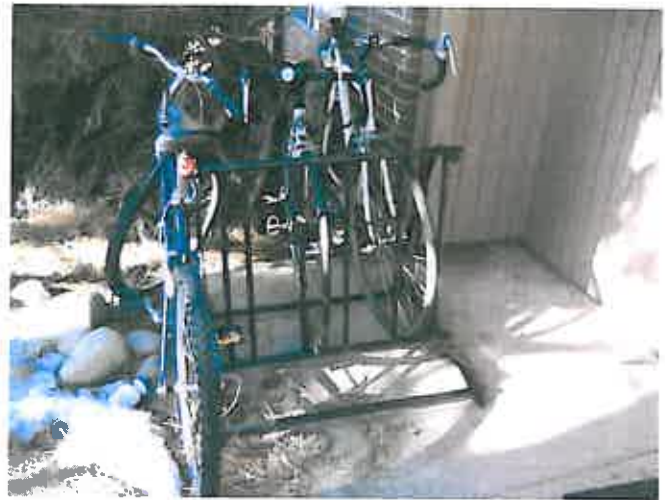
Comp #: 1309 Bicycle Rack - Replace

Due to the minimal cost to replace these racks, we recommend replacing these on an as needed basis using operating funds. Therefore, reserve funding is not necessary at this time.

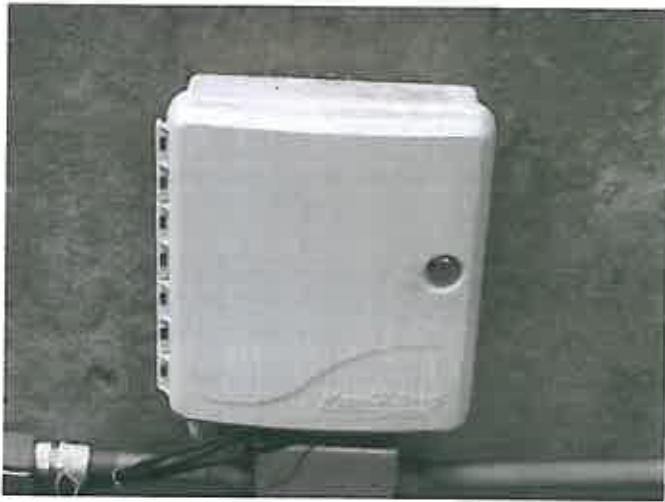
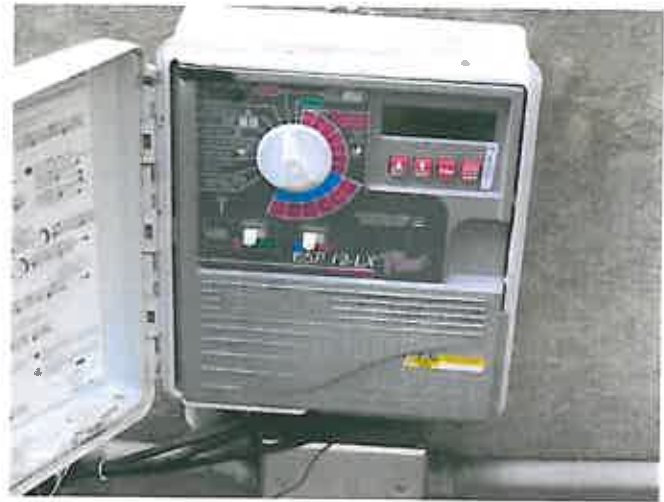
Comp #: 1703 Irrigation Timeclock - Replace

No problems noted with irrigation clock at the time of inspection. Due to the minimal replacement cost associated with this clock reserve funding is not appropriate. Replace as necessary as an operating expense.

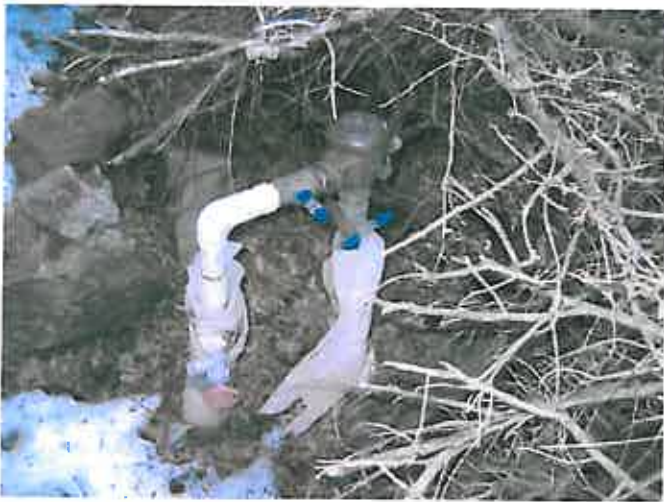
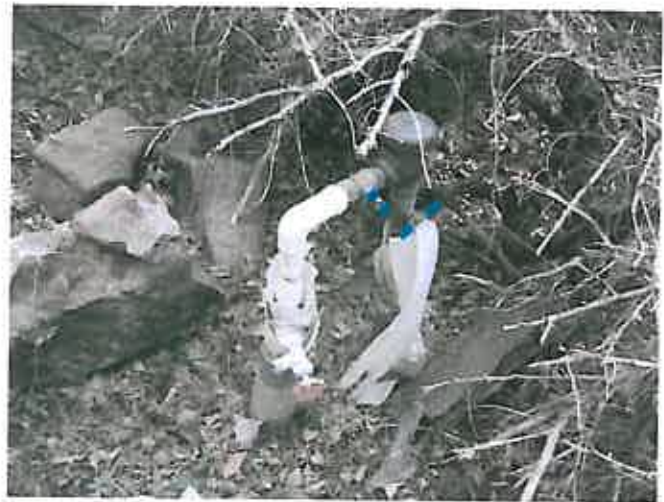
Comp #: 1706 Backflow Devices - Replace

No problems noted at the time of inspection. Due to the minimal replacement cost (\$500 - \$800 each) and unpredictable useful life associated with this component, reserve funding is not appropriate. Make repairs and replacements as necessary as an operating expense.
