Level 1, Premium Reserve Analysis

Alpine Condominiums 1895 Alpine Boulder CO. 80308

FINAL VERSION

Date of Property Observation – October 28, 2022

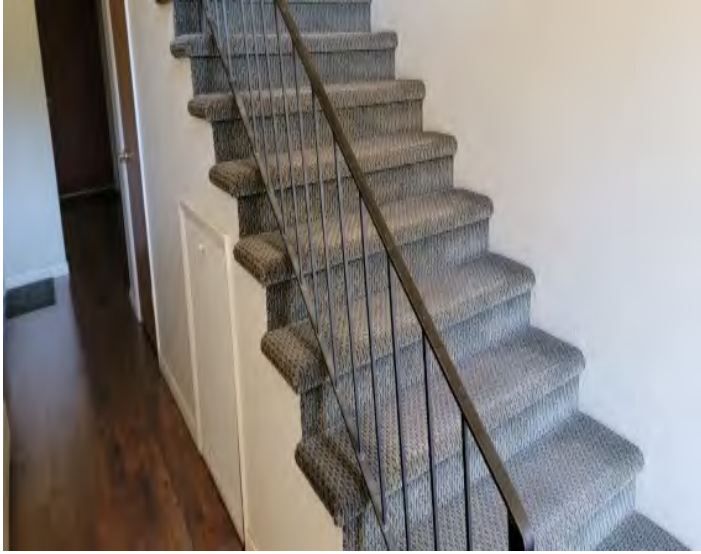
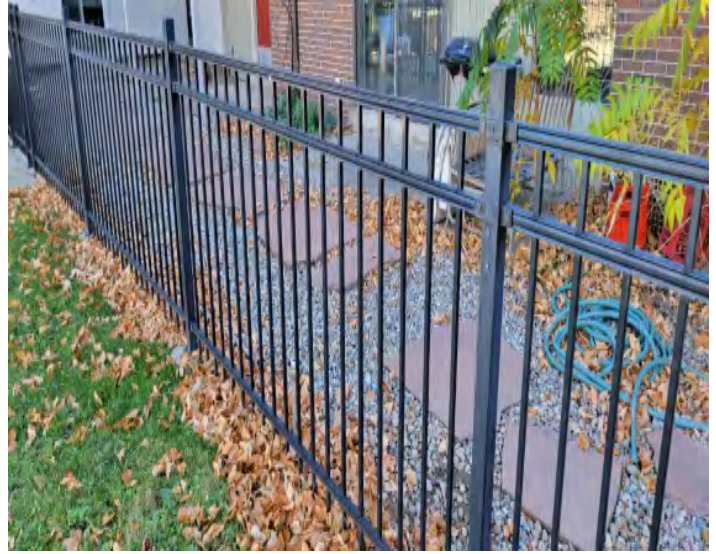
Comp #: 212 Metal Fence/Handrails - Repaint

- Interior handrails are repainted along with other interior surfaces.
- The pool fence should be painted at the same time as exterior surfaces for best cost estimate
- Since these specific surfaces are painted with other surfaces, separate funding is not required for this specific component

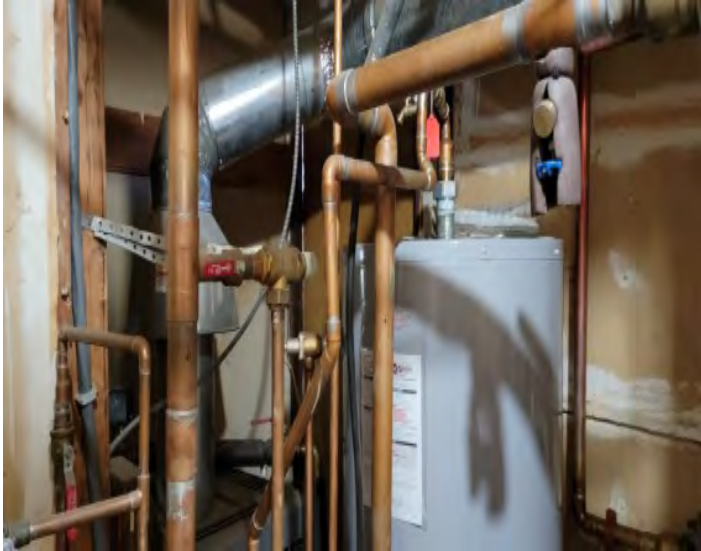
Comp #: 726 Miscellaneous Equipment - Replace

- Due to varying life expectancies of miscellaneous items (circ pumps, mixing valves, plumbing repairs, flue pipes, etc.), we have included an allowance for periodic repairs and upgrades to miscellaneous equipment every 5 years

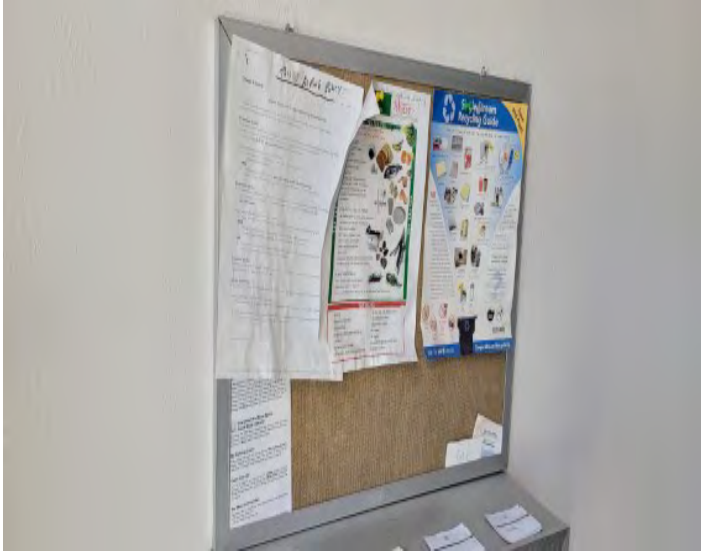
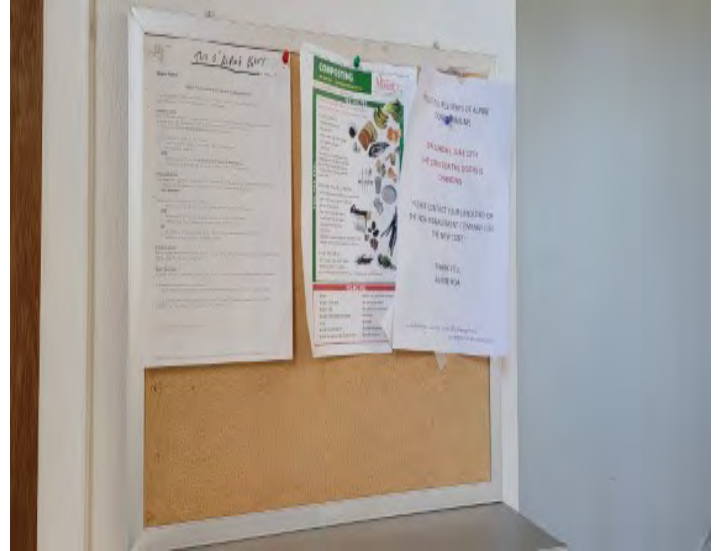
Comp #: 802 Bulletin Boards - Replace

-Due to inexpensive replacement cost, we recommend replacing on an as needed basis with operating funds.

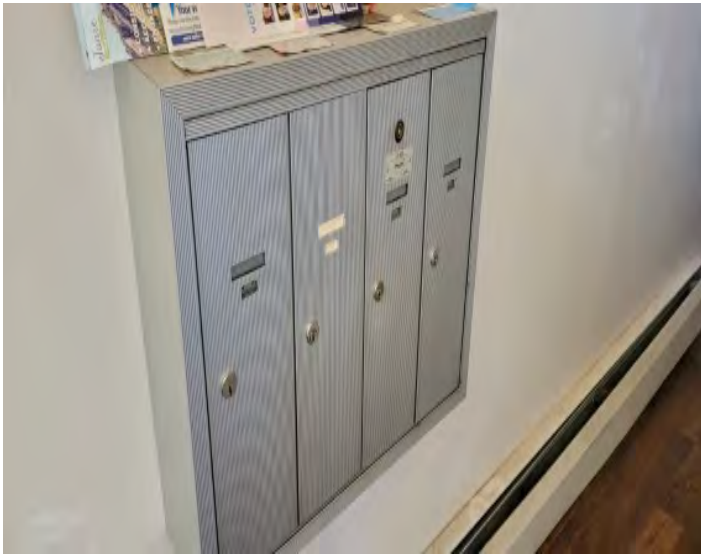
Comp #: 803 Mailboxes - Replace

- These are installed inside and protected from the elements.
- As a result, a longer replacement cycle should be expected.
- Based on our experience, these boxes will have a life expectancy of 25 - 30 years due to location and quality.
- Remaining life is based observed condition.

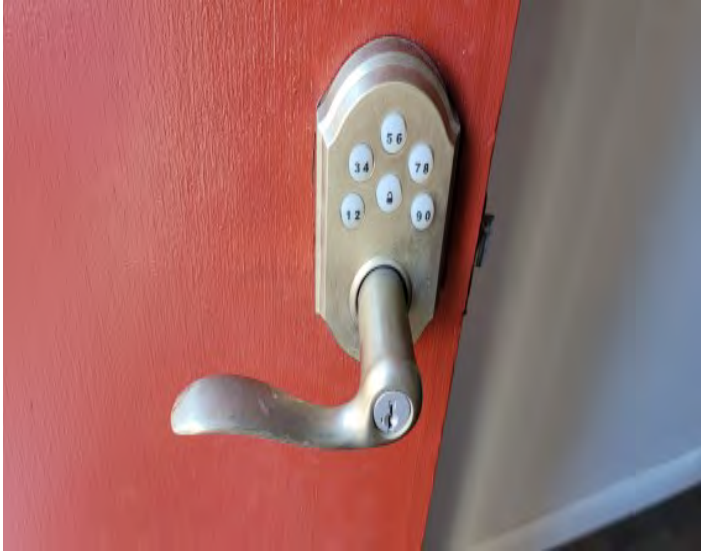
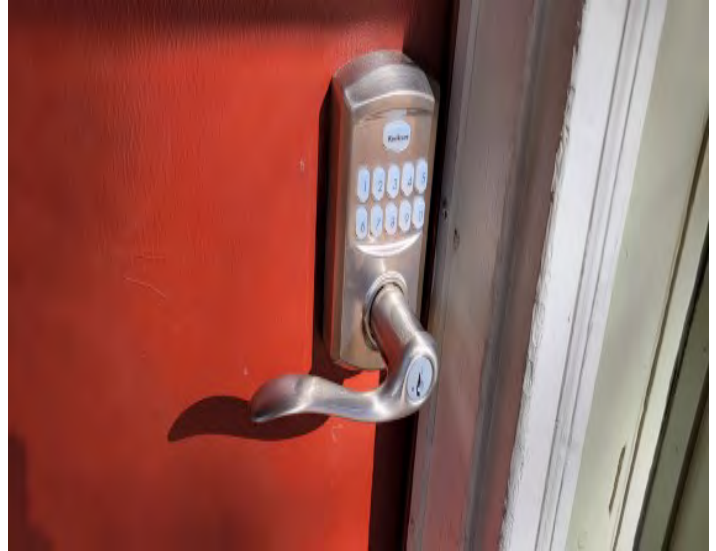
Comp #: 908 Combo Door Locks - Replace

- Types of locks differ from door to door, so we assume these are being replaced on an as needed basis with general operating funds.
- Unless otherwise reported, Reserve funding will not be required for this component.

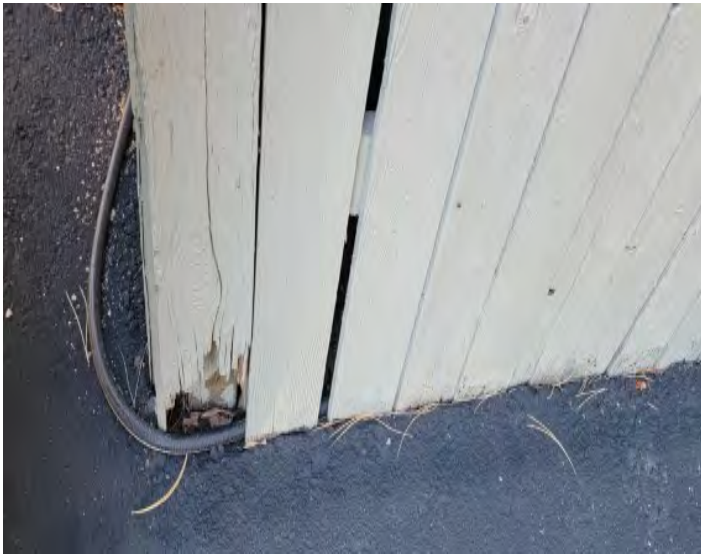
Comp #: 1001 Wood Fencing - Replace

- Fencing (approximately 25 LF) between A and F was recently replaced and is in good condition. Also, Fence had not been stained as of our site visit date, but it is expected that it will be stained.
- In general, conditions and ages of fences vary throughout the property.
- Due to varying ages and conditions, we have established Reserve funding to replace 60 LF every 6 years.

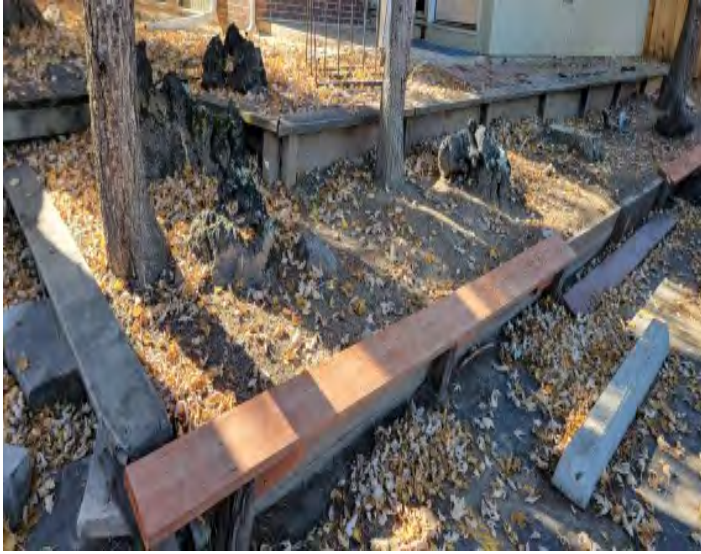
Comp #: 1007 Wood Retaining Wall - Replace

- Wood retaining wall is leaning badly and in poor condition.
- We recommend that the wall be replaced with a block retaining wall.
- Future life expectancy can be adjusted based on the type of wall that is installed.
- Despite the current condition, we have extended the replacement by a year to allow the association to address more important components.

Best Cost: **\$7,200**
 \$40/GSF; Estimate to replace with block wall

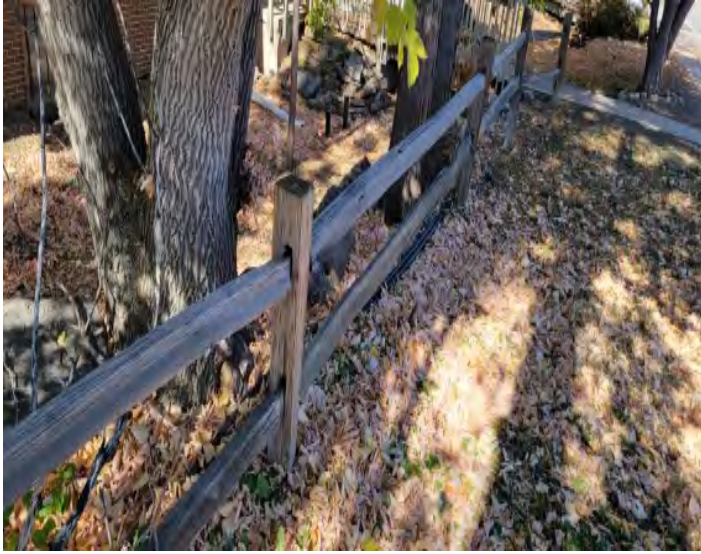
Comp #: 1009 Split Rail Fencing - Replace

- This type of fence is supposed to have an older and authentic appearance.
- Typically, sections can be replaced as needed to maintain the integrity of the fence and the new sections will eventually blend in with the older sections.
- At this time, separate funding is not required due to small area, or plan to replace as needed with operating.

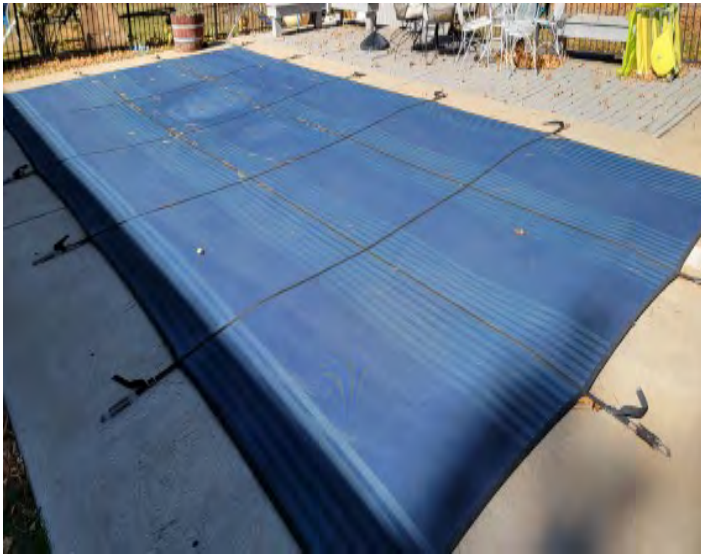
Comp #: 1101 Fiberglass Pool - Gel Coat

- Pool was winterized and covered at time of inspection, so we were unable to evaluate the entire surface.
- No records of the pool being recoated in the past several years.
- The major maintenance requirements is to gel coat the surface every 3 - 5 years, depending on the chemical levels and the amount of use.
- With no reported coating recently, we assume the surface needs to be recoated in the near future
- Despite the current condition, we have extended the replacement by a year to allow the association to address more important components.

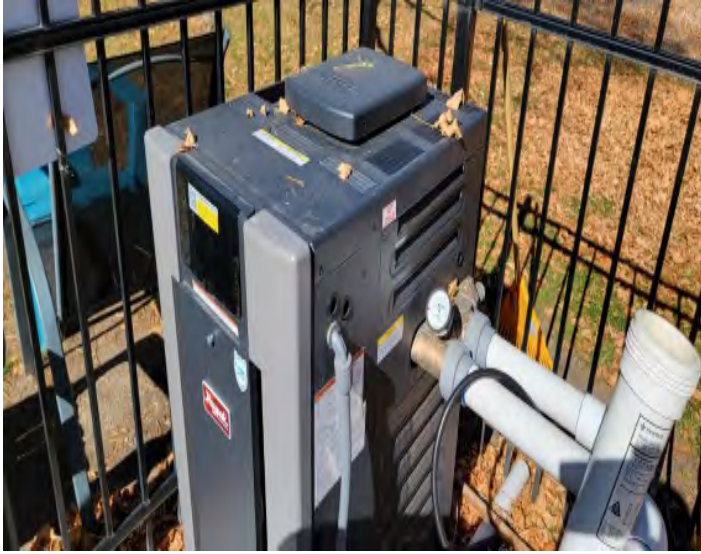
Comp #: 1104 Pool Heater - Replace

- Heater was replaced in 2022 and is in good condition.
- This type of pool heater typically has a useful life of approximately 10 to 12 years.
- Outside, unprotected installation shortens life expectancies of mechanical equipment
- Remaining life based on current age and condition.

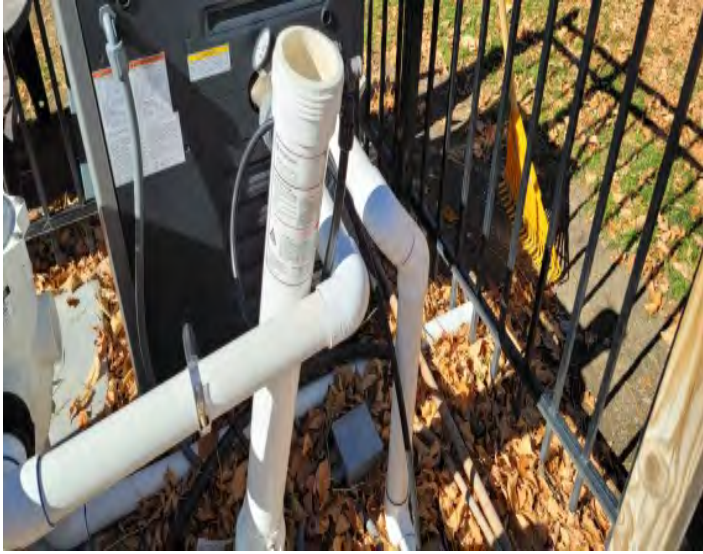
Comp #: 1117 Miscellaneous Equipment - Replace

- Major plumbing and miscellaneous equipment was replaced or repaired during complete equipment replacement in 2022
- While plumbing is not always required when equipment is replaced, some extra funds should be allocated for miscellaneous equipment
- We have added an allowance for miscellaneous equipment every 10 years

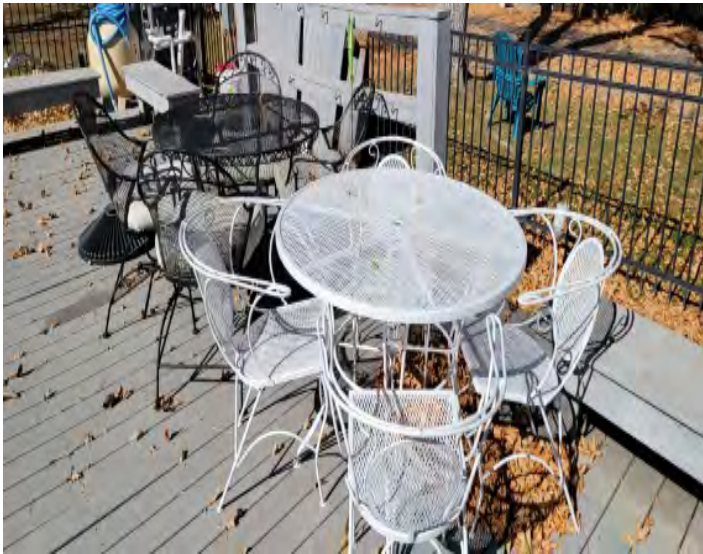
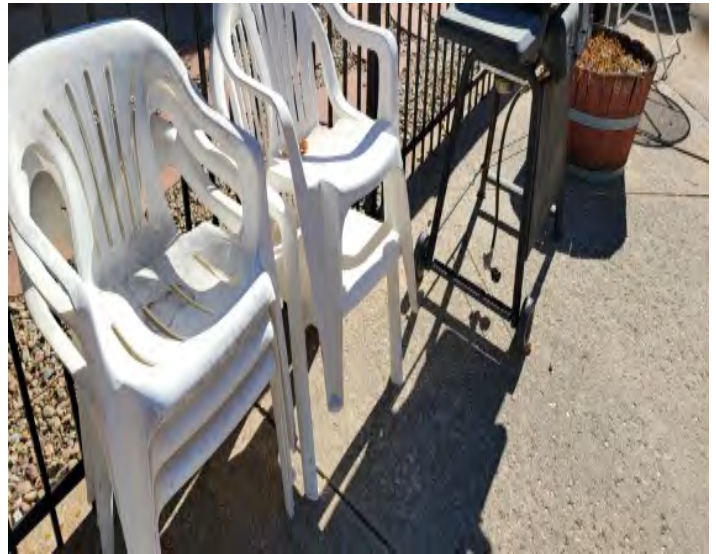
Comp #: 1121 Pool Furniture - Replace

- Due to varying types of furniture and different levels of use each piece received, we recommend replacing as needed with general operating funds.

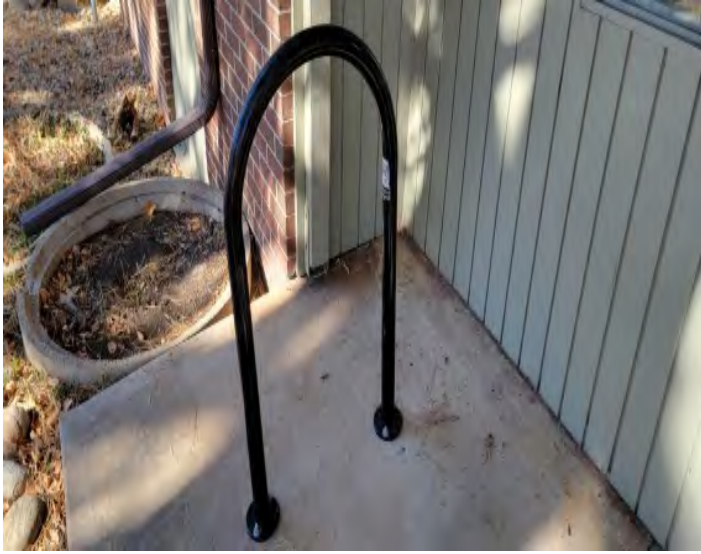
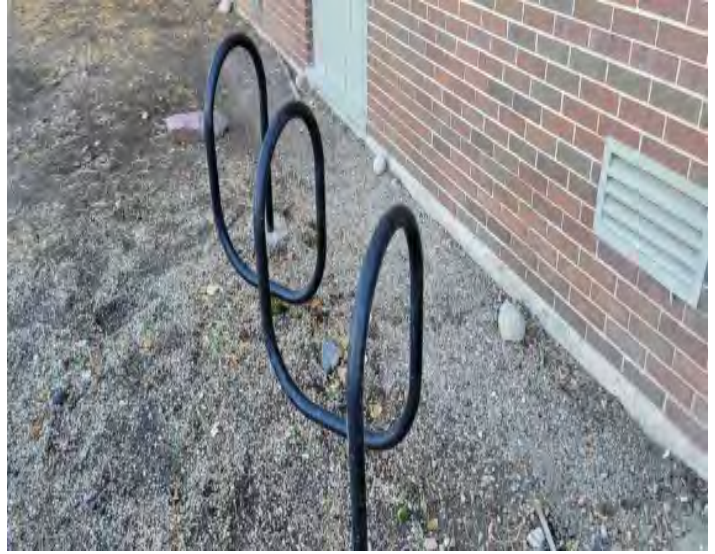
Comp #: 1309 Bicycle Rack - Replace

- Due to the minimal cost to replace these racks, we recommend replacing these on an as needed basis using operating funds.
- Therefore, reserve funding is not necessary at this time.

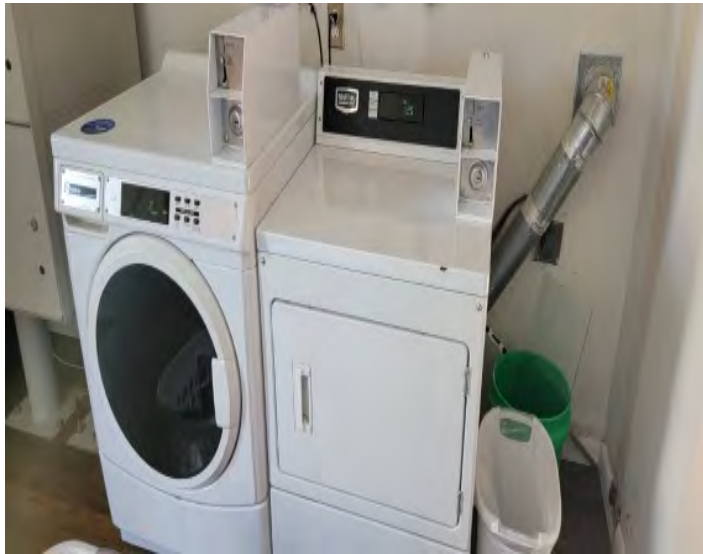
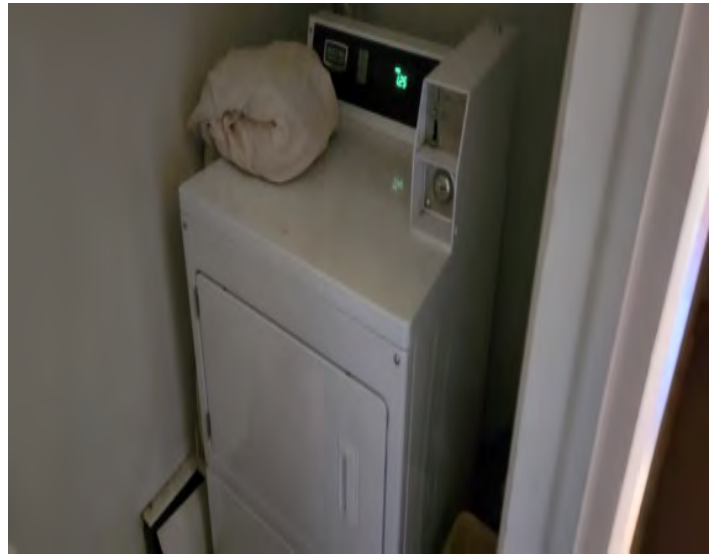
Comp #: 1401 Laundry Equipment - Replace

- These machines are leased through Clean Designs and are not the responsibility of the association.
- Therefore, separate Reserve funding is not required for this component.

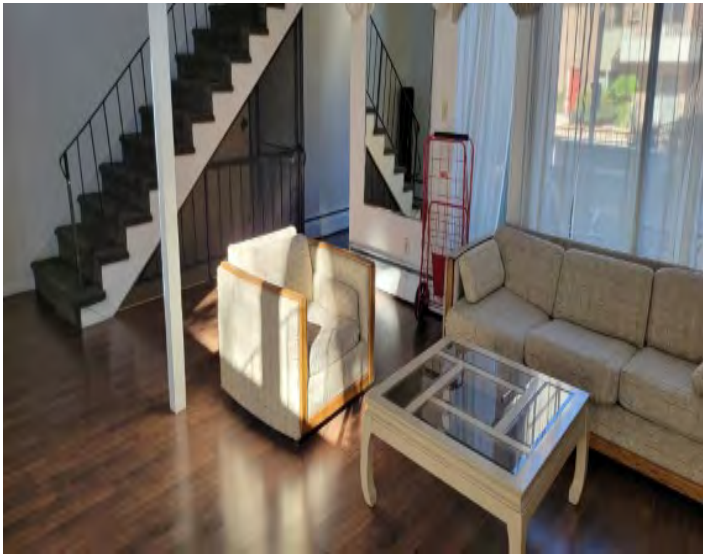
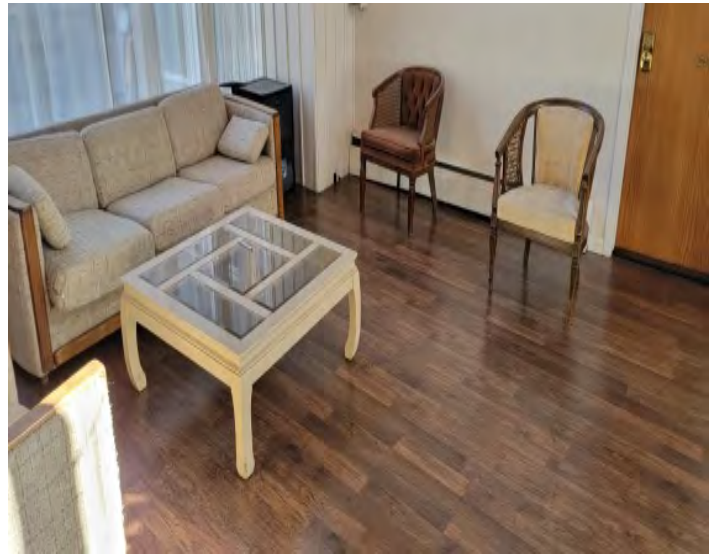
Comp #: 1405 Furnishings - Replace

- Older furniture in fair to poor condition.
- Based on observed condition, we recommend updating and replacing furniture within the near future.
- Replacement cycles depend on level of use and care.
- Despite the current condition, we have extended the replacement by a year to allow the association to address more important components.

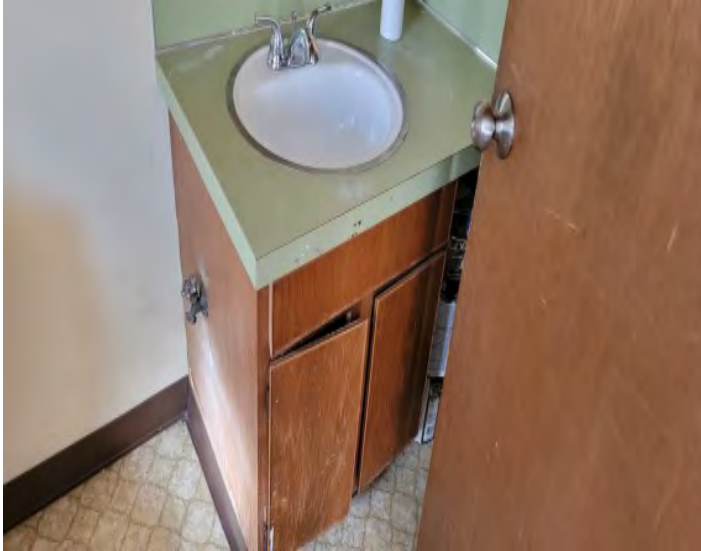
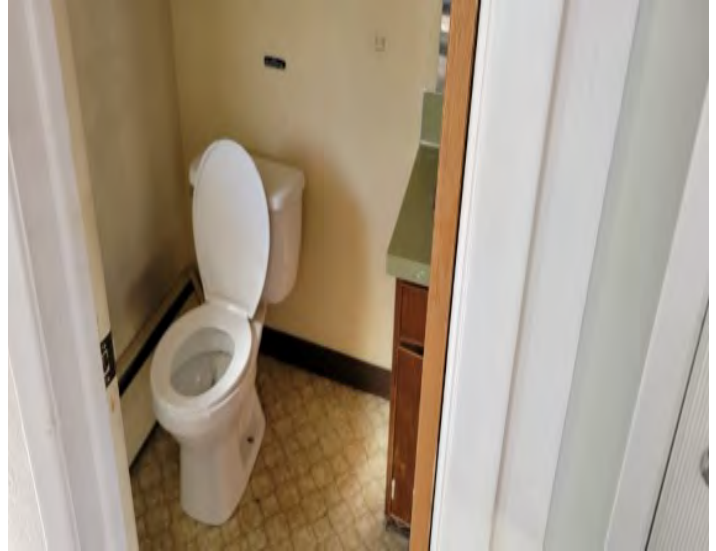
Comp #: 1413 Restroom - Remodel

- Restroom contains older fixtures and it is out of date. Based on observed condition, this restroom needs to be remodeled immediately to restore to appropriate appearance.
- Most associations perform a general remodel of the restroom/locker room interiors every 15 - 20 years to maintain appearance and keep up with current decorative trends.
- The final decision is up to the community members in deciding when to spend the money to perform this project since it is considered cosmetic.

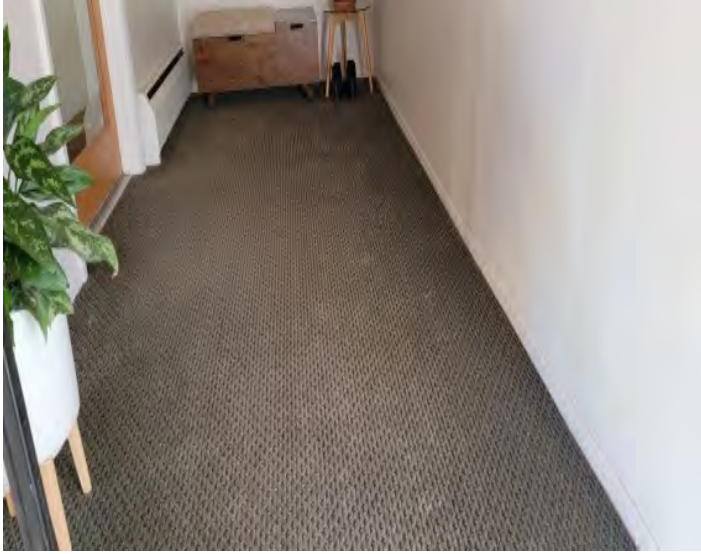
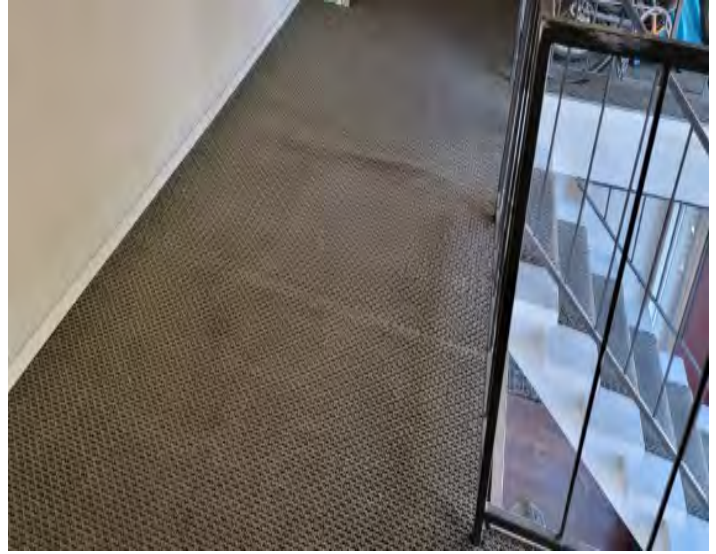
Comp #: 1501 Carpet - Replace

-In general, the carpeting is worn and in poor condition. Many areas of carpet that has lifted and is uneven. It is possible these lifted, or wrinkled, areas is a possible trip hazard, so replacement should take place as soon as possible.

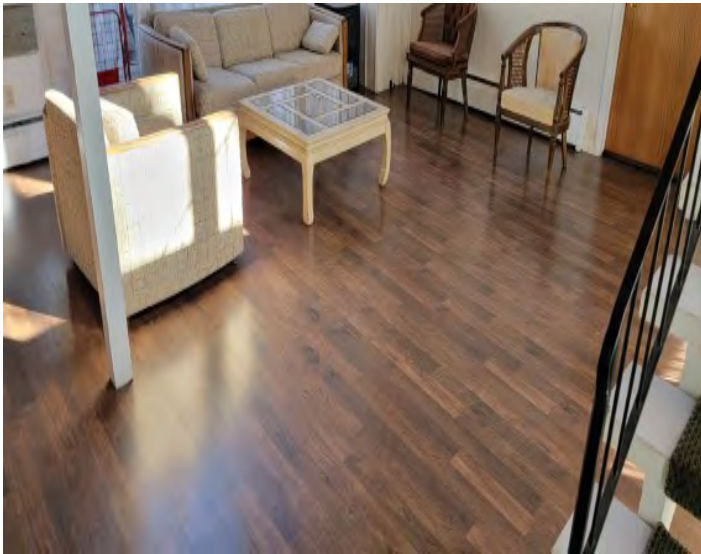
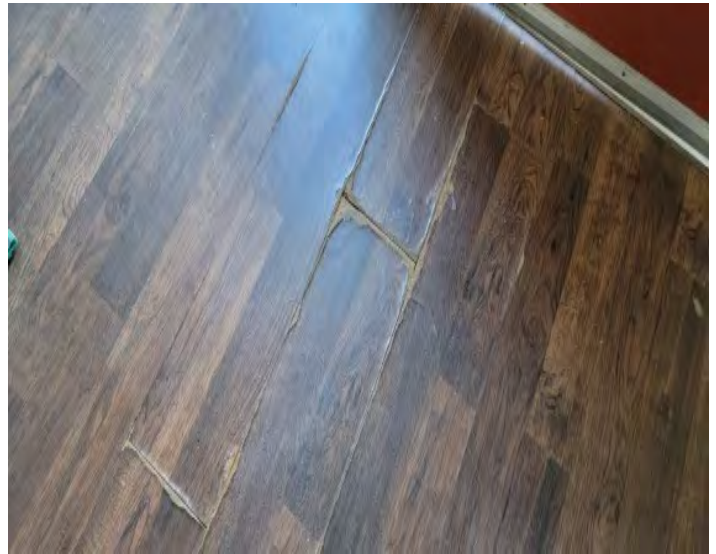
Comp #: 1502 LVP Flooring - Replace

- All corridors and lobby flooring was replaced with Luxury Vinyl Plank (known as LVP) flooring and is in good condition.
- Building H flooring was delaminating at the entrance. This area should be replaced to restore appearance
- This type of flooring is relatively new to the commercial industry, but should have a replacement cycle of about 15 - 20 years under normal conditions.
- It is likely that style trends may change prior to this floor wearing out, but establish a cycle of 18 years at this time, and adjust in future Reserve Study updates if necessary
- Remaining life is based on assumed age of flooring

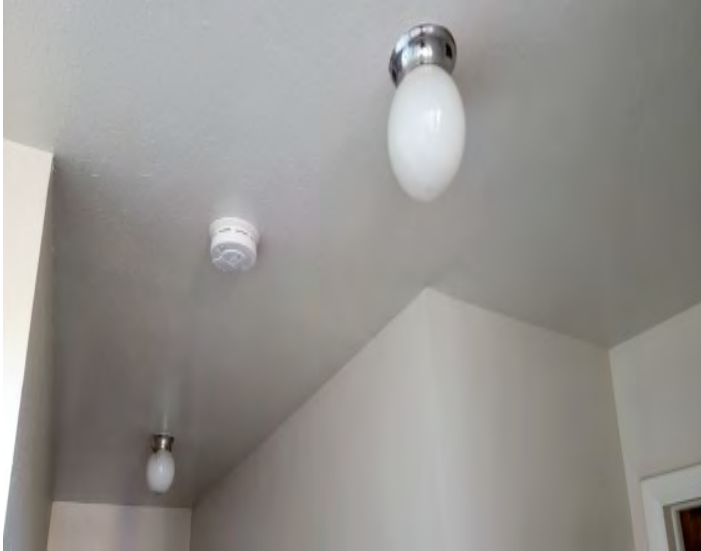
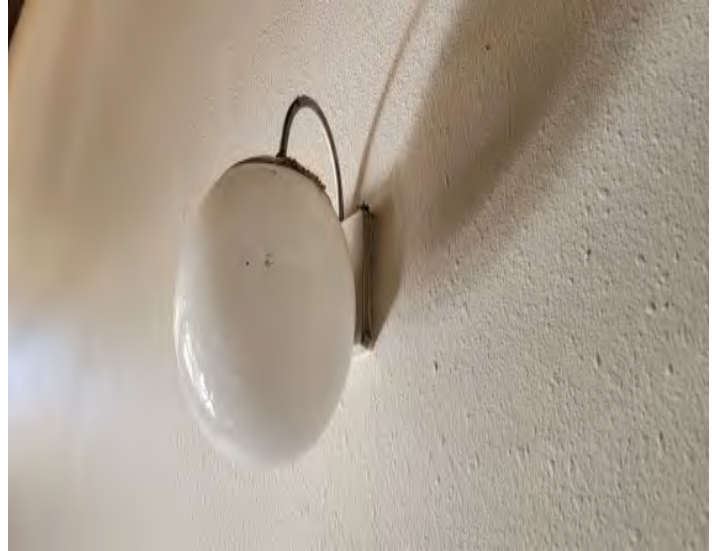
Comp #: 1601 Interior Hallway - Replace

- Typically, associations prefer to upgrade and modernize lighting every 15 - 20 years, depending on changes in trends.
- Suggest replacing all fixtures at same time to get best cost estimate and match decor throughout all buildings.
- Replace non-decorative lights (florescent lights, recessed can lights, etc.) on an as needed basis with operating funds
- This is a low priority item, so we have extended the remaining life a few years to allow the association to address other components.

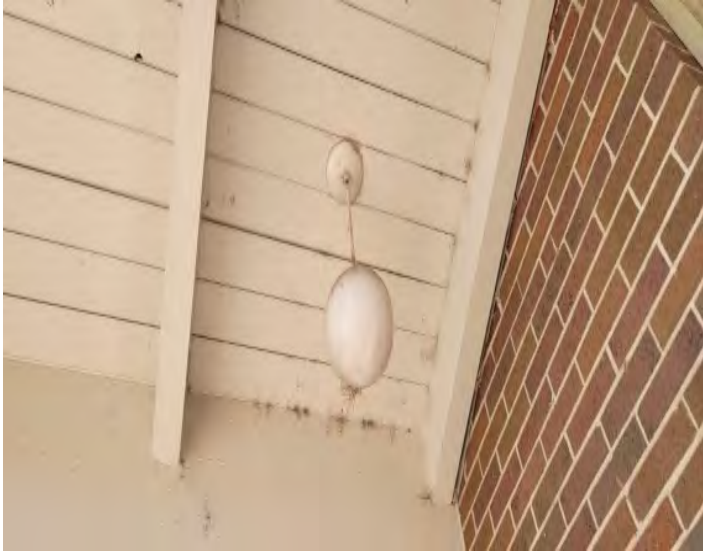
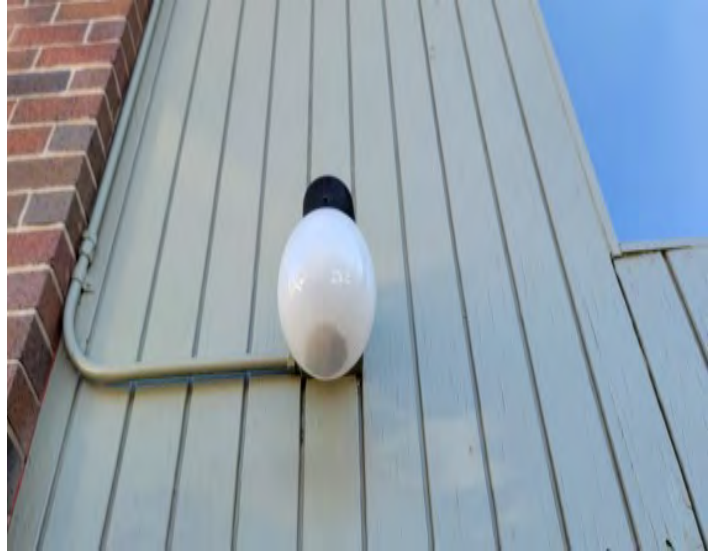
Comp #: 1602 Exterior Lights - Replace

- While replacement can occur on an as needed basis, it is our opinion and recommendation to replace all lights at the same time every 15 - 20 years to maintain a consistent appearance throughout the property.
- By replacing multiple fixtures, the association will be able to obtain a quantity discount for replacement and installation of the fixtures.
- This will also ensure a consistent appearance for the community by replacing all at the same time.

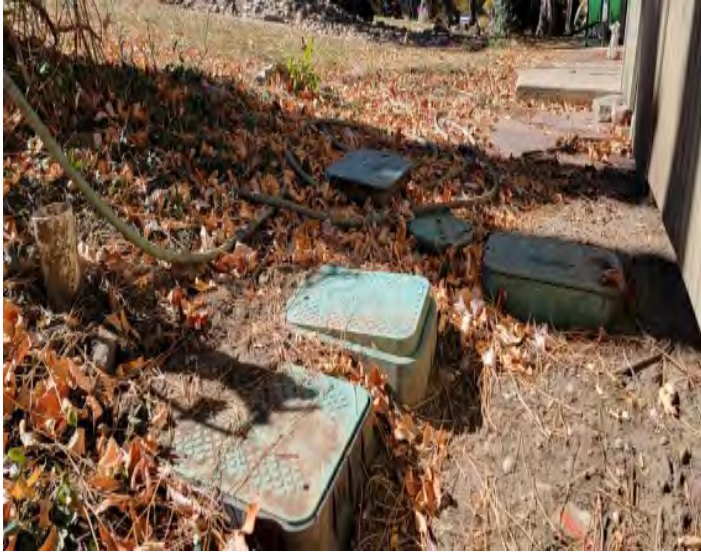
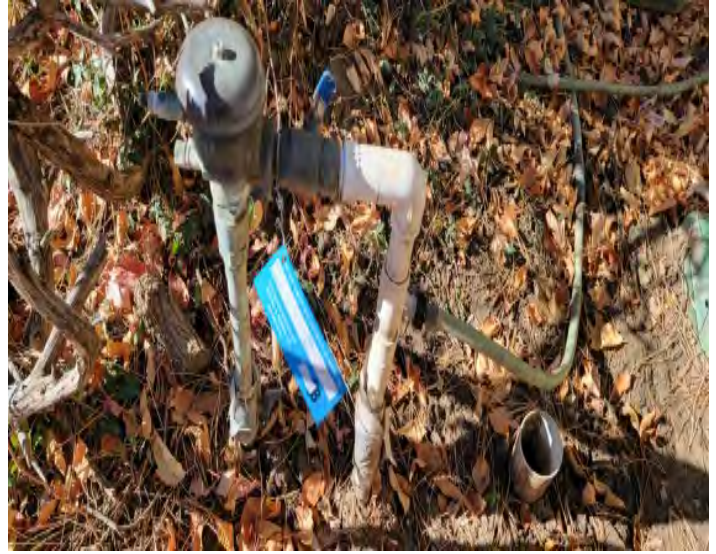
Comp #: 1701 Irrigation System - Major Repairs

- This line item is for repairs and replacement that lies outside the scope of routine maintenance: bulk sprinkler head replacement, bulk valve replacement, backflow devices, rerouting lateral lines, rewiring, etc.
- In order to ensure the funds are available for major repairs, we recommend reserving funds for these projects every 4 - 5 years.
- The funding on this line item is for major repairs and is not to be interpreted as complete irrigation system replacement.

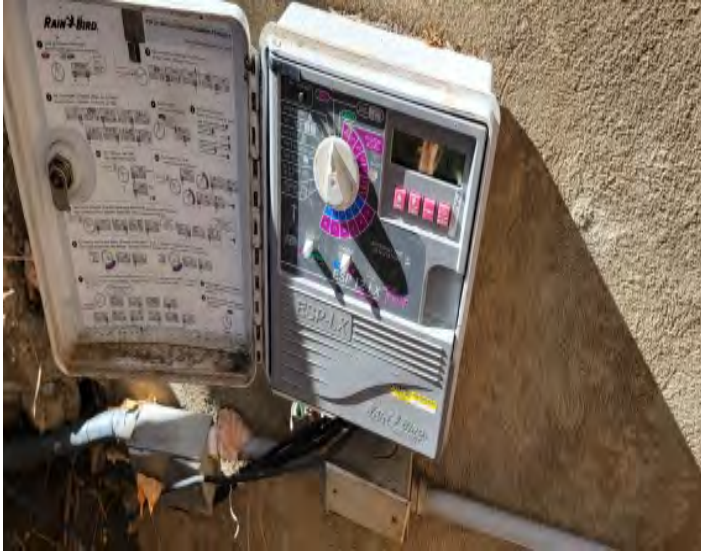
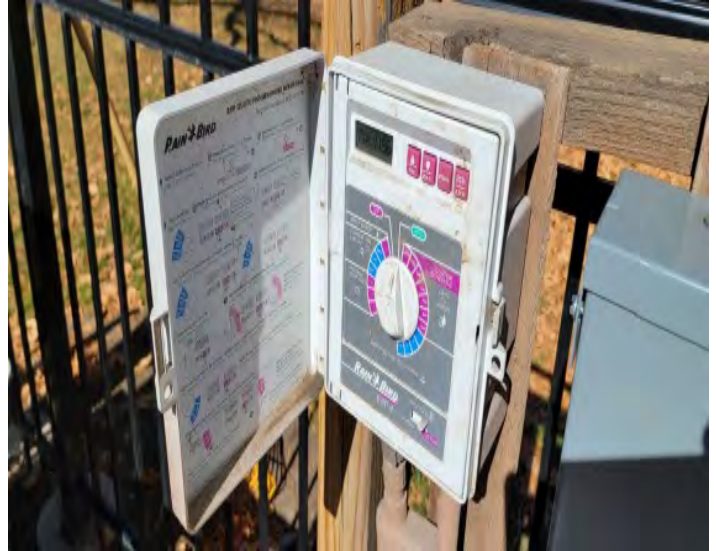
Comp #: 1703 Irrigation Controller - Replace

- Due to the minimal replacement cost associated with these controllers, Reserve funding is not appropriate.
- Replace as necessary as an operating expense, or include with irrigation system repairs (see component #1701)

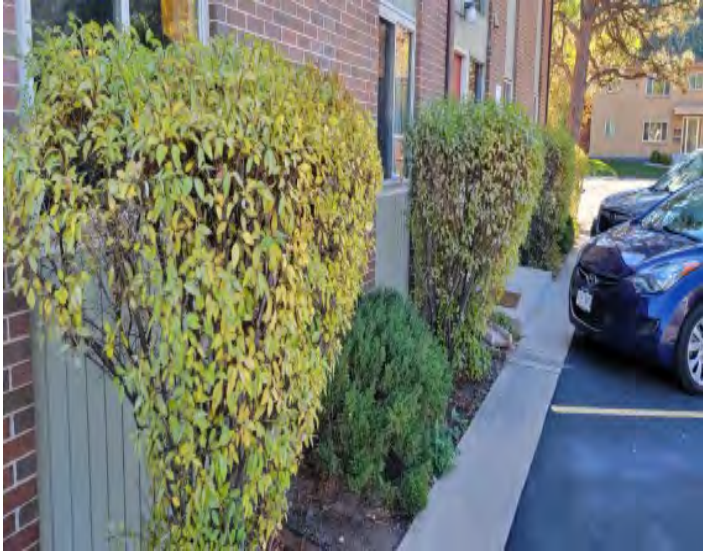
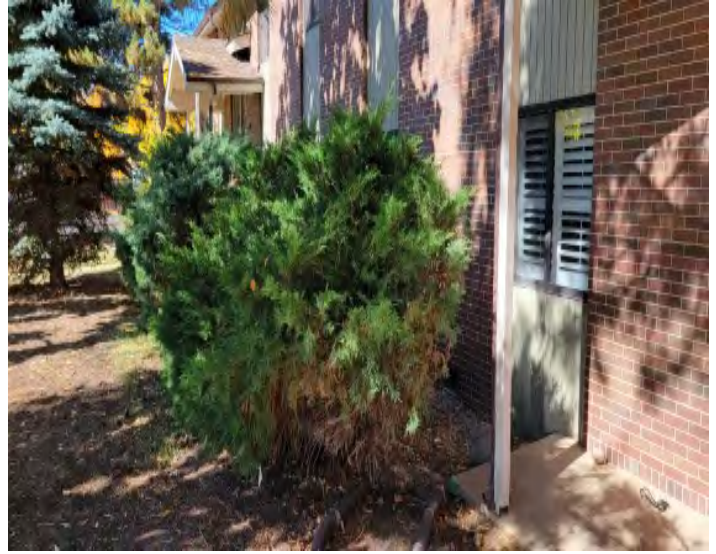
Comp #: 1801 Groundcover - Replenish

- This line item, similar to irrigation repairs, is for projects that lie outside the scope of routine maintenance.
- In order to preserve an attractive curb appeal and to maintain the health of the plants and shrubs, we recommend reserving for refurbishment projects every 2 - 3 years.
- This line item is for cyclical refurbishment and should not be considered as complete landscaping replacement.

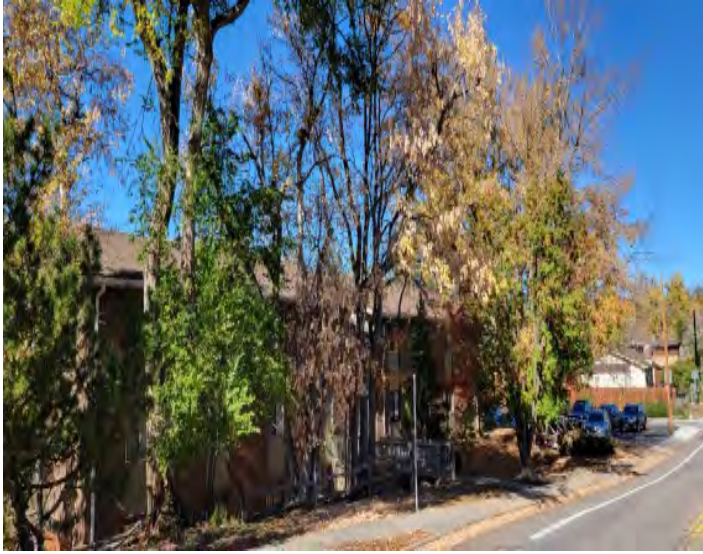
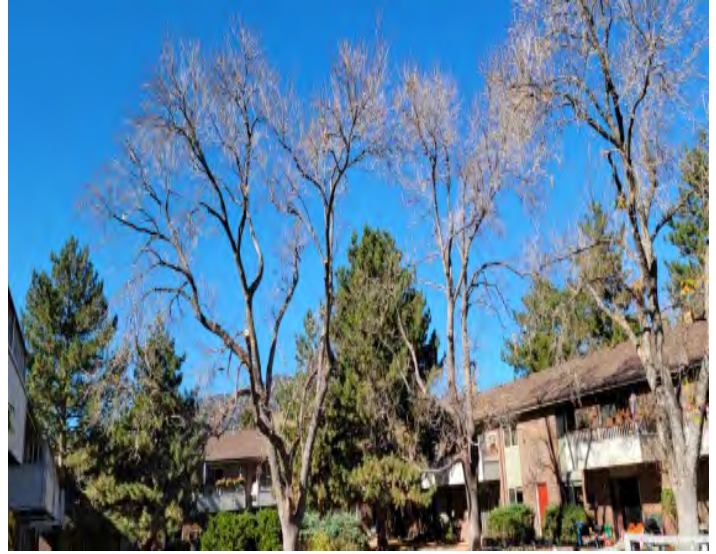
Comp #: 1804 Tree - Replacement/Major Maintenance

- It is very difficult to predict a replacement cycle for trees as there are several factors that will contribute to a tree dying.
- Factors such as disease, infestation of insects, heavy snow storms, etc. can all attribute to eventual tree replacement.
- Since it is difficult to predict when the replacement will be necessary, Reserve funding is typically not a factor.
- However, based on our recent experience, an allowance for periodic replacement has been included.

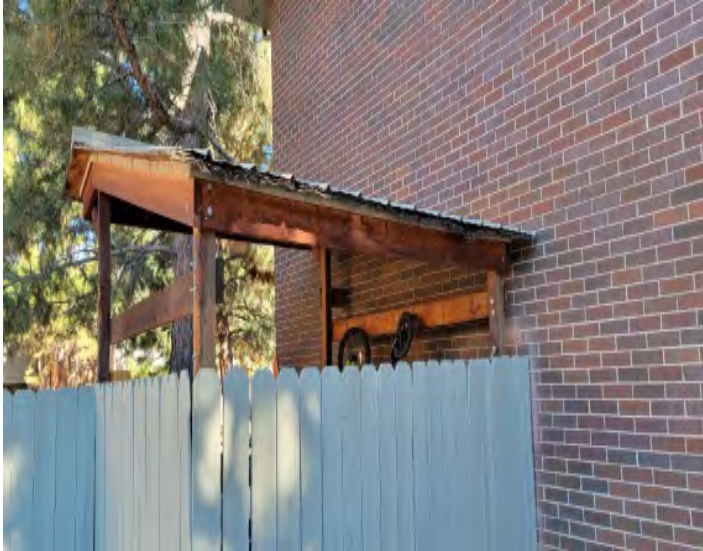
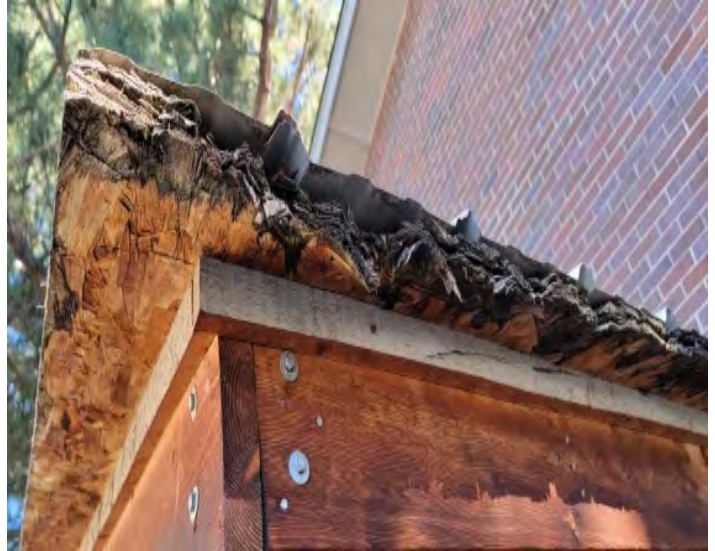
Comp #: 2001 Bicycle Shelter - Major Repairs

- At the time of site observation, the wood sheathing is rotted out and needs replaced. The support structure is well built and appears to have been recently constructed
- Depending on the effects of the weather and the level of maintenance, we expect the shelter will need to be replaced every 12 - 15 years
- Despite the current condition, we have extended the replacement by a year to allow the association to address more important components.

Best Cost: **\$3,150**
 \$35/GSF; Estimate for major repairs
