Shady Hollow Townhomes Shady Hollow East and Shady Hollow West Boulder, CO 80304

Level 1 Reserve Analysis

Report Period – 01/01/15 – 12/31/15

Date of Property Observation - July 17, 2014

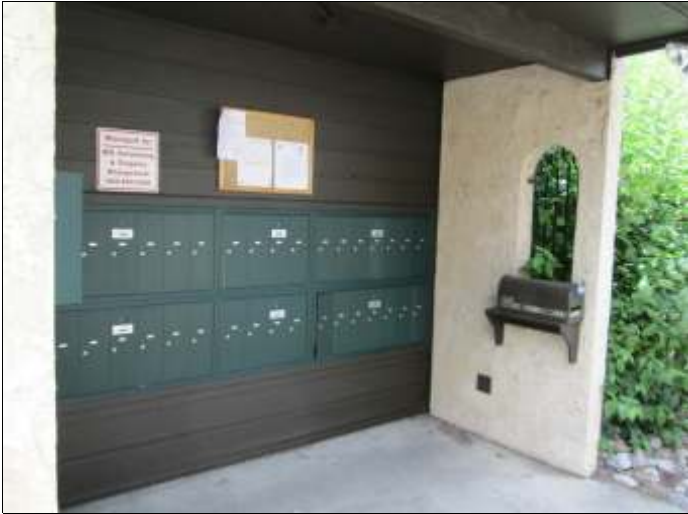
Comp #: 804 Mail Box Kiosks - Replace

- The mailbox kiosks have been well maintained and complete replacement is unlikely.
- Stucco and siding repairs and painting are included with other line items in this report.
- No separate reserve designation is necessary for this component at this time.

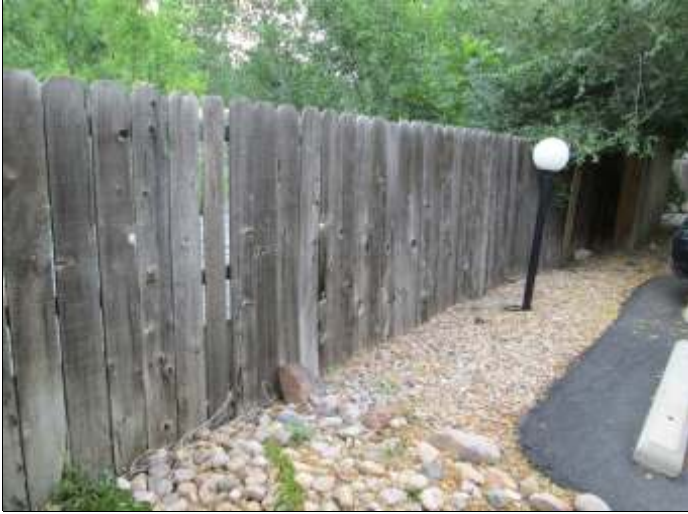
Comp #: 1001 Perimeter Fencing - Replace

- West perimeter fence appeared in poor condition with dry and damaged wood apparent in several areas.
- In order to restore appearance and function, we recommend replacing this fiscal year (2015).
- To maximize the life expectancy of this fence, restrain every 3-4 years while reserving to completely replace every 20 years.

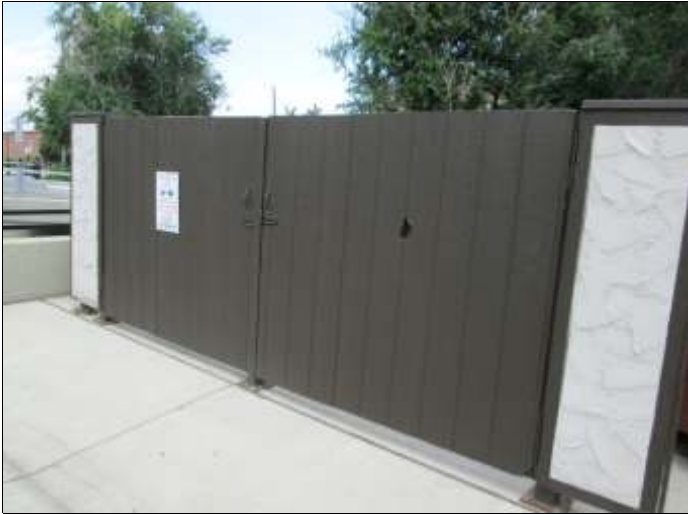
Comp #: 1010 Trash Enclosures - Replace

- Under normal conditions and with proper maintenance, we do not expect that the trash enclosures will need to be completely replaced.
- Funding on this line item is for gate replacement only; due to rubbish company's tendency to be very rough with trash enclosure gates, we recommend reserving to replace the gates every 6 years.

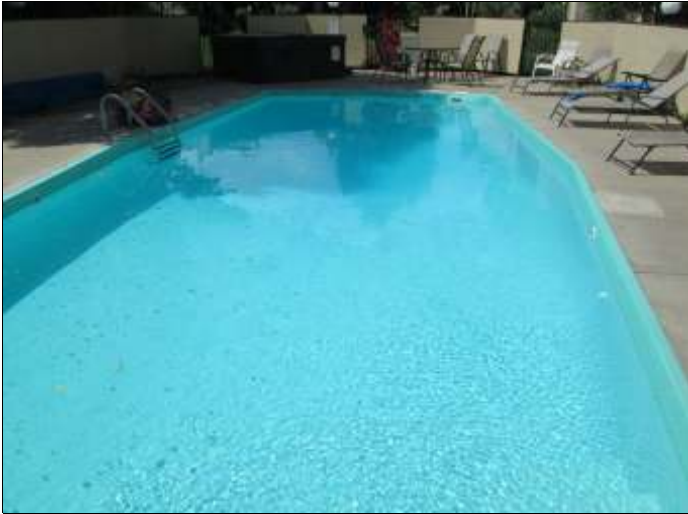
Comp #: 1101 Pool - Resurface

- The pool can be recoated, however, the repainting/resurfacing of fiberglass pools is very costly and only has a life expectancy of 4 - 5 years in a best case scenario.
- Due to the location of the pool and the fact that it is protected from the harshest UV rays in the late afternoon, we expect that the pool will not have any major issues in the foreseeable future.
- If deterioration rates change over time, we can add funding for resurfacing or shell replacement in future updates of this report.

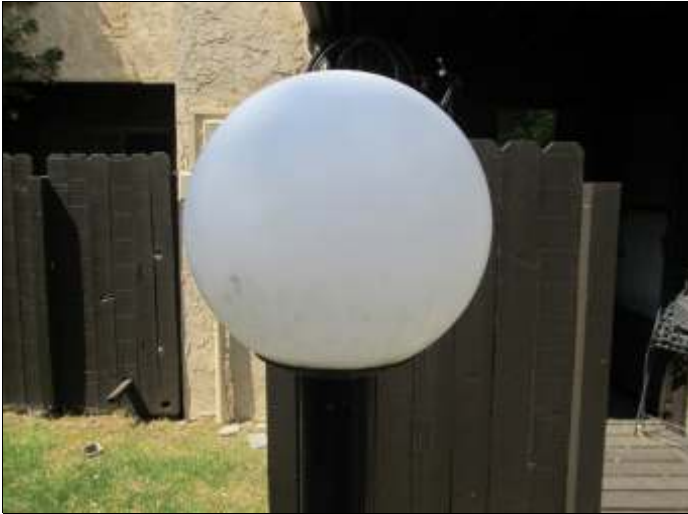
Comp #: 1604 Pole Lights - Replace

- Pole lights appear to be well maintained and there were no signs of damaged or faded globes.
- The globe lights are slightly dated in appearance, however, based on the overall good condition of the fixtures we have deferred replacement so the association can get maximum life out of the fixtures.
- Under normal conditions and with proper maintenance, expect to replace/update the fixtures every 18 - 20 years.

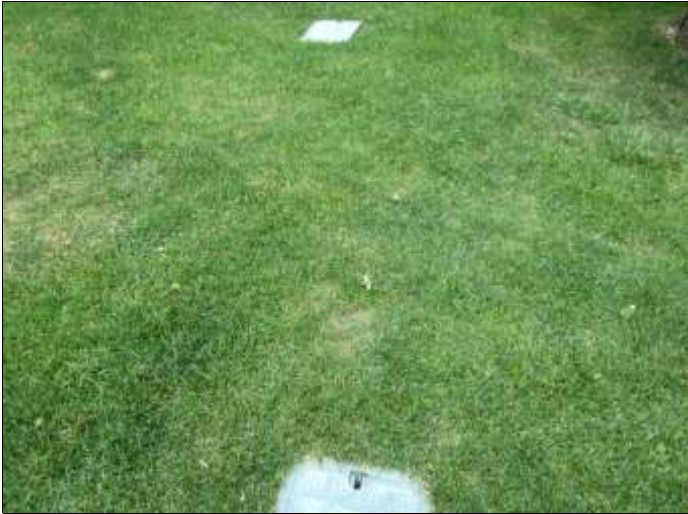
Comp #: 1701 Irrigation System - Rebuild

- It was reported upon review of the draft report that the irrigation system is in need of complete replacement.
- The costs below were reported during a phone conversation with the client.
- If the new system is properly maintained, expect a useful life of approximately 30 years under normal conditions.

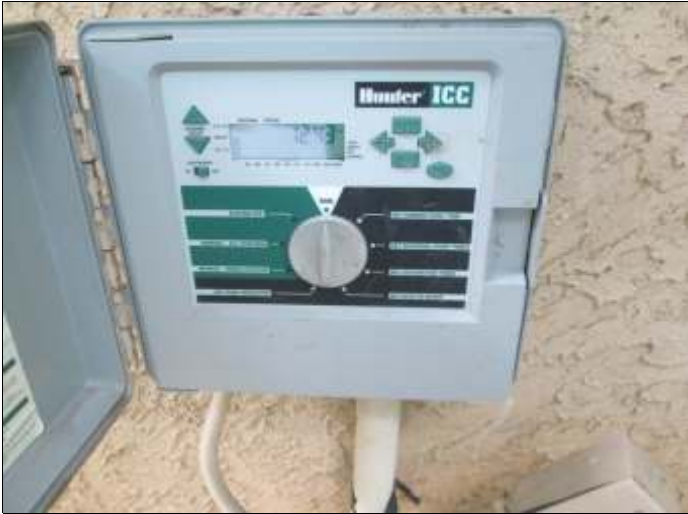
Comp #: 1703 Irrigation Controllers - Replace

- Expect to replace irrigation controllers every 10 - 12 years if properly maintained and under normal conditions.
- Funding is for replacement with evapotranspirative controllers as these are more efficient and can be controlled remotely by landscaping experts, saving the association irrigation water costs.

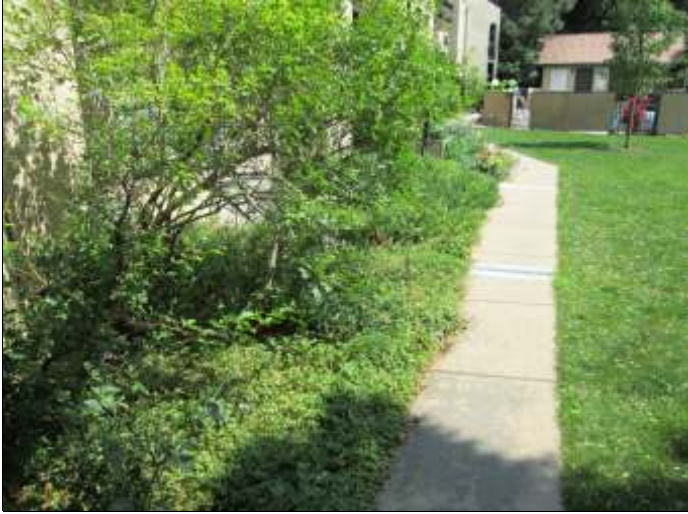
Comp #: 1801 Landscaping - Refurbish

- This line item, similar to irrigation repairs, is for projects that lie outside the scope of routine maintenance.
- In order to preserve an attractive curb appeal and to maintain the health of the plants and shrubs, we recommend reserving for refurbishment projects every 3 - 4 years.
- This line item is for cyclical refurbishment and should not be considered as complete landscaping replacement.

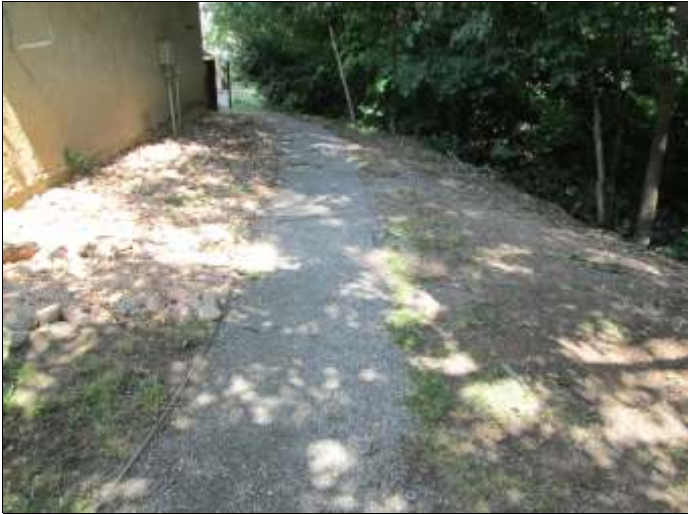
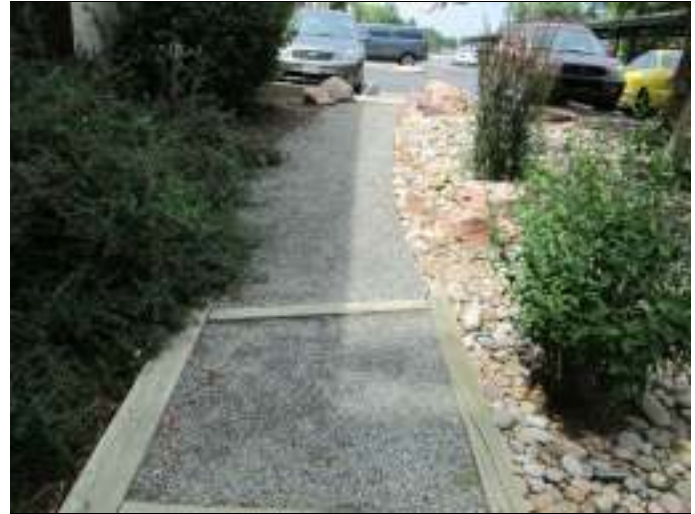
Comp #: 1813 Breeze Paths - Replenish

- The material on these paths should be replenished every 2 - 3 years to maintain a sure and attractive walking surface.
- Due to the low quantity of material, however, this can be done on an as needed basis using operating funds; no reserve funding necessary for this component at this time.

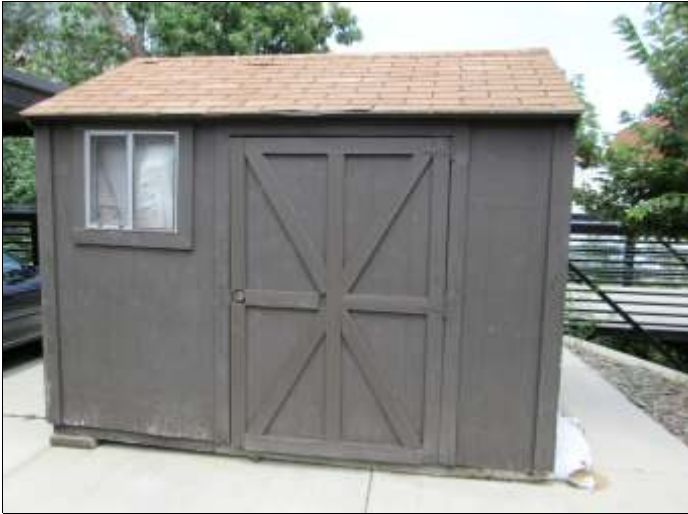
Comp #: 1904 Storage Shed - Replace

- The shed appeared in fair to poor condition at time of observation and replacement should be expected within the next 2 - 3 years to restore appearance and security.
- According to Tuff Shed, this shed should have a typical useful life of approximately 25 years if properly maintained.
